# **CITY OF FREDERICKSBURG HISTORIC REVIEW BOARD**

**TUESDAY, OCTOBER 11, 2022**

## **6. CERTIFICATE OF APPROPRIATENESS APPLICATIONS**

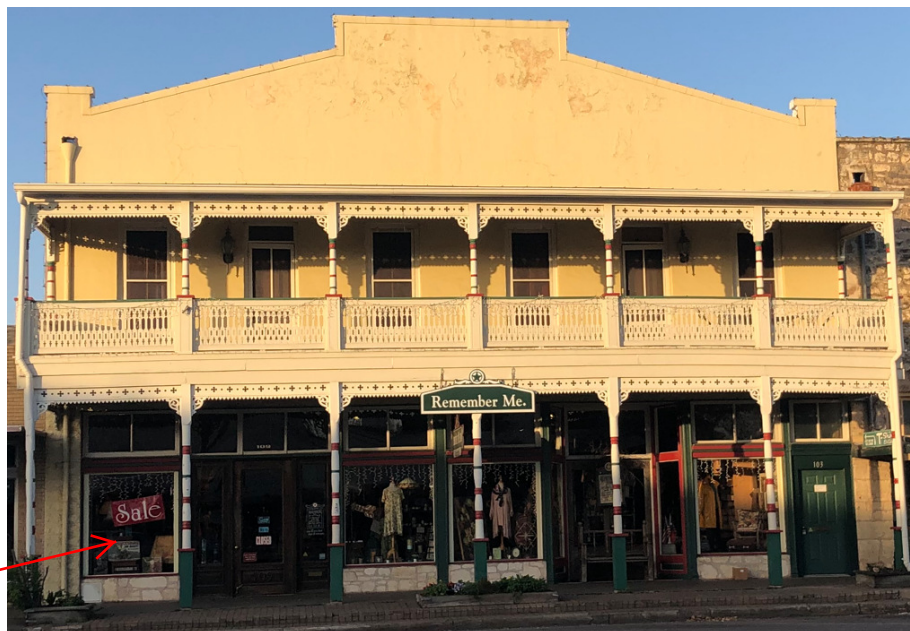
EXISTING CONDITIONS PHOTOGRAPH

INSTALL NEW EXIT  
DOOR AT THIS  
LOCATION

## NORTH ELEVATION (STREET FACADE)

A new exterior door is required for access to the upstairs. The proposed design fits into the existing storefront with minimal alterations. The storefront frame will remain. The proposed new wood door will be painted the same green as currently found on the building. Staff recommends approval based on 3.2.10 Storefronts (f)

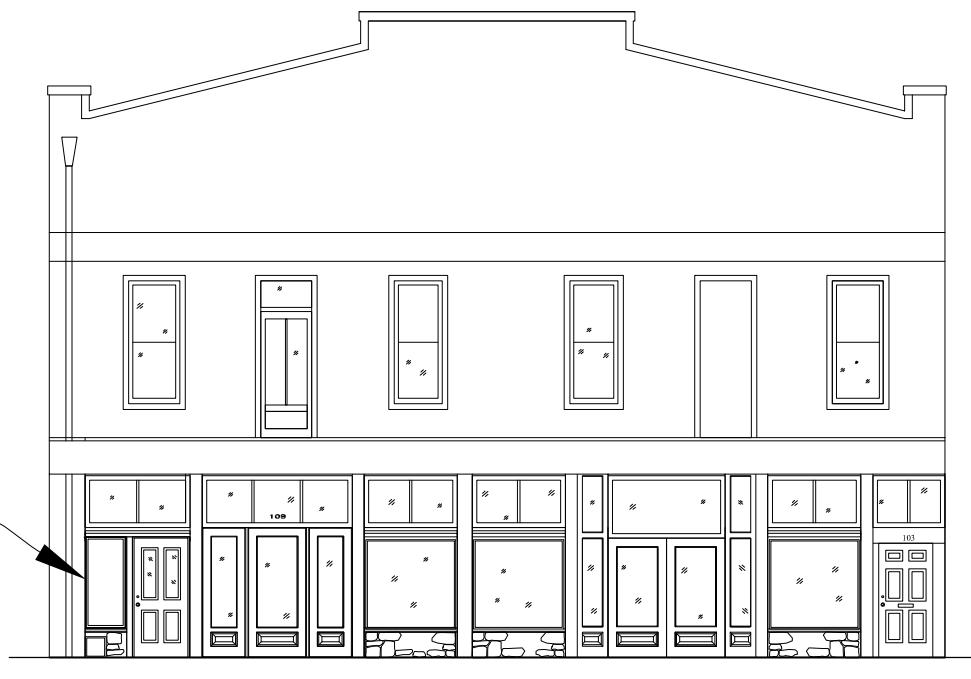
## NORTH MAIN STREET ELEVATION (Without porch/balcony)

INSTALL NEW EXIT  
DOOR FROM  
SECOND FLOOR

PROPOSED

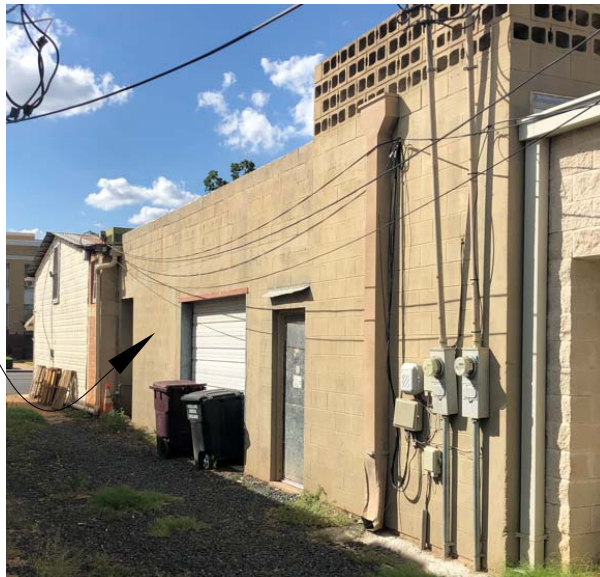
## EXISTING ALLEY VIEW LOOKING WEST

APPROX. LOCATION  
OF NEW EXIT DOOR

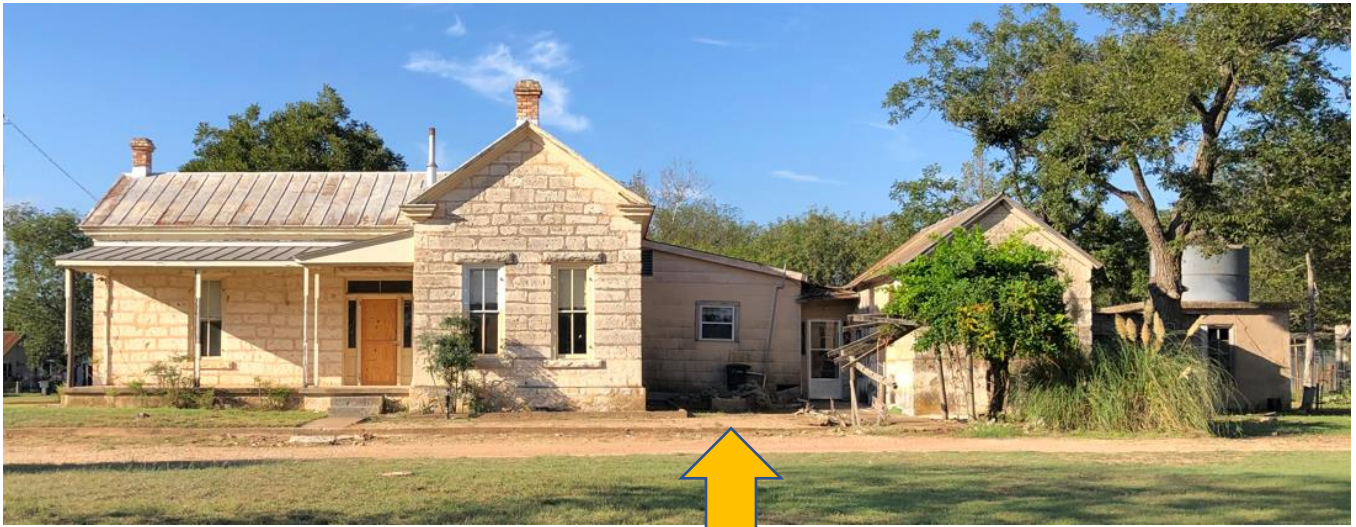
North Elevation - Remove wood framed lean to addition

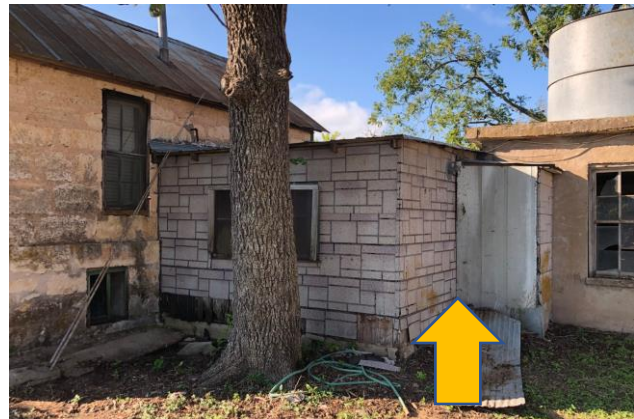
Remove wood framed infill – Protect tree.

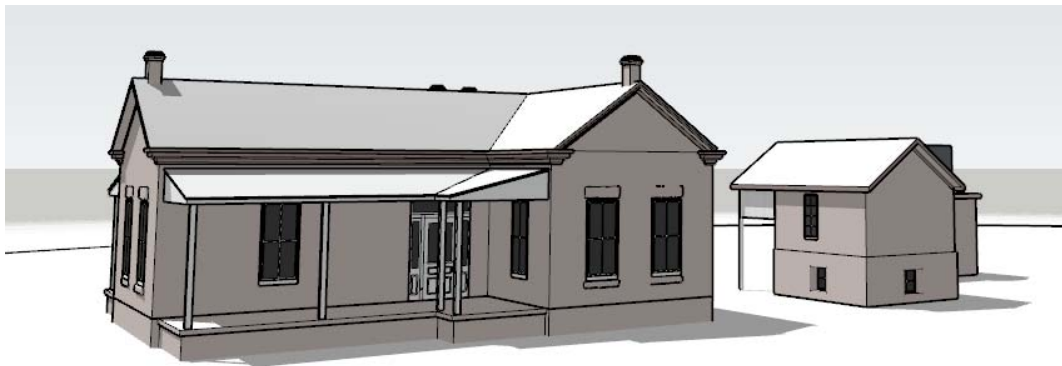
NORTH VIEW OF HOUSE POST DEMOLITION PHASE

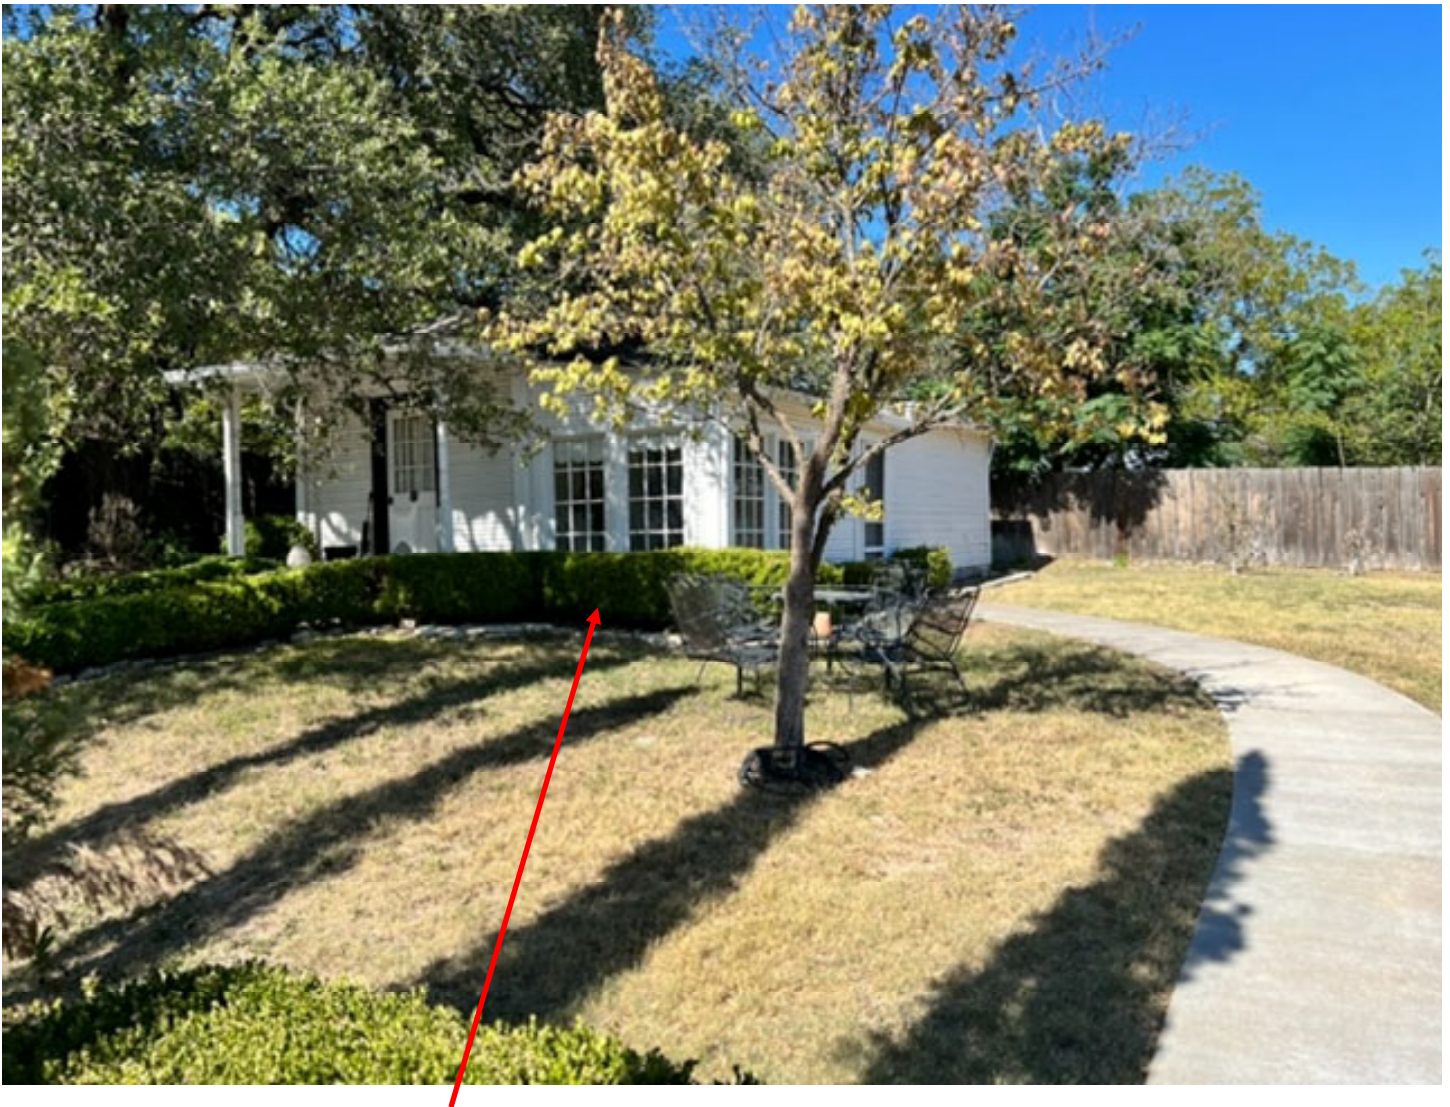
Historic aged ADU with non-historic lean-to addition (to be removed)

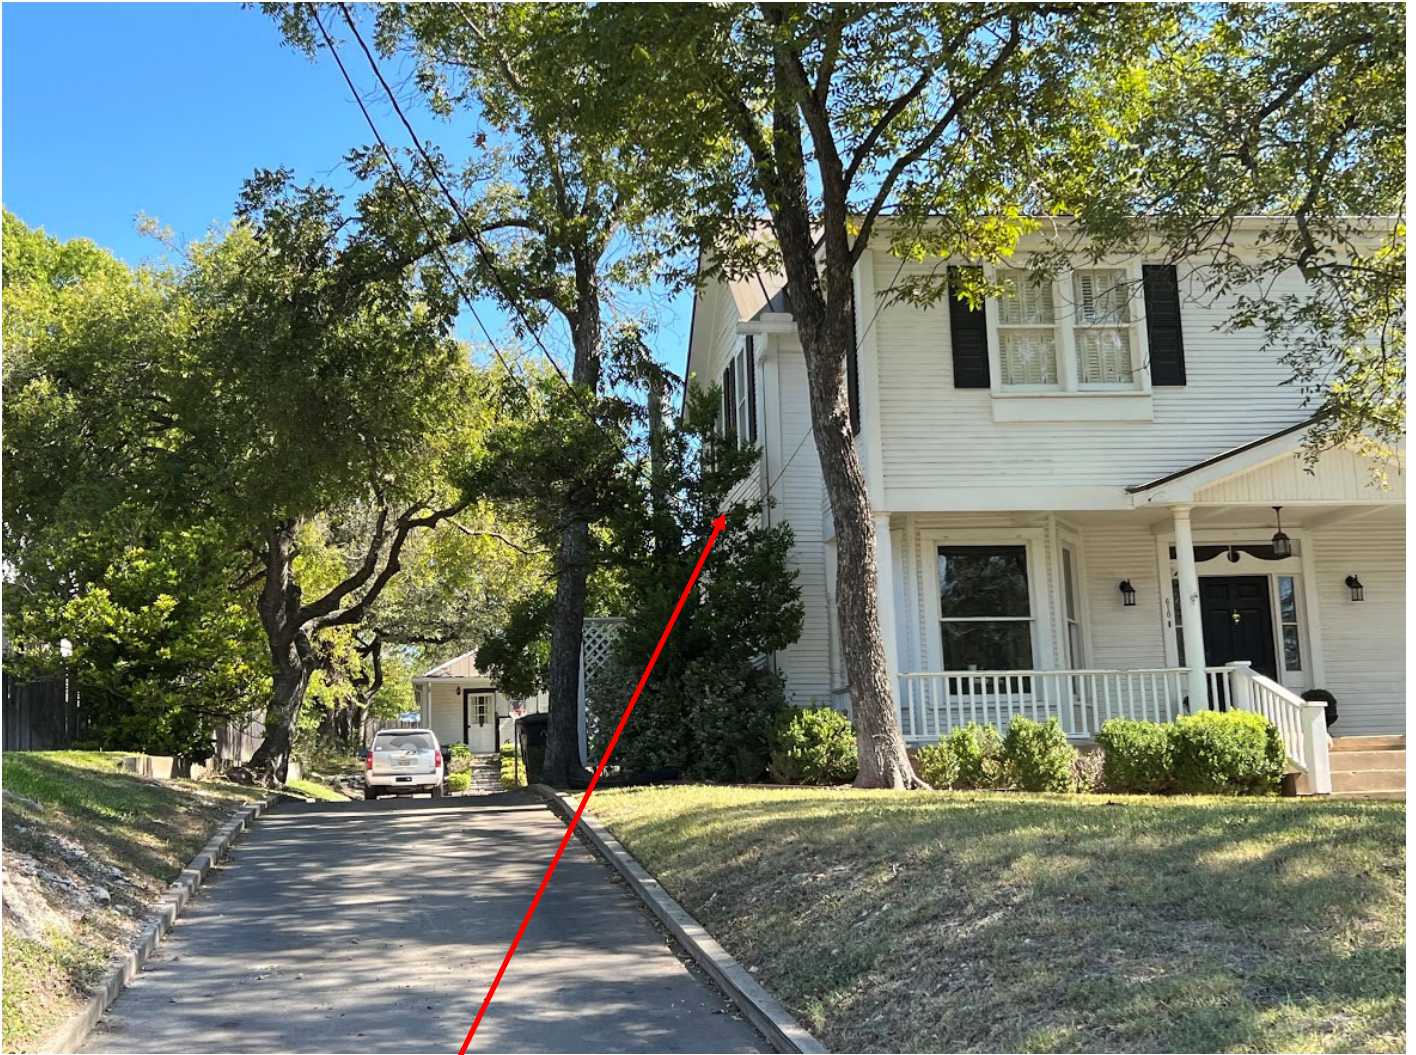
Location of proposed new chimney

The proposed outboard chimney would be a new feature not known to have existed before. There is some obvious repair/patching on the west elevation, but it is not obvious if a feature was removed and patched or it was just rotted wood that was repaired. The addition of the chimney would not be in keeping with section 3.2.4 (c).

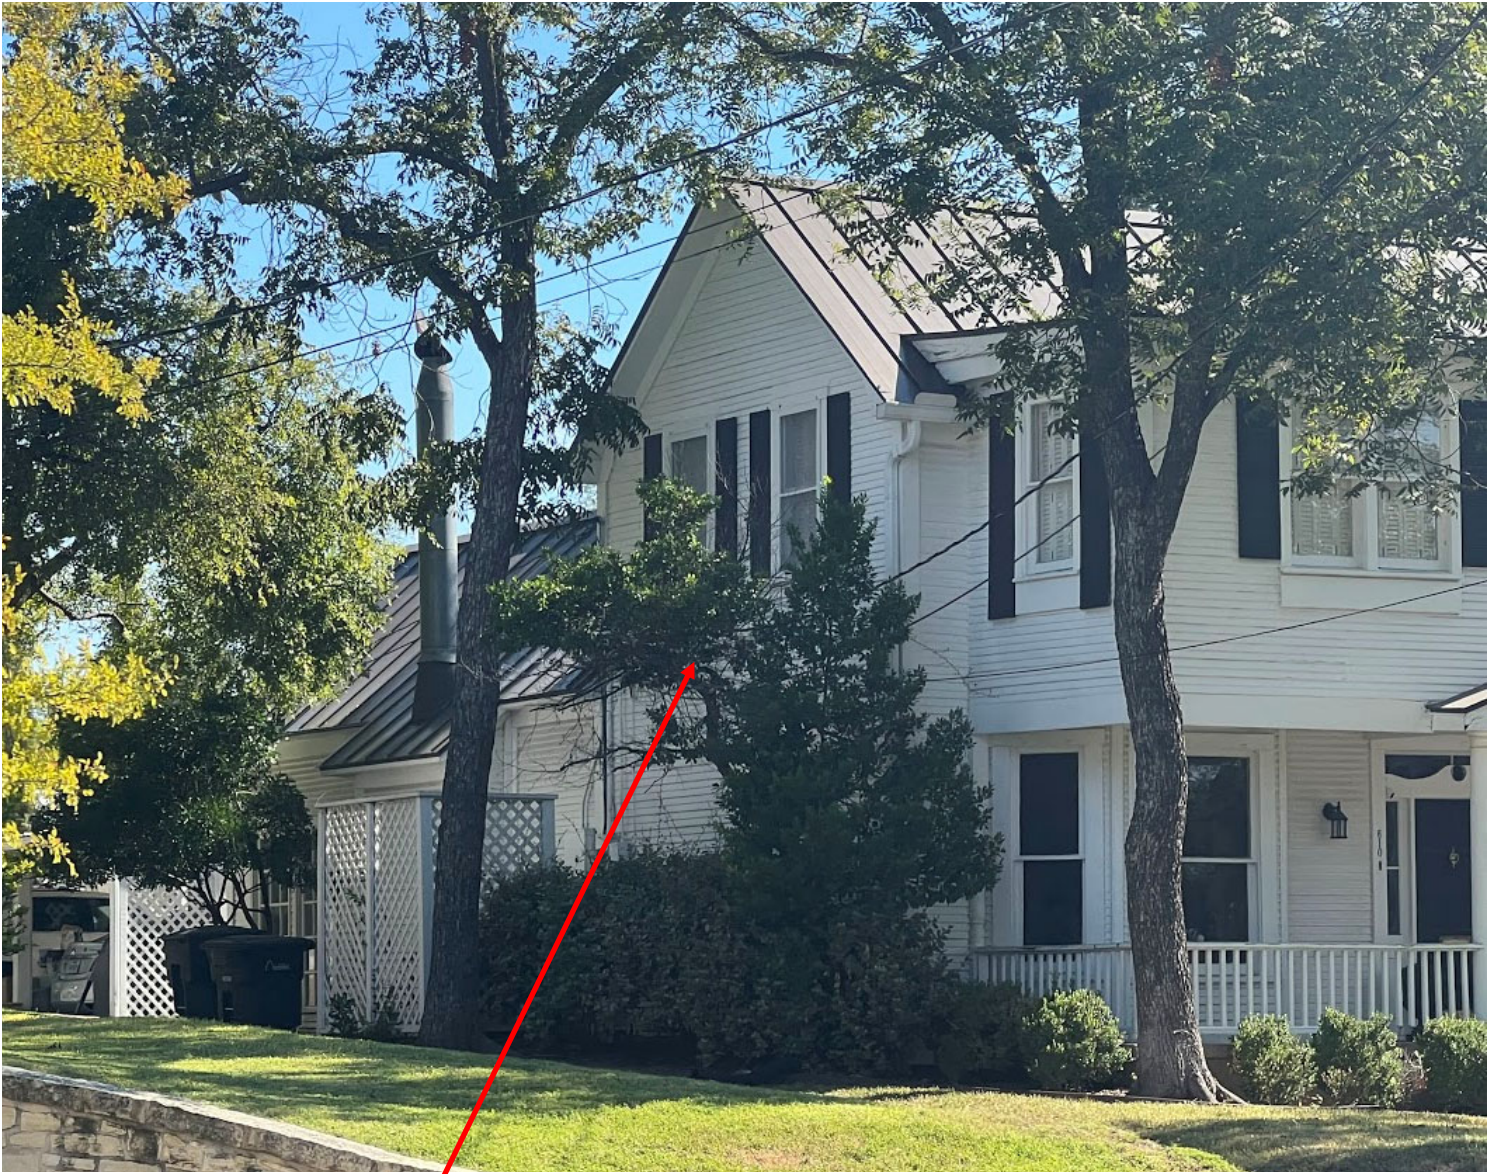
Location of proposed new chimney
