# City of Fredericksburg

Historic Review Board Meeting Agenda  
Tuesday, March 14, 2023 ~ 5:30 PM  
Law Enforcement Center  
1601 E. Main Street  
Fredericksburg, Texas 78624

## 6. CERTIFICATE OF APPROPRIATENESS APPLICATIONS

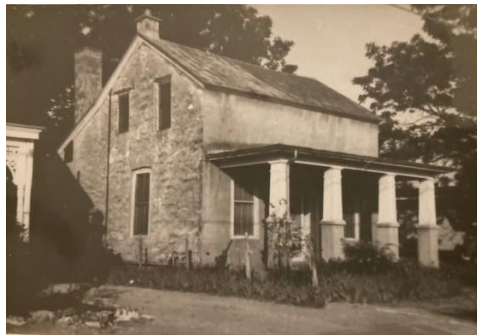
Figure 1 Front porch, circa 1970

Miss Stehling made several changes to the house. The front room was divided into a bedroom and sitting room. Plumbing was added to the kitchen and a bathroom was carved out of the room. A standing seam metal roof replaced the original wood shingles. The three windows in the front room were replaced with larger one-over-one single hung windows. The windows are larger than the original six-over-six window in the kitchen. To cover the rough edges of the enlarged window openings the front of the house was plastered. A front porch with four craftsman style columns was added.

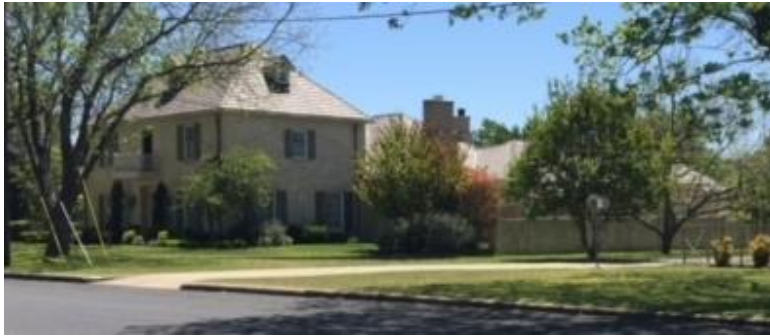
*Figure 3 Example of polymer composite shingles at 707 West Creek Street*

It is requested that two roofing materials be approved, the first being a standing seam metal roof with a standing seam ridge, similar to the existing roof and painted green similar to the existing color, and the second being polymer composite shingles, such as DaVini, with the appearance of wood shingles. Estimated cost will determine the final roofing material.

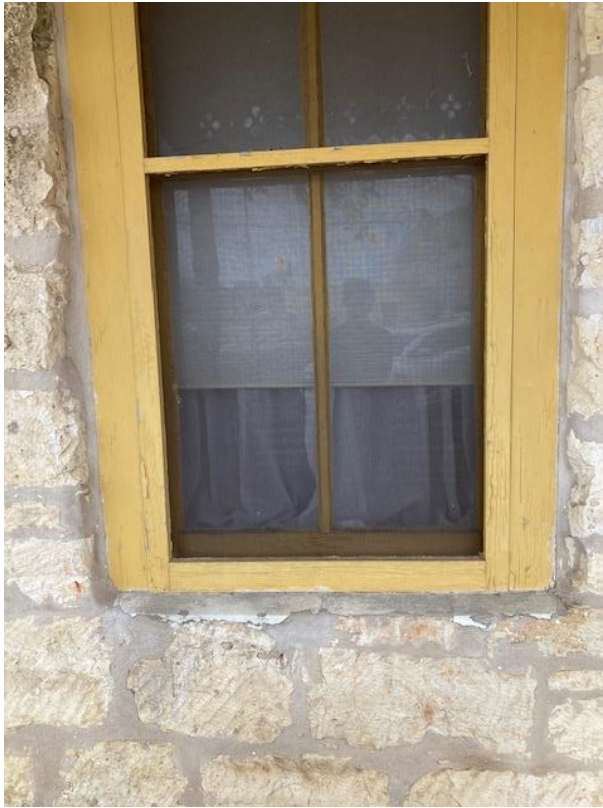
*Figure 4 Rough edges caused by 1920s window enlargements*

Approval is requested for replacement of the plaster on the front of the house. This will allow the rough edges caused by the window enlargements in the 1920s to be covered and hidden.

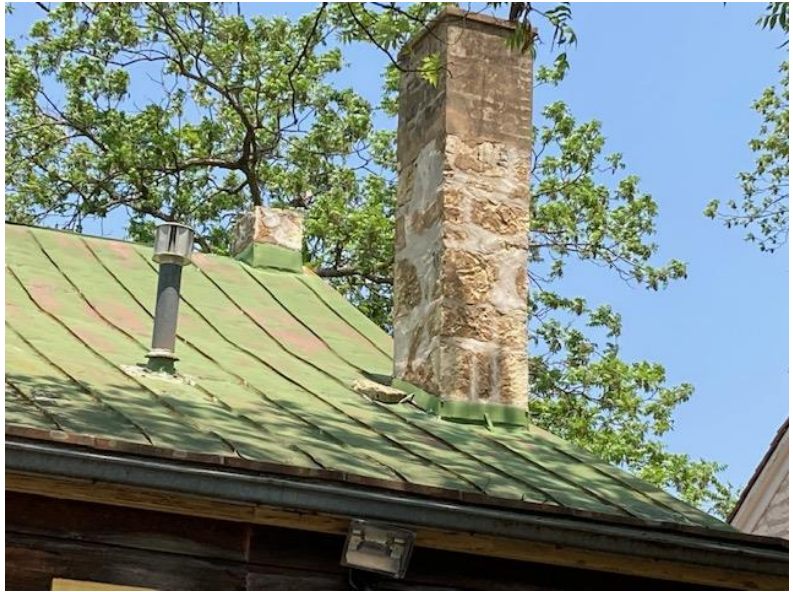
*Figure 5 Chimneys after caps were blown off. Part of chimney crown is resting on roof.*

It is requested that restoration of the chimneys be approved. The chimneys are no longer being used. The crown and cap of the chimney for the front room were blown off in a windstorm. The rock that formed the crown was saved. Approval is requested for repair of the crown and installation of an appropriate cap. The cap of the chimney for the kitchen was also blown off. The chimney was raised at

some point in the past and a concrete crown was added. Approval is requested for the installation of an appropriate cap.

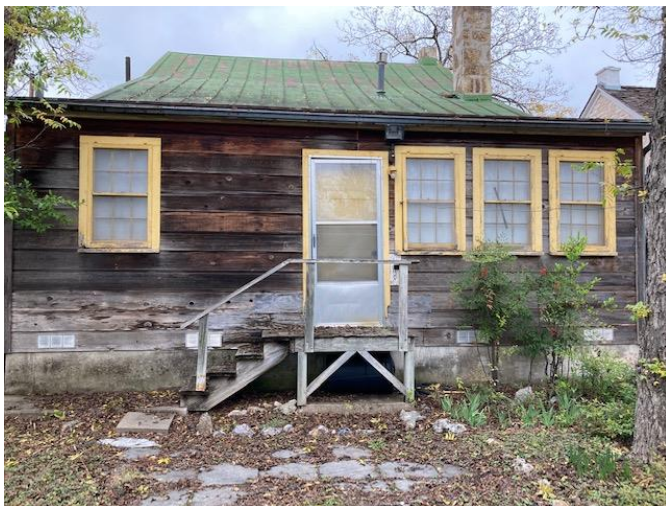
*Figure 6 Back of house showing back door landing and steps to be replaced with deck.*

Approval is requested for the removal of the landing and steps at the back door and replacement with a deck. (See Sheets 6 & 7 of floorplans) The deck will not be visible from the street.

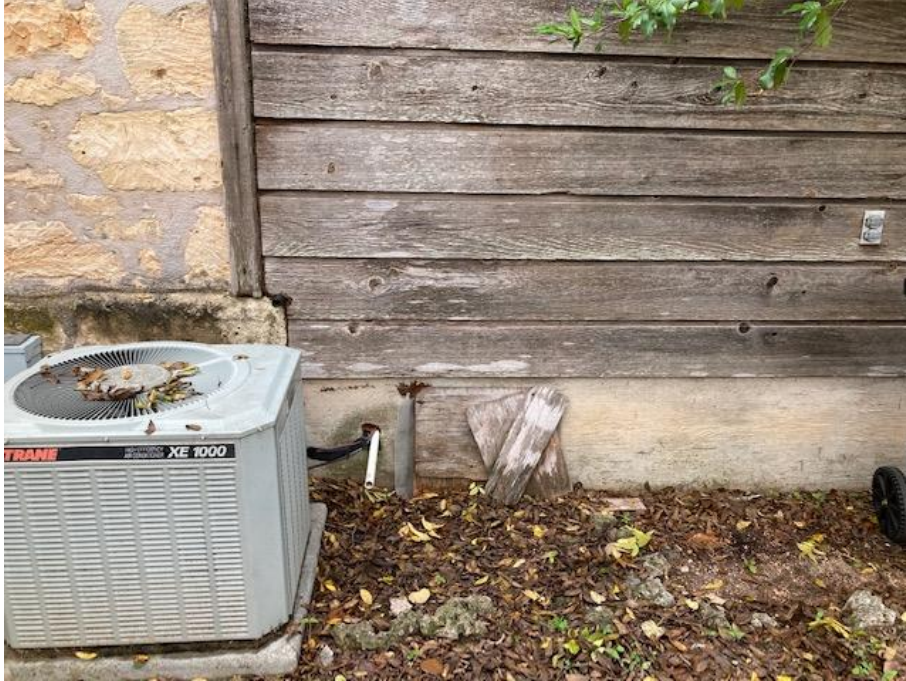
*Figure 7 Proposed location of water softener next to air conditioner compressor.*

Approval for the addition of a water softener is requested to prevent deterioration of the water supply system and appliances. Approval of placement of the water softener next to the air conditioner compressor is requested.
