# City of Fredericksburg

Historic Review Board Meeting Agenda  
Tuesday, October 8, 2024 ~ 5:30 PM  
New City Hall at East Campus  
2818 E. U.S. Hwy. 290  
Fredericksburg, Texas 78624

**CAPTION:** **2024-804** - 202/204 E Main - Dillion Reeh - Request Replacement of Exterior Windows, Canopy, and Exterior Painting.

**CAPTION:** 2024-796 - 608 N Llano - Randy Zgabay - Request to replace wood windows with metal-clad windows and replace the roof with new standing seam roof

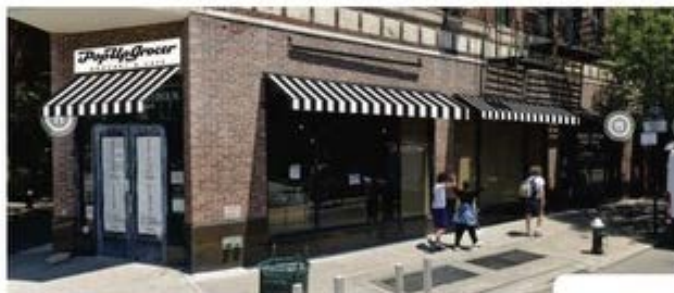
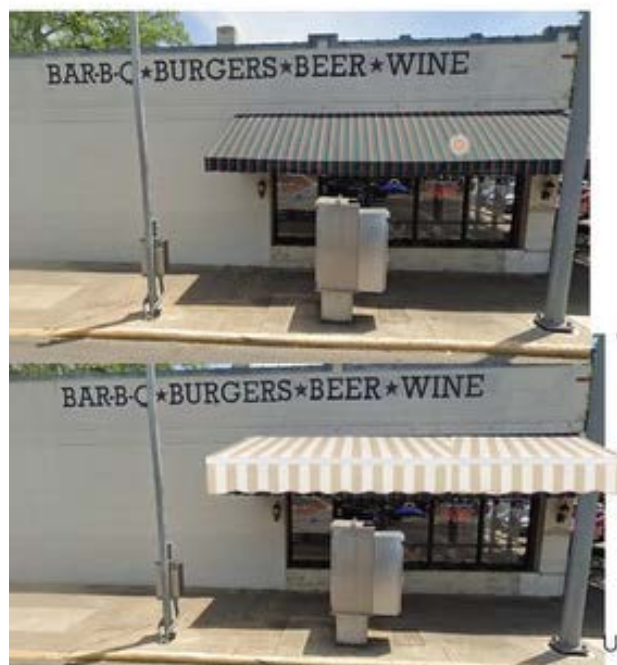
Proposing: Updating the awning along the perimeter of the building to beige and white

Current

Update awning; paint over existing verbiage

The existing canopy is not historic and was added to the building as part of previous development, however, no element of a historic canopy should be removed (b). If replacement is necessary, match the original in design, profile, finish, and texture (c). Do not add ornamentation or details that were not historically present (d).

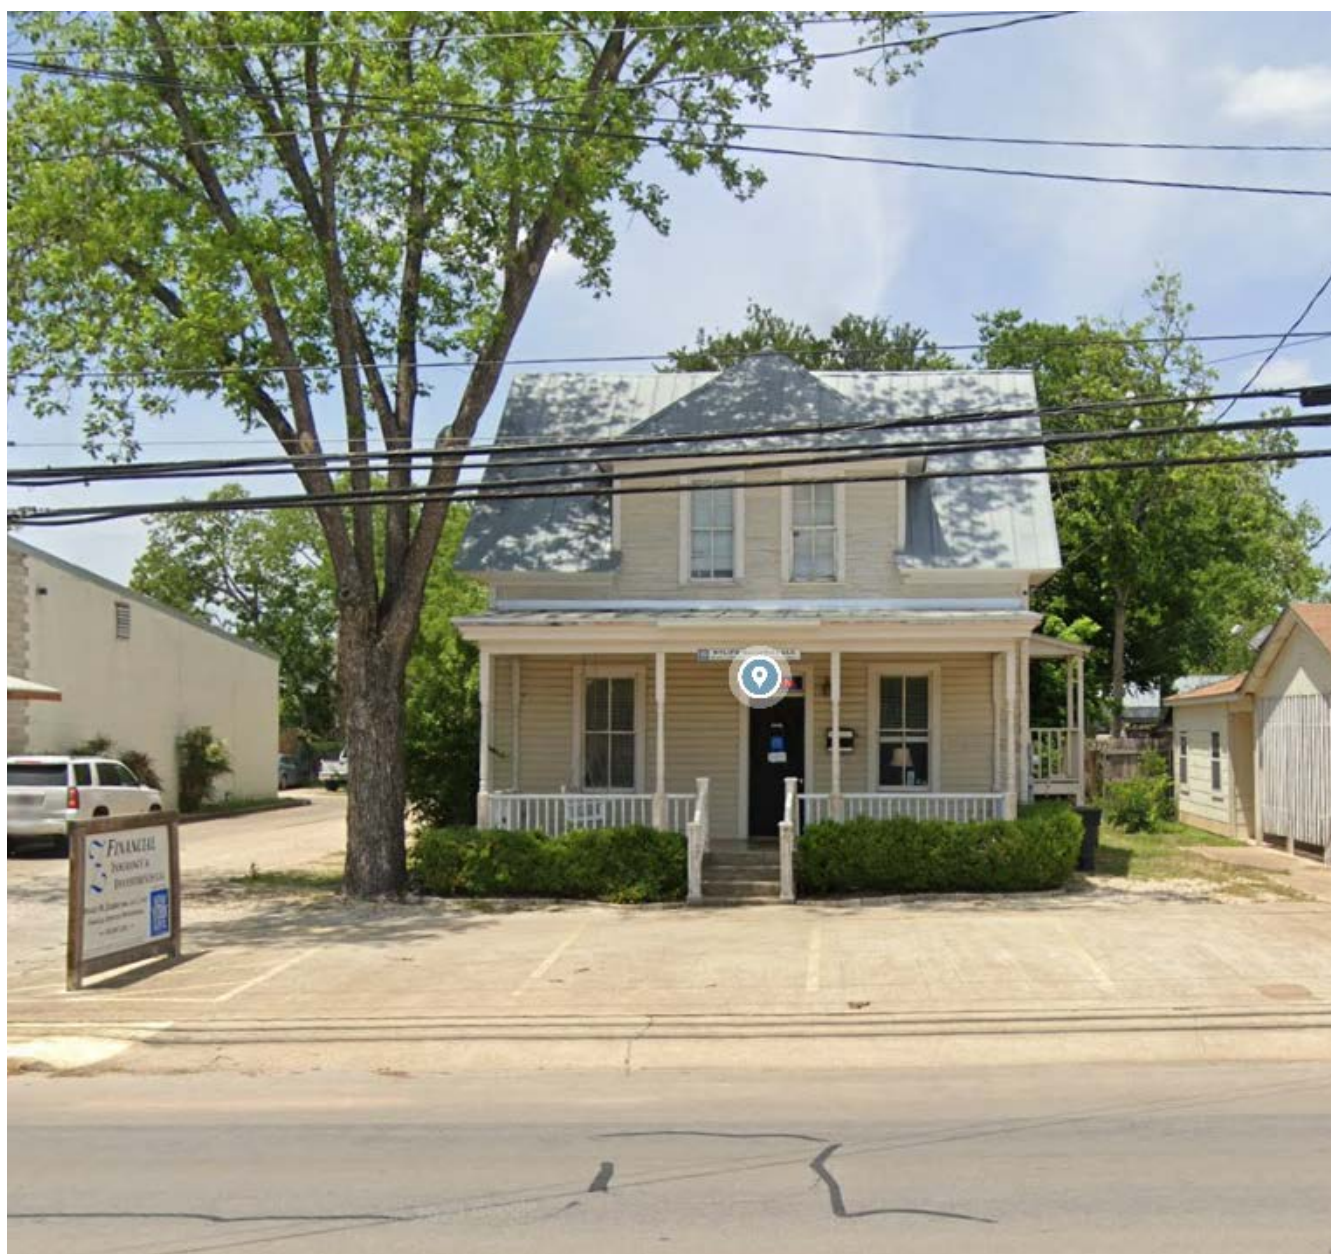
608 N. Llano St

Old window damaged by hail storm and is rotten

The windows were damage by hail in April 2022. I have dealing with the insurance company to get the windows fixed or replaced. After two years the insurance company decided it would be most cost effective to replace the windows instead of fixing them. I found an almost exact match to the window (wood on the inside and iron clad on the outside). The hail also beat the paint off two sides of the structure. The roof was damaged in a windstorm and will be replaced with a standing seam just like the front and back porch. The improvements should put the structure in a very close appea

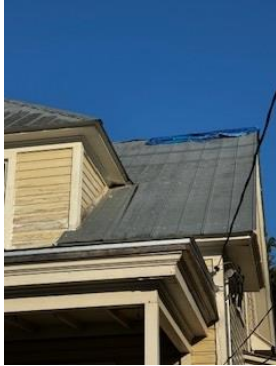
old roof damage from wind storm

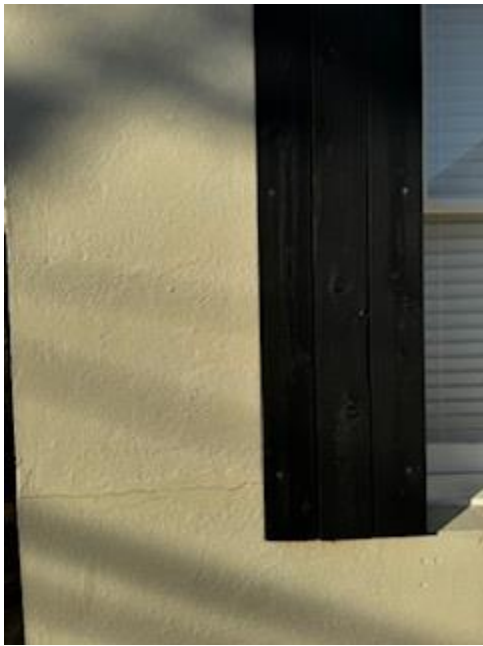
new paint color

Appendix G provides several references to paint palettes. Staff referred to Figure G-2, a Victorian palette from the Harrison Brothers and Company, and found that the requested cream color is in keeping with Appendix G.

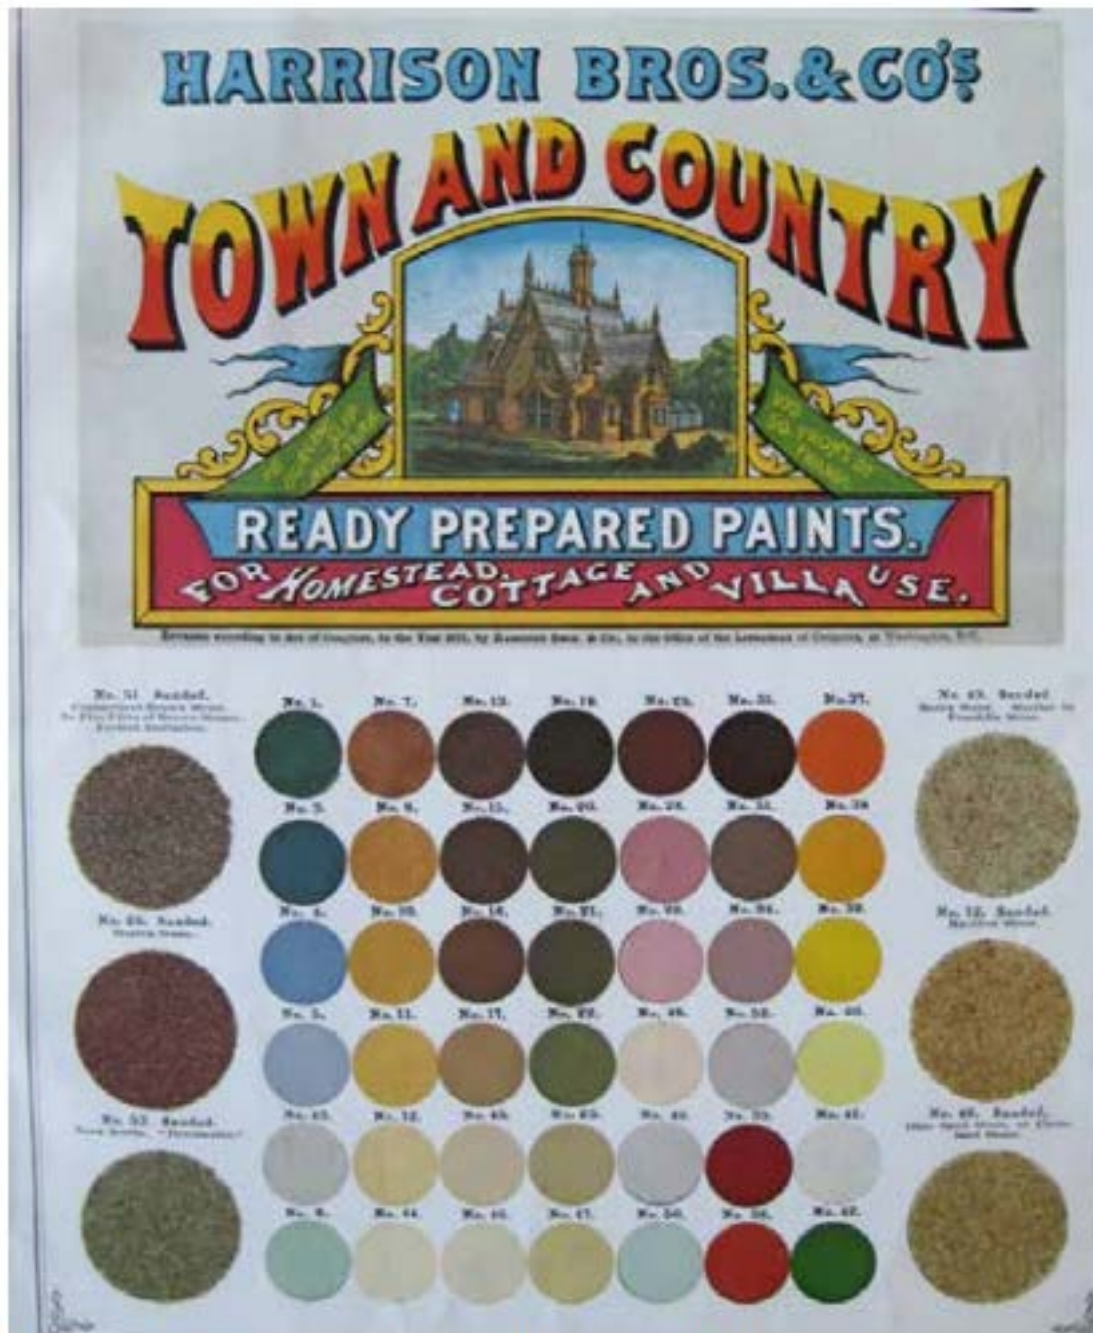
**Figure G-2.** Victorian palette from the Harrison Brothers and Company, Inc., 1871. Source: Sara McLean, "Then, Now & Forever® - The Victorian Era Color Collection," Dunn-Edwards Paints, accessed May 5, 2020, <https://www.dunnedwards.com/colors/specs/posts/then-now-and-forever-r-the-victorian-era-color-collection>.

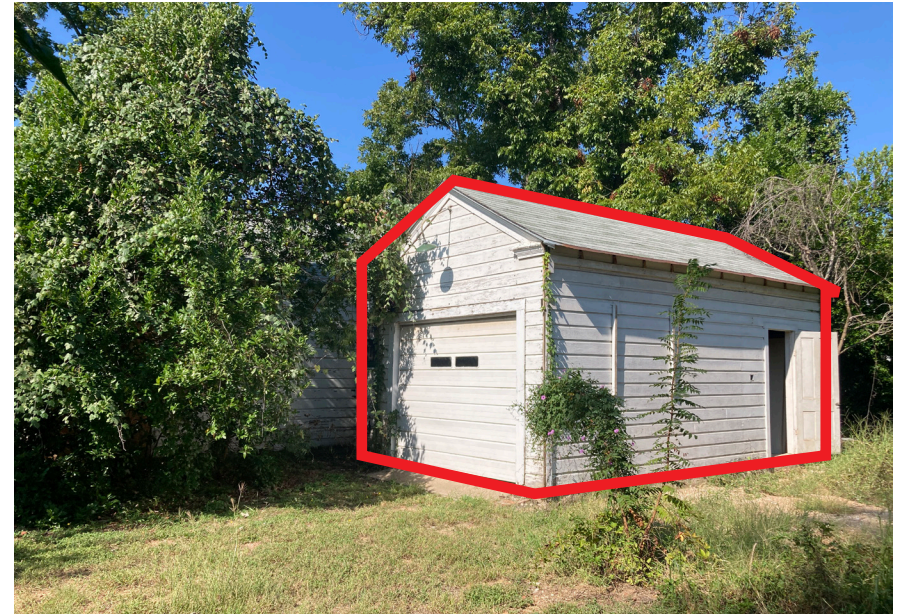
**ONE CAR GARAGE TO BE REMOVED**

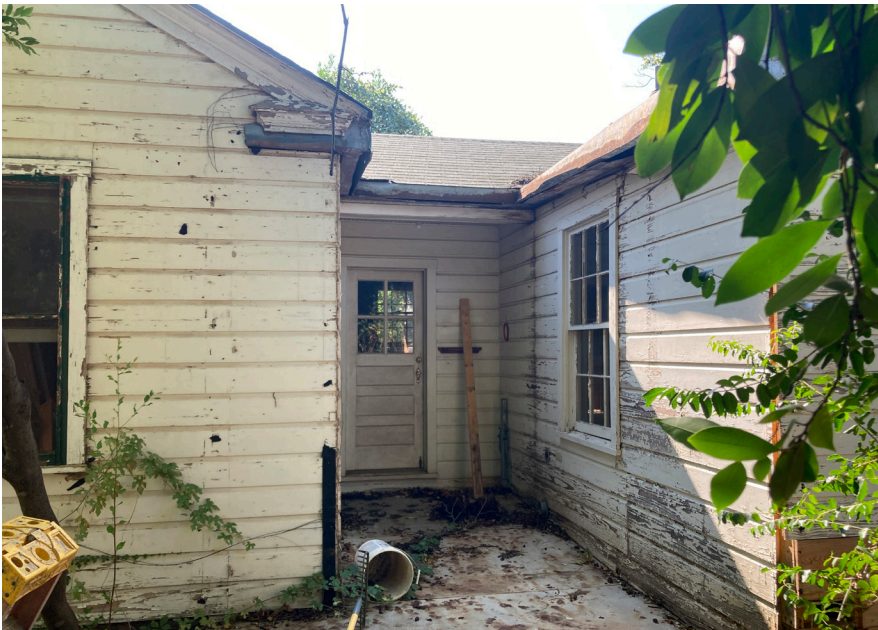
**REAR (NORTHWEST ELEVATION) OF HOUSE TO BE PRESERVED  
GARAGE TO BE REMOVED ON LEFT**

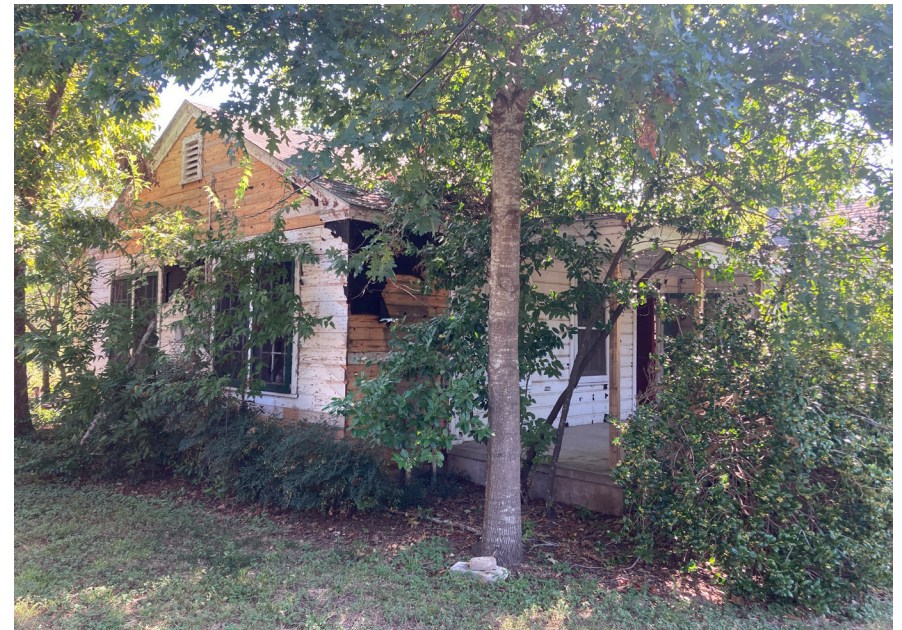
**SOUTHWEST ELEVATION. PORCH ON RIGHT TO BE RESOTRED TO  
ORIGINAL CONDITION**

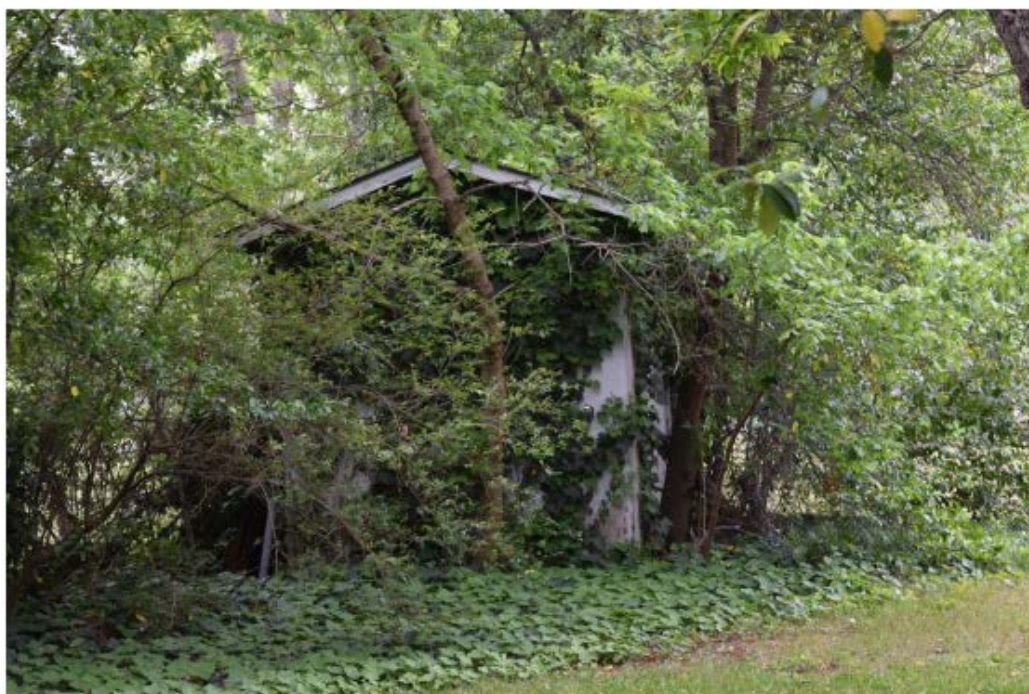
Garage addition at rear
