# City of Fredericksburg

Historic Review Board Meeting Agenda  
Tuesday, July 8, 2025 ~ 5:30 PM  
New City Hall at East Campus  
2818 E. U.S. Hwy. 290  
Fredericksburg, Texas 78624

## 6. CERTIFICATE OF APPROPRIATENESS APPLICATIONS

- A. **2025-529** - 416/418 East Main - Brookes Bubble Bar - Request to Construct an Outdoor Bar
- B. **2025-555**- 210 W Travis - Request to build a parking structure.
- C. **2025-590** - 106 S Lincoln - Re-rate the guest house to Low.
- D. **2025-549** - 301 South Adams - Demolition of the entire property with concept plans to replace it.
- E. **2025-656** - 520 E Main - Church door replacement.
- F. **2024 - 532** - 401 E College - Demolish outbuilding and Construct New Accessory Dwelling Unit using Salvaged Materials.
- G. **2025-639** - 109 W Centre - Mary Cunningham - Request to construct a 1,600 sq ft addition to the rear of the building.

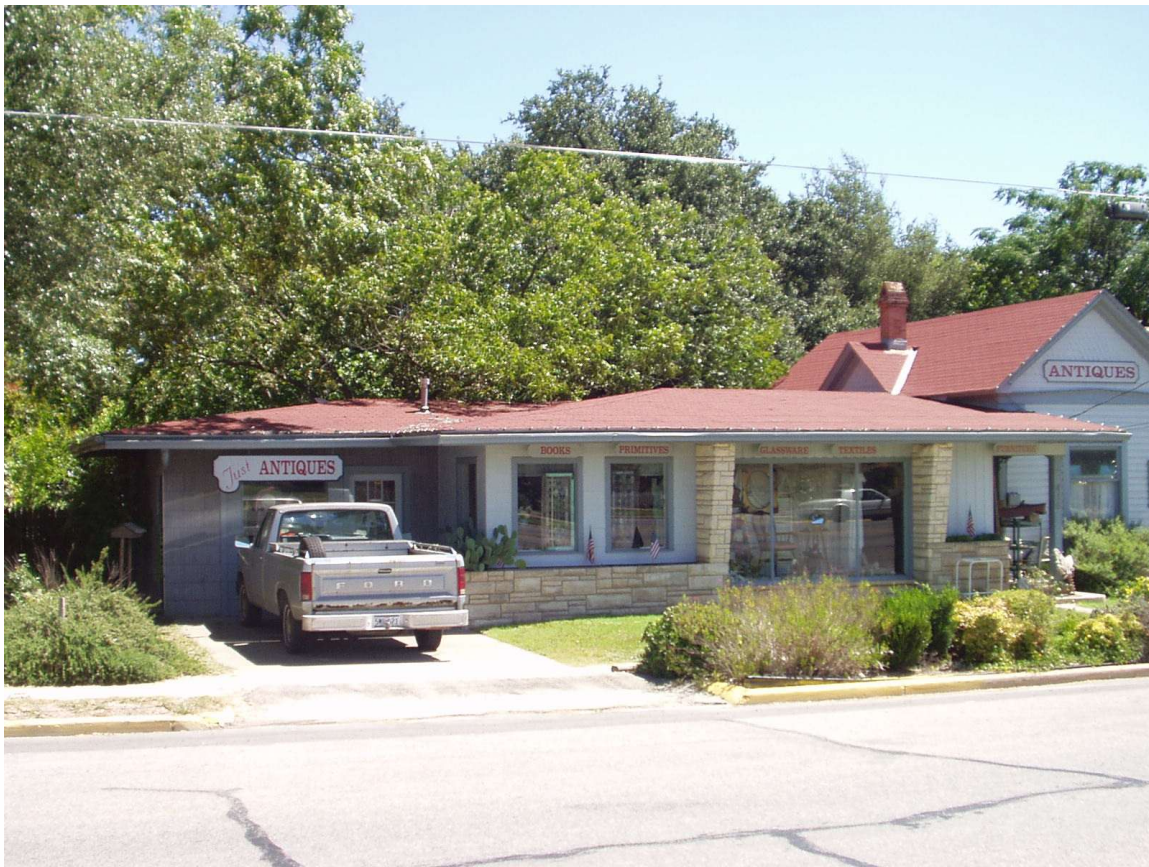
### 2002 Photo

Function	Domestic: Single-Family; Commerce/Trade	No of Stories	1
Style	not provided	Construction	wood-frame
Plan	irregular	Foundation	slab
Exterior Walls	wood siding	Roof	hipped
Porches	inset	Windows	fixed wood sash
Outbuildings	not provided	Doors	single-leaf door
Alterations	exterior materials

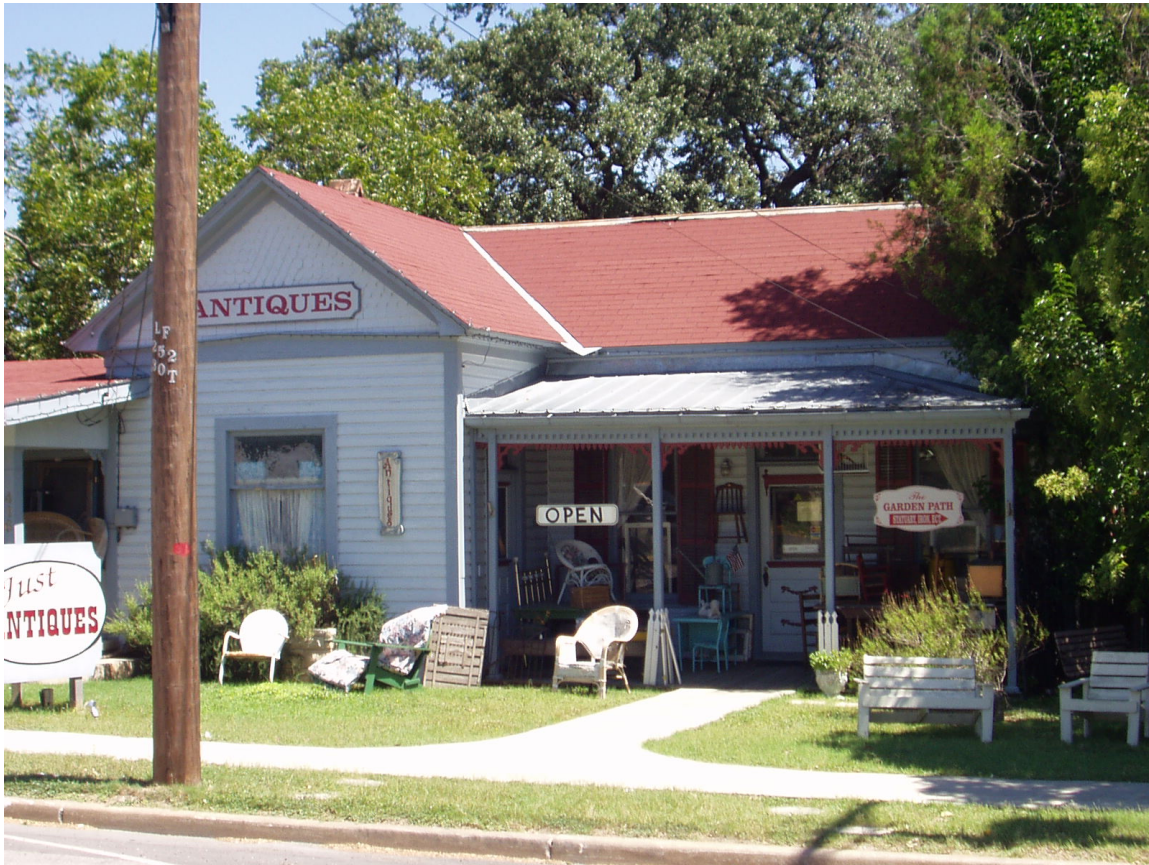
### 2002 Photo

Function	Domestic: Single-Family; Commerce/Trade	No of Stories	1
Style	vernacular	Construction	wood-frame
Plan	wing-and-gable/L-plan	Foundation	pier and beam
Exterior Walls	wood siding	Roof	gable
Porches	hipped	Windows	double-hung wood sash
Outbuildings	not provided	Doors	original
Alterations	addition

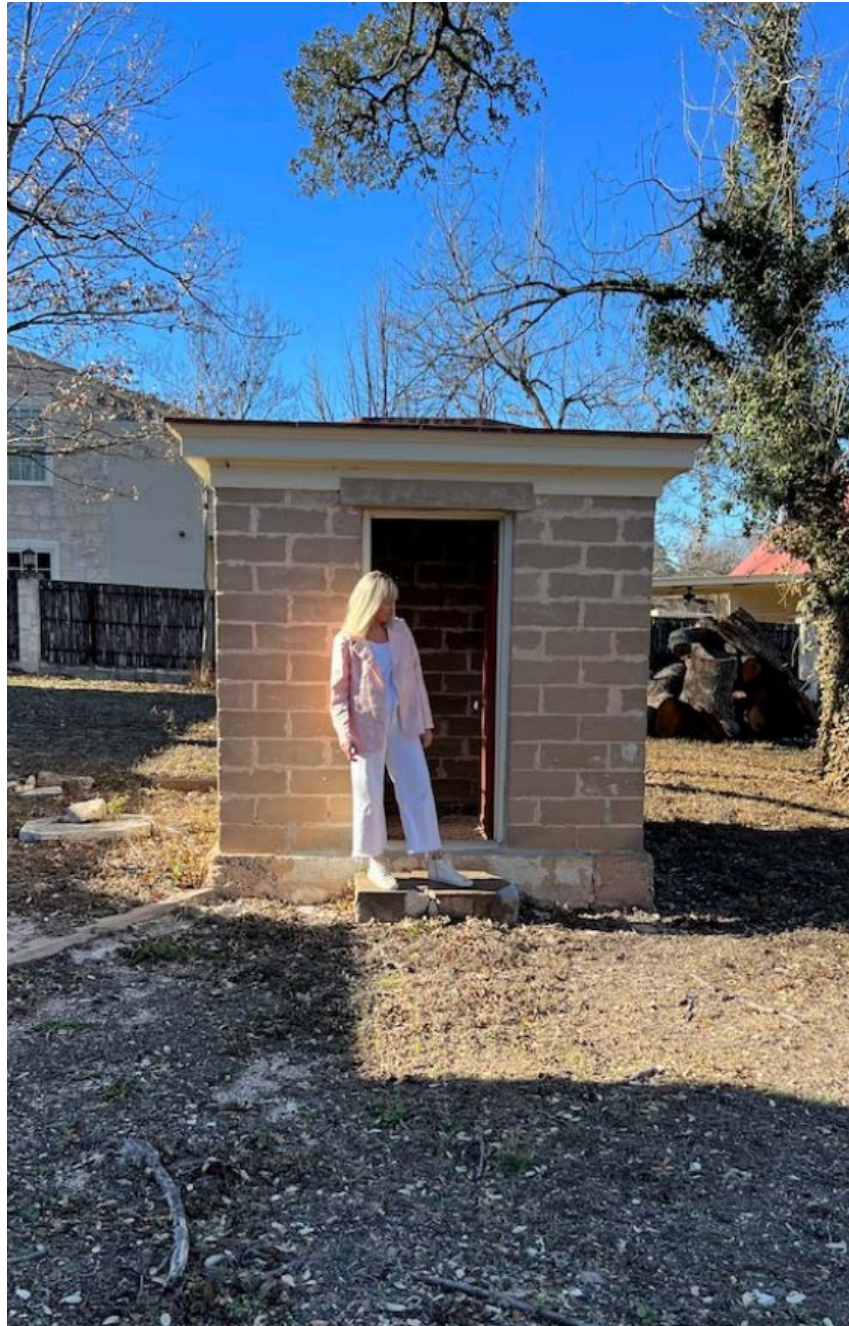
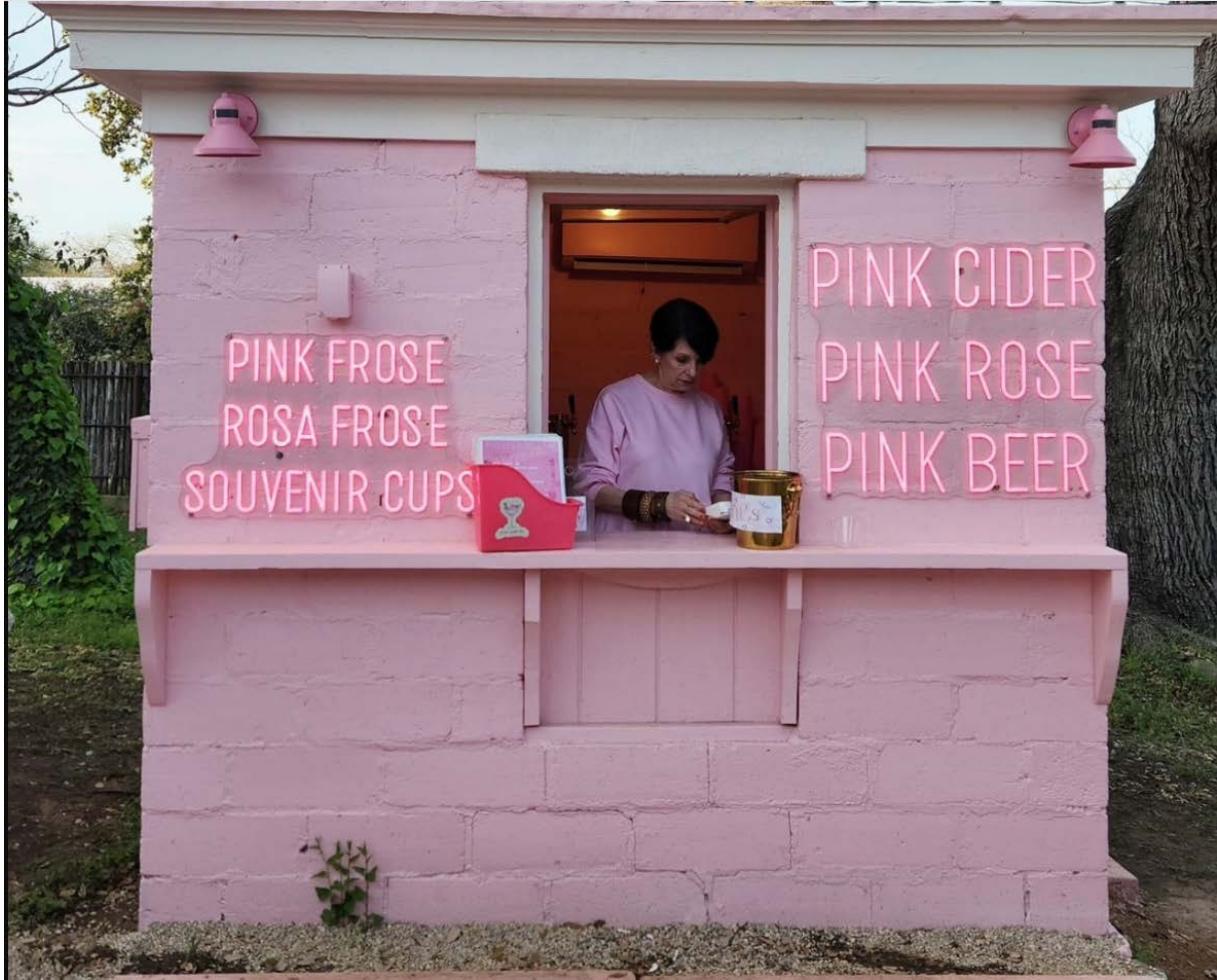
416 – 418 E Main Accessory Building Photos

SAME PAINT USED ON ALL  
STRUCTURES TO MATCH  
BUILDING APPROVED COLOR

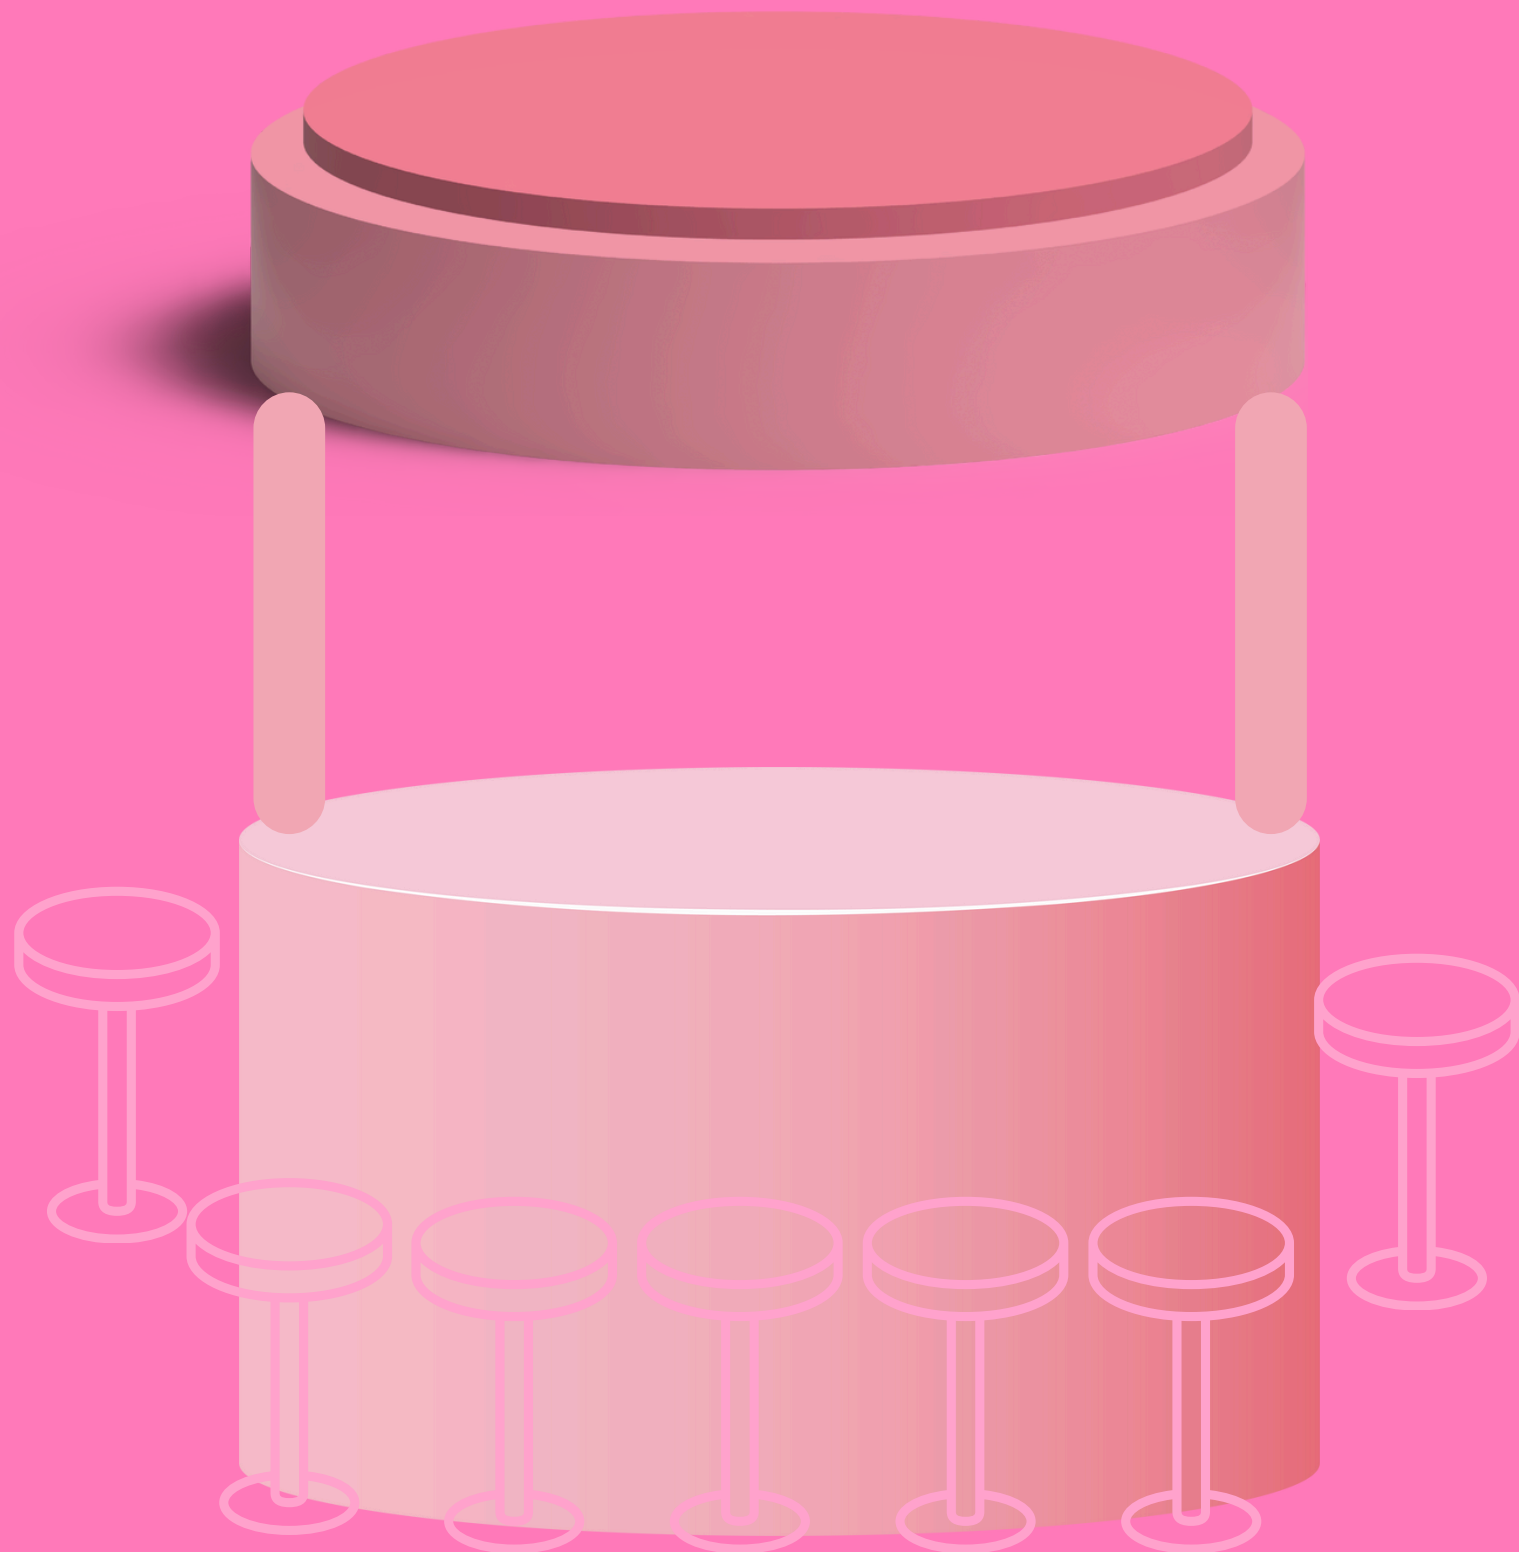
## STRUCTURE

METAL CIRCULAR OUTDOOR BAR FOR MORE SEATING  
IN BACKYARD

THIS METAL STRUCTURE IS ONLY TO ENSURE  
ADDITIONAL SEATING IN THE BACKYARD OF BAR.  
IT IS NOT GOING TO BE USED FOR ANY OTHER  
PURPOSE.

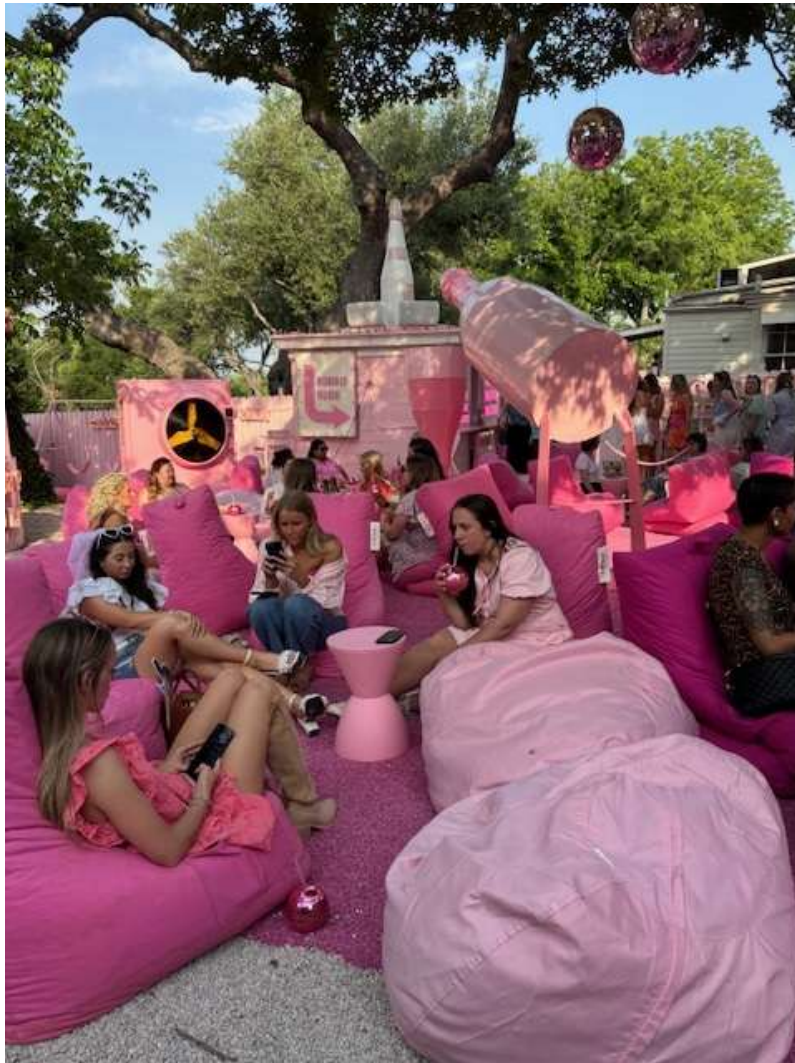
Tank House

416 E Main – Backyard Photos

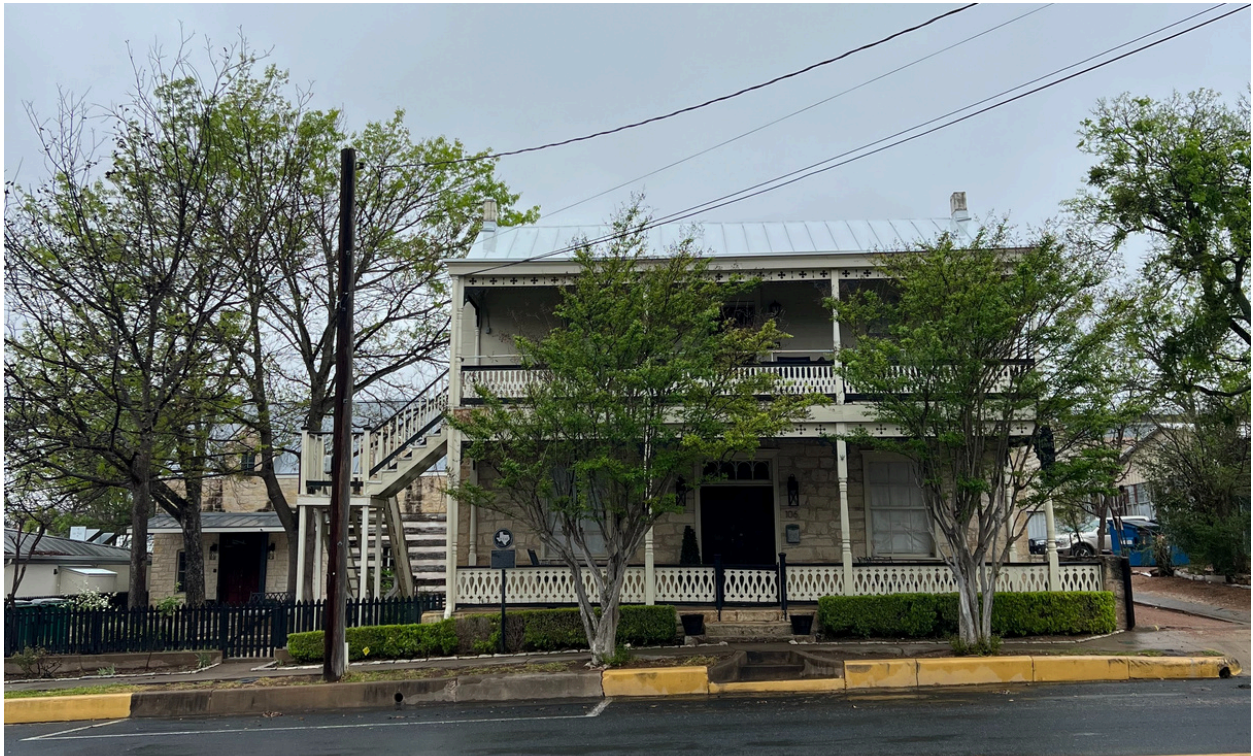
View from the street of the Main House and Guest House (back, left).

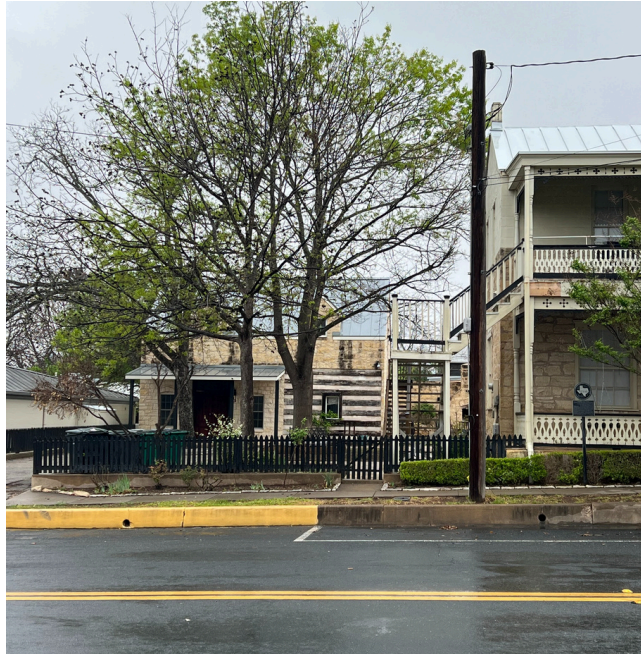
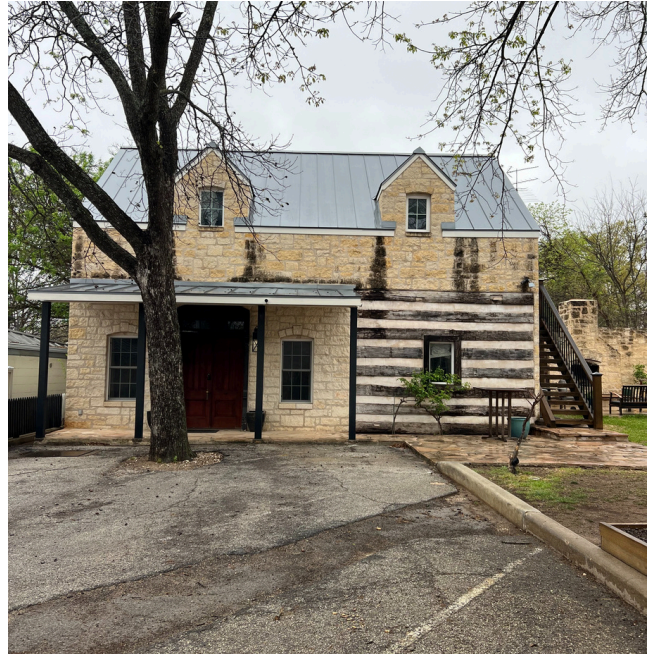
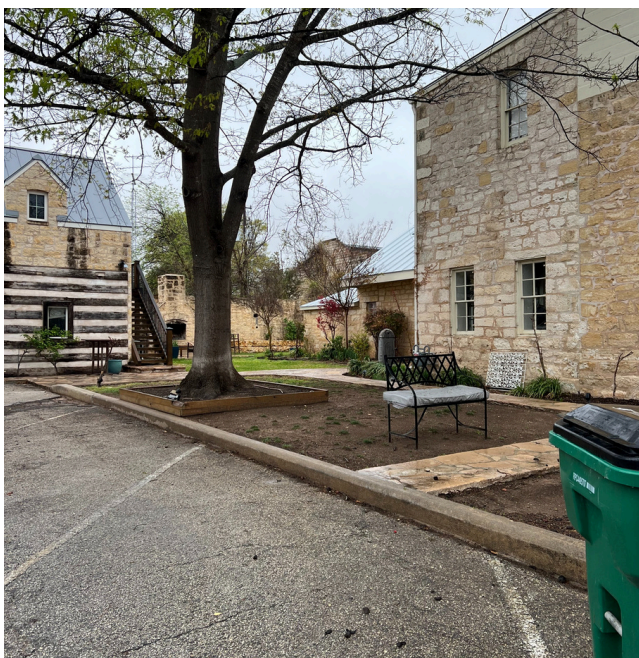
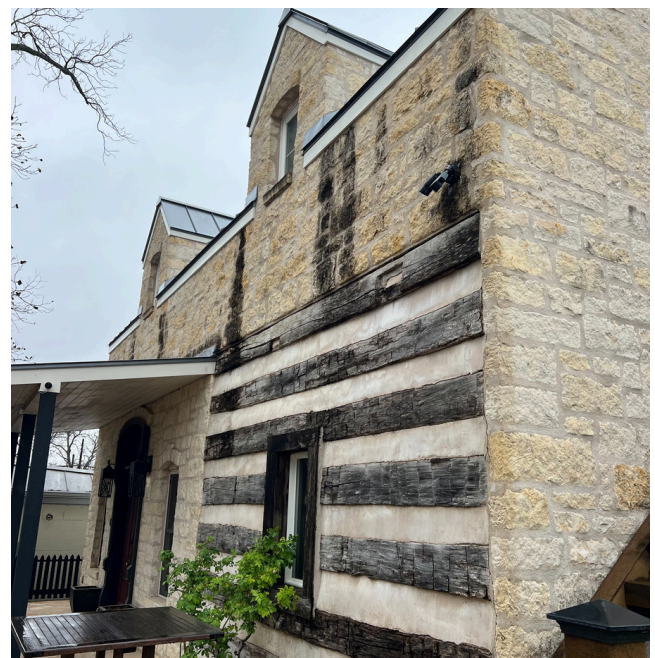
# GUEST HOUSE

The guest house built in 2016 (per GCAD) sits at the rear of the property.

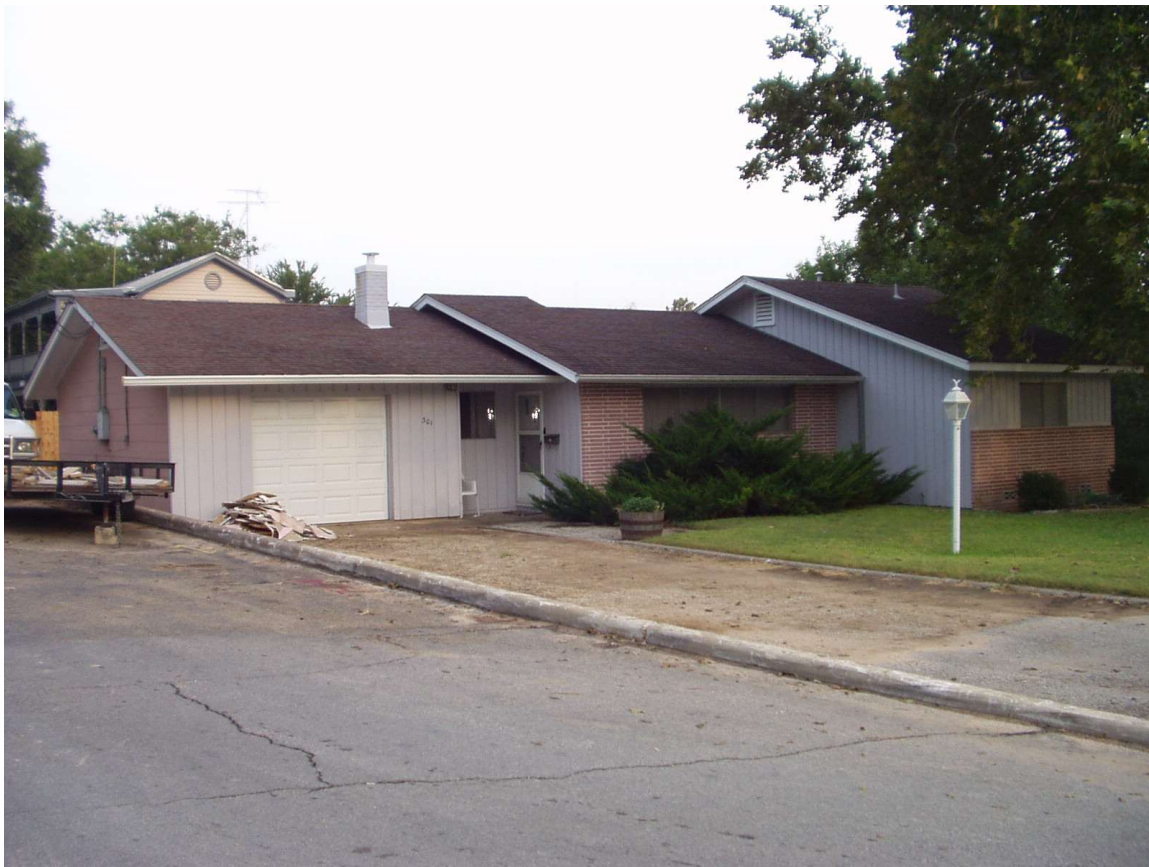
### 2002 Photo

Example of a more recent common local building form, architectural style or plan type with no known historical associations. Resource has undergone alterations.

Exterior walls reclad w/vertical plywood siding and brick veneer and original windows replaced on front façade.

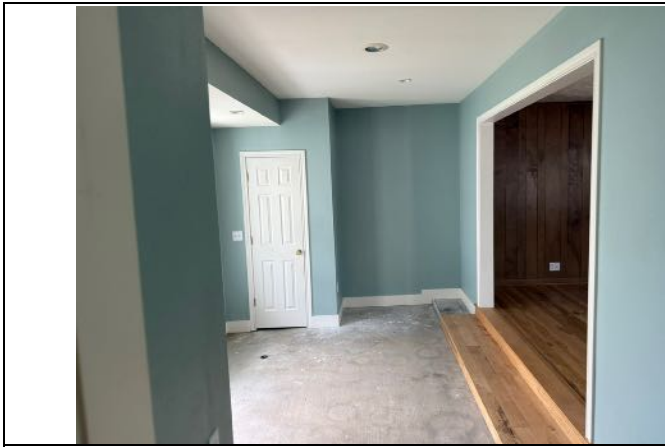
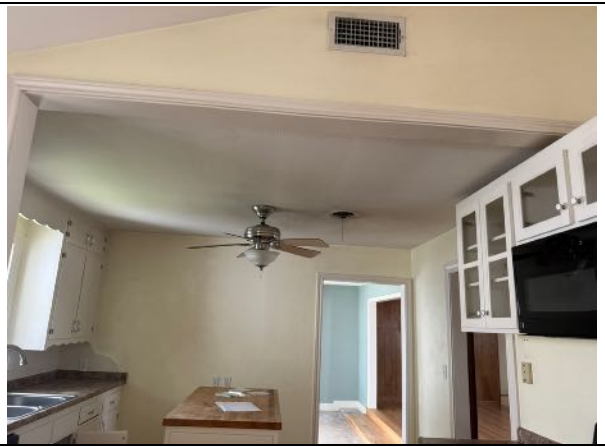
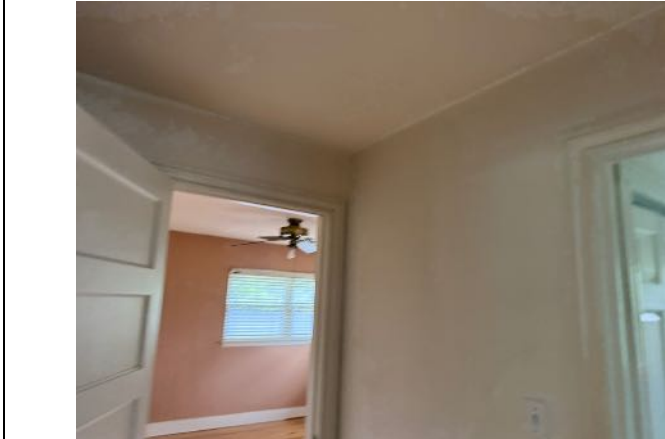
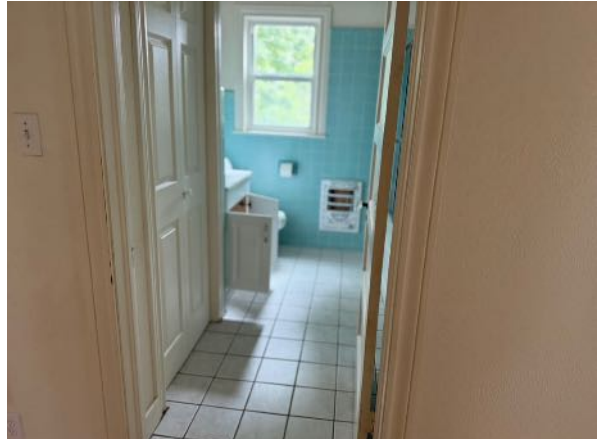
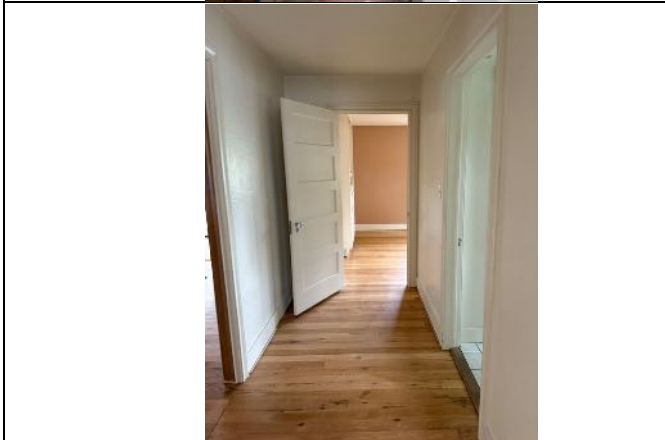
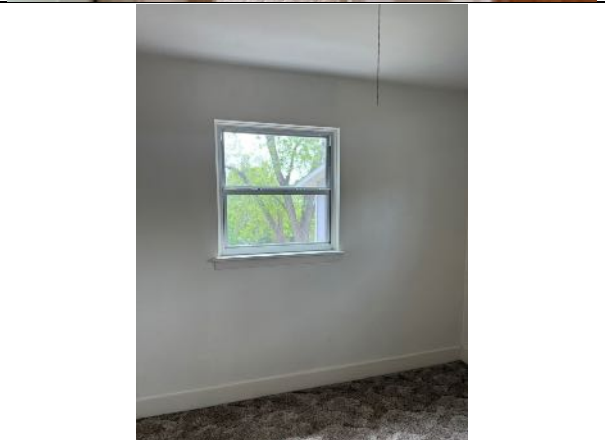
Asbestos Containing Materials Photos

Relocation of the structure is not viable due to hazardous materials and construction limitations. A Limited Asbestos Survey dated April 25, 2025, confirmed the presence of regulated asbestos-containing materials (RACM)—including 20% Chrysotile in exterior siding and 2–3% Chrysotile in interior joint compound. These materials pose a significant health and environmental hazard and must be abated before any disturbance, relocation, or structural manipulation.

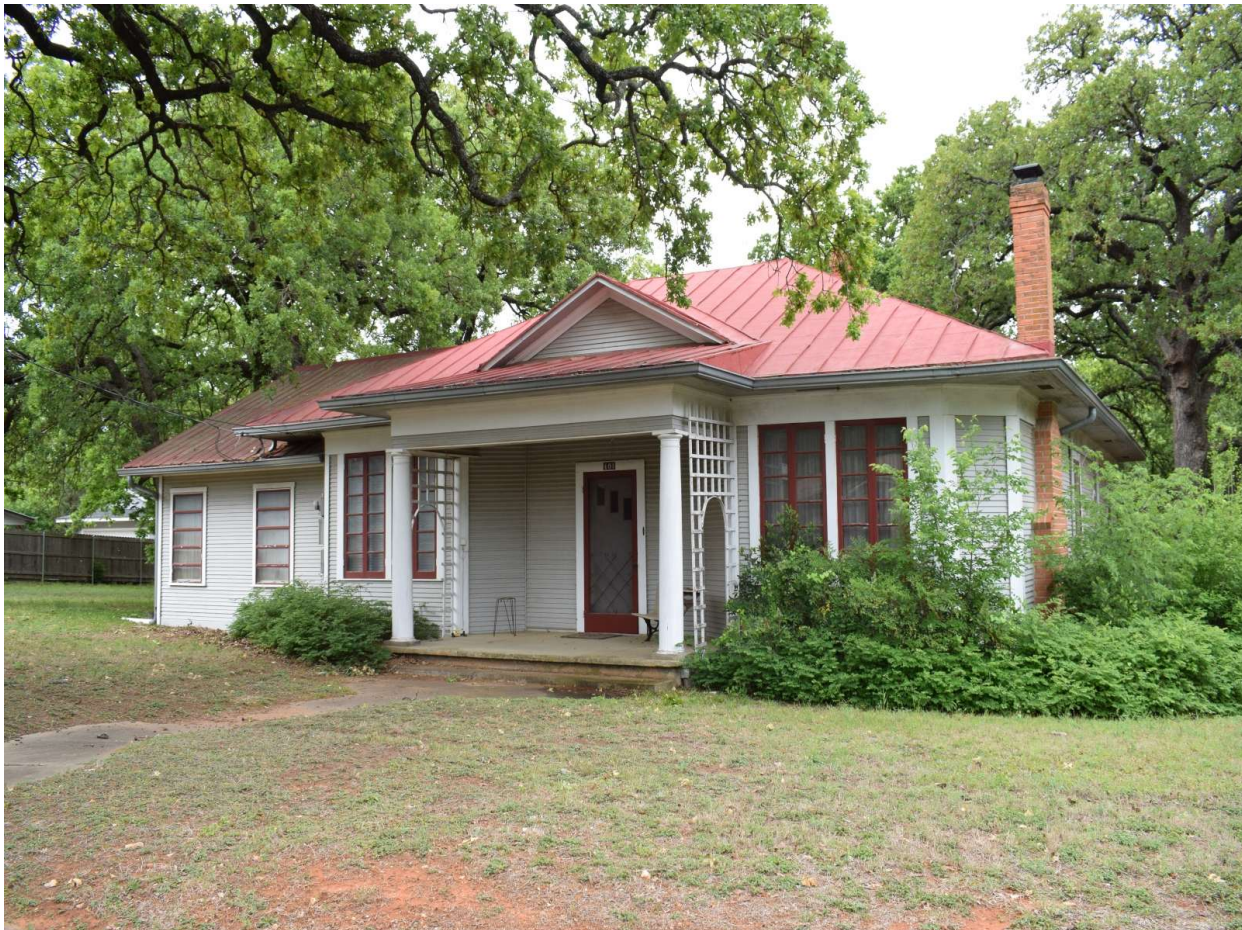
**YR. BUILT** 1916 **YR. SOURCE** CAD **FORM** Irregular  
**TYPE** Building **CURRENT FUNCTION** Domestic: Single dwelling  
**PRIMARY STYLE** Colonial Revival **HISTORIC FUNCTION** Domestic: Single dwelling  
**SECONDARY STYLE** No secondary style

**ALTERATIONS** Addition to side elevation (historic-age)  
 Door (primary) replaced  
 Roof replaced w/ incomp. materials  
 Windows replaced – some

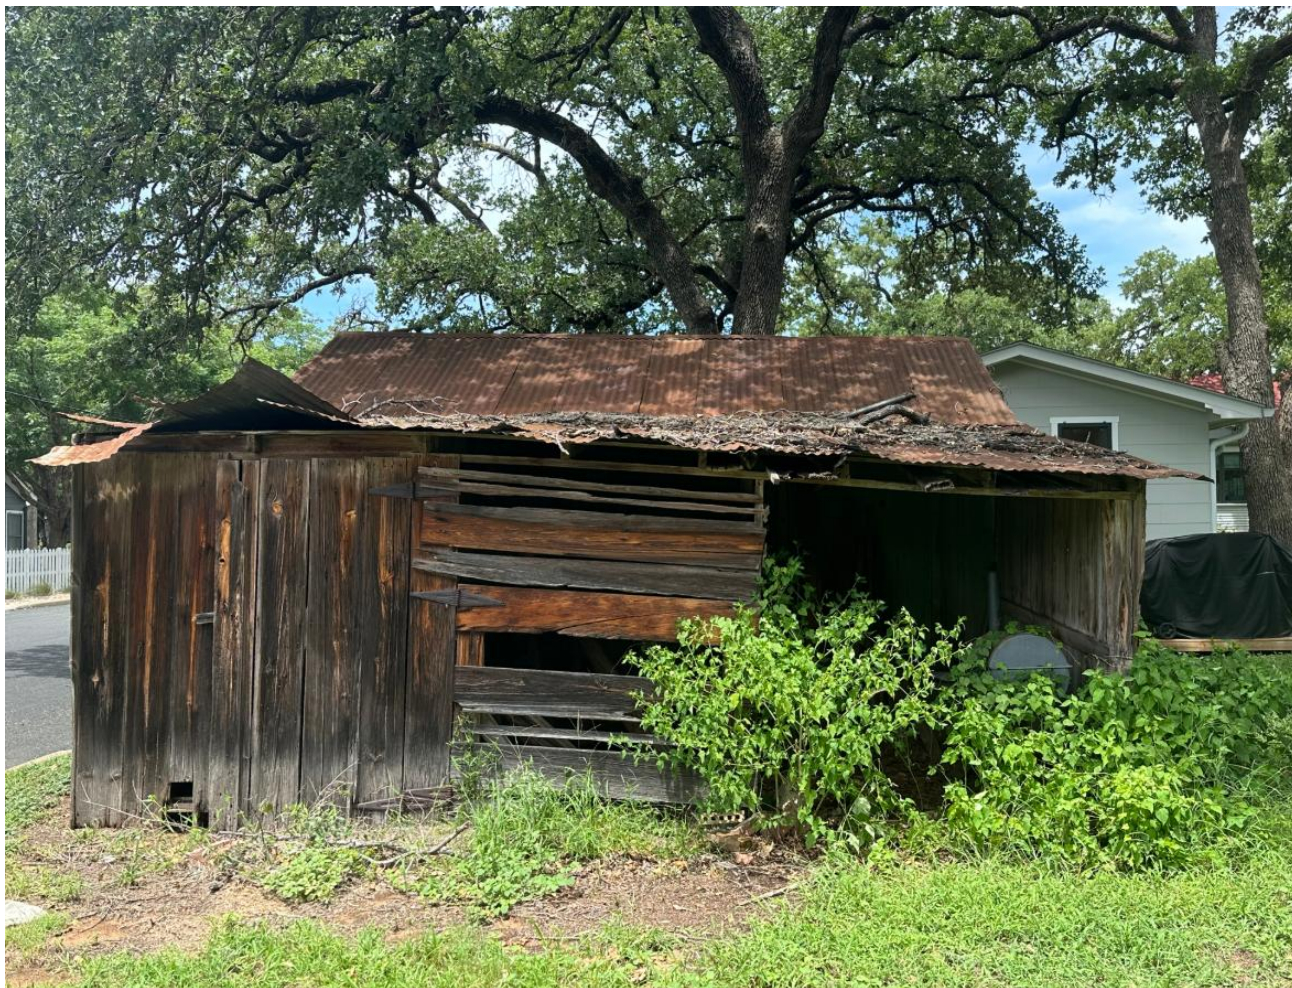
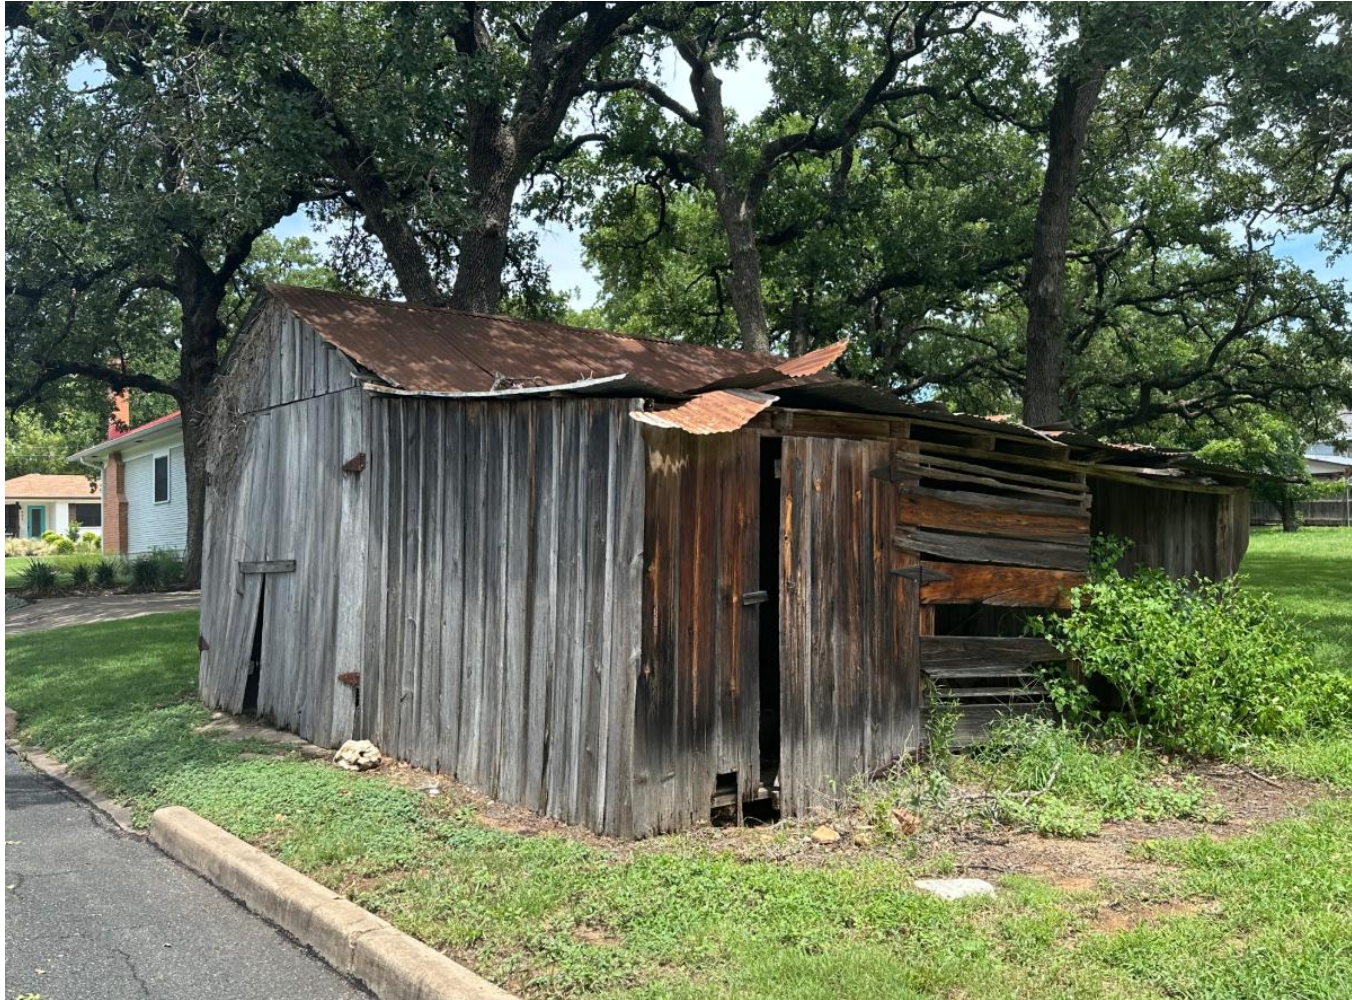
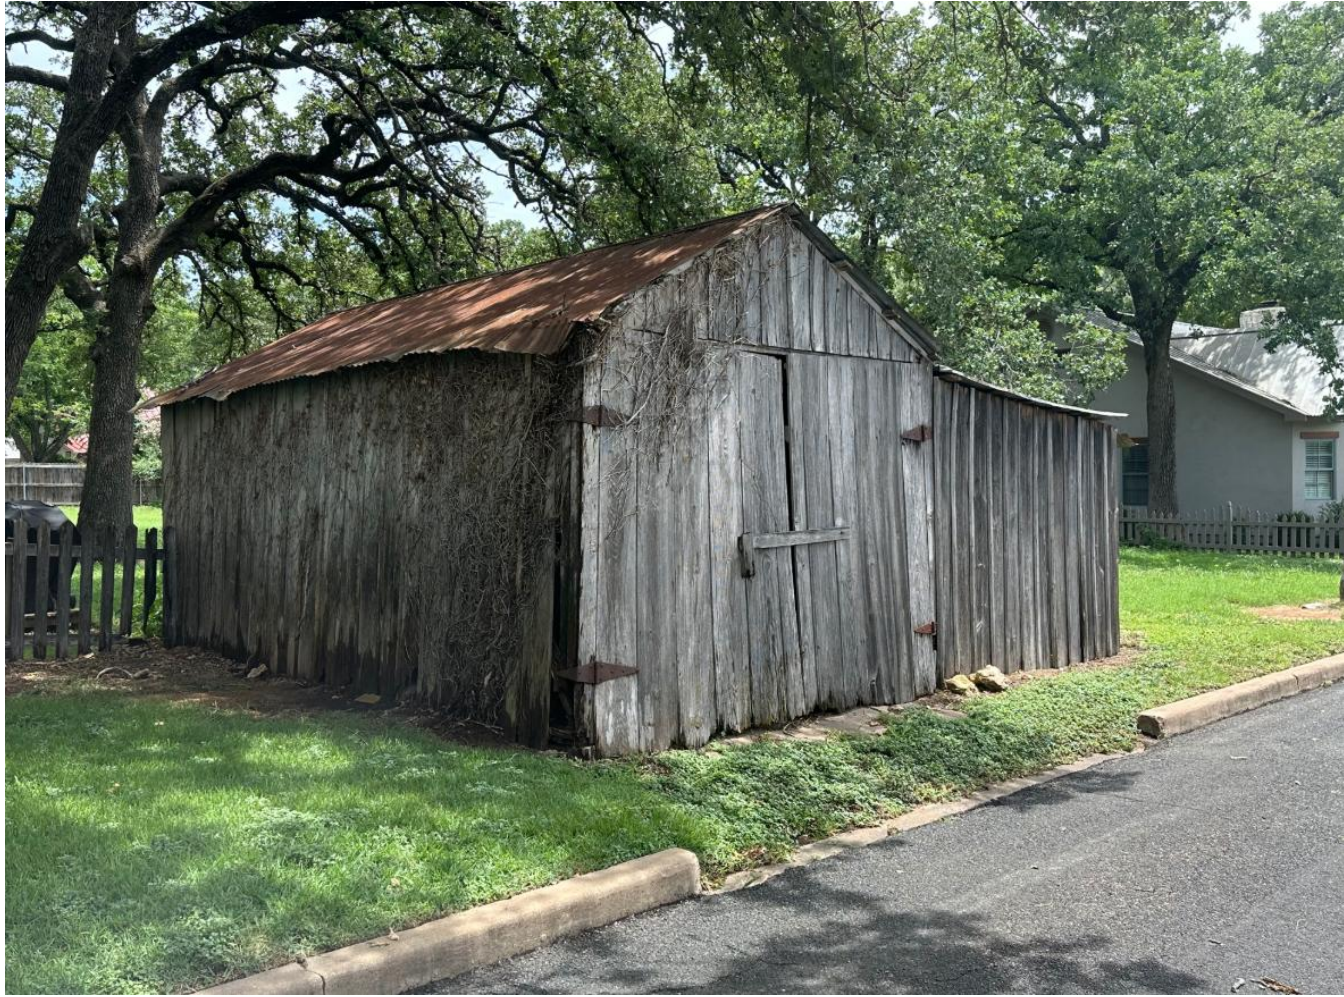
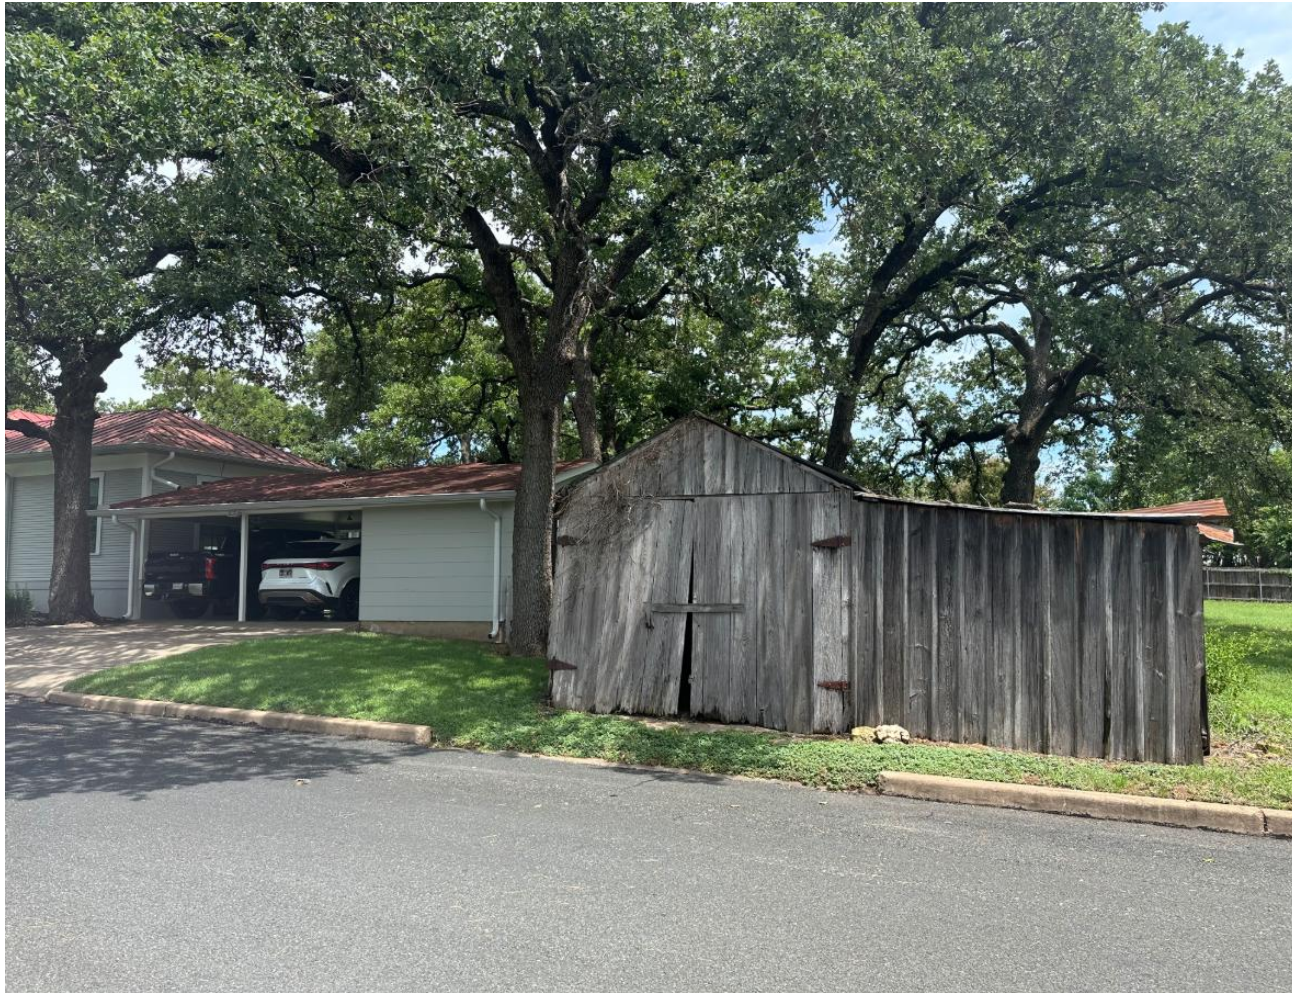
**401 East College – Photos Existing Outbuilding**

Request to change historic rating of dilapidated accessory building from medium to low, and allow disassembly of existing structure due to its deteriorated, dangerous, and hazardous condition. Request to obtain approval to construct a replacement building in same location (with approval of a setback variance) within current code requirements, recreating the appearance and heritage of the existing structure, using any reasonably salvageable materials from original structure.

(c). The building is structurally dangerous and hazardous to public safety. Please see attached stamped letter from Civil Engineer Andrew Belton. To summarize his findings, the building is “deteriorating and beyond repair”, the condition

creates an “unsafe situation”, and that, due to its deteriorated condition, the “structure would collapse” if manipulated.

(f) 1. The only reusable building materials in the structure are one interior barnwood wall and a portion of the rear wall facing the backyard. Less than 20% of the existing barnwood cladding is useable as full-length boards. The remaining structural components, roofing, and barnwood cladding are deteriorated beyond use.

(f) 2. Due to the deteriorated condition of the building, and as confirmed by the Licensed Professional Engineer, any attempt to move or reposition the building would result in collapse of the structure.
