# City of Fredericksburg

Historic Review Board Meeting Agenda  
Tuesday, July 8, 2025 ~ 5:30 PM  
New City Hall at East Campus  
2818 E. U.S. Hwy. 290  
Fredericksburg, Texas 78624

## 6. CERTIFICATE OF APPROPRIATENESS APPLICATIONS

- A. **2025-529** - 416/418 East Main - Brookes Bubble Bar - Request to Construct an Outdoor Bar
- B. **2025-555**- 210 W Travis - Request to build a parking structure.
- C. **2025-590** - 106 S Lincoln - Re-rate the guest house to Low.
- D. **2025-549** - 301 South Adams - Demolition of the entire property with concept plans to replace it.
- E. **2025-656** - 520 E Main - Church door replacement.
- F. **2024 - 532** - 401 E College - Demolish outbuilding and Construct New Accessory Dwelling Unit using Salvaged Materials.
- G. **2025-639** - 109 W Centre - Mary Cunningham - Request to construct a 1,600 sq ft addition to the rear of the building.

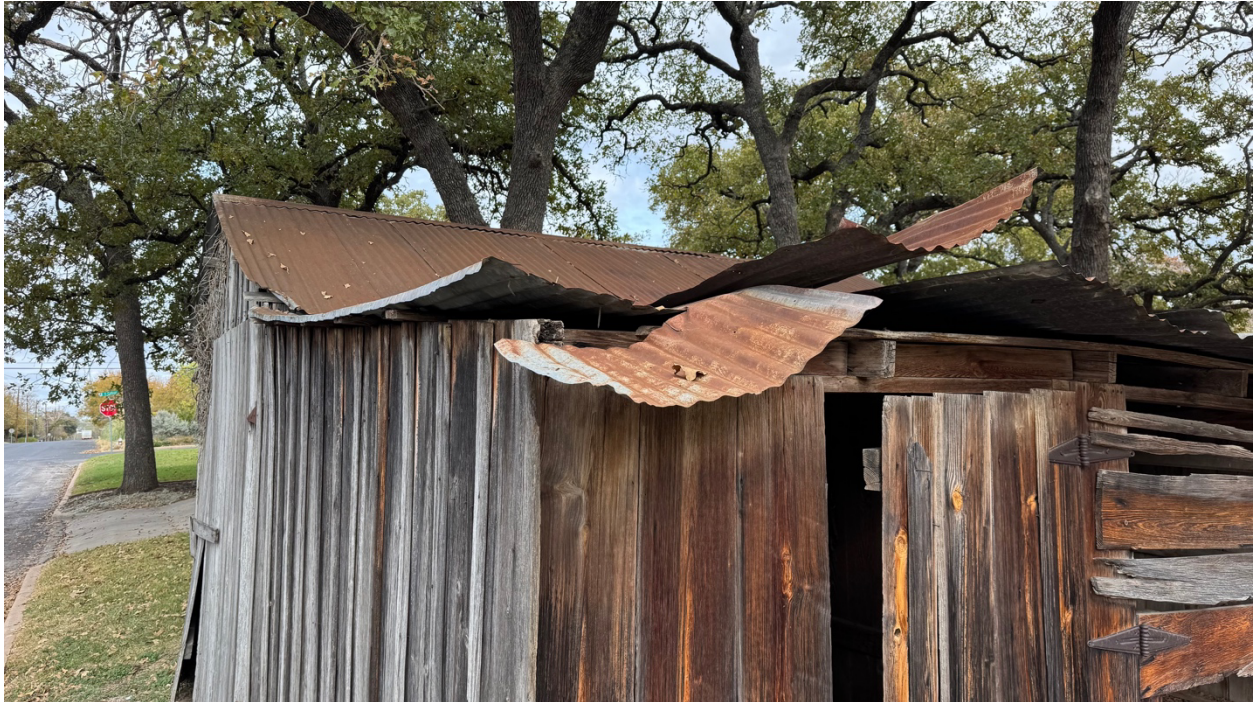
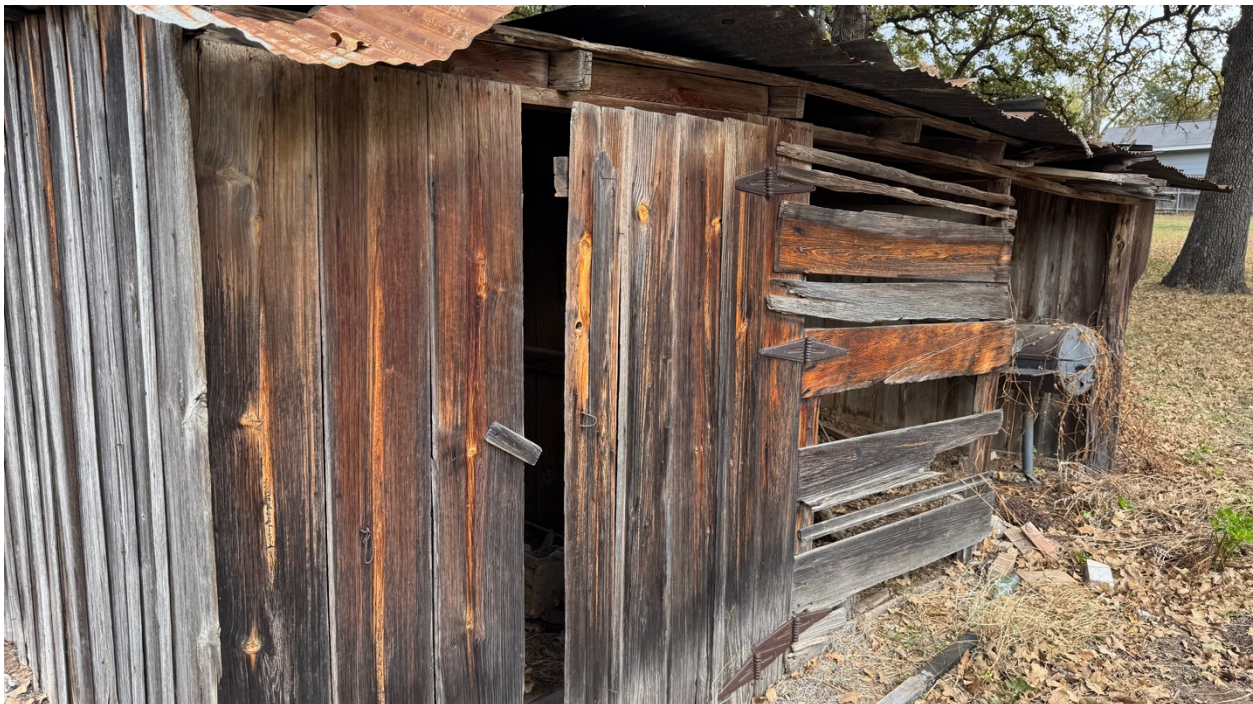
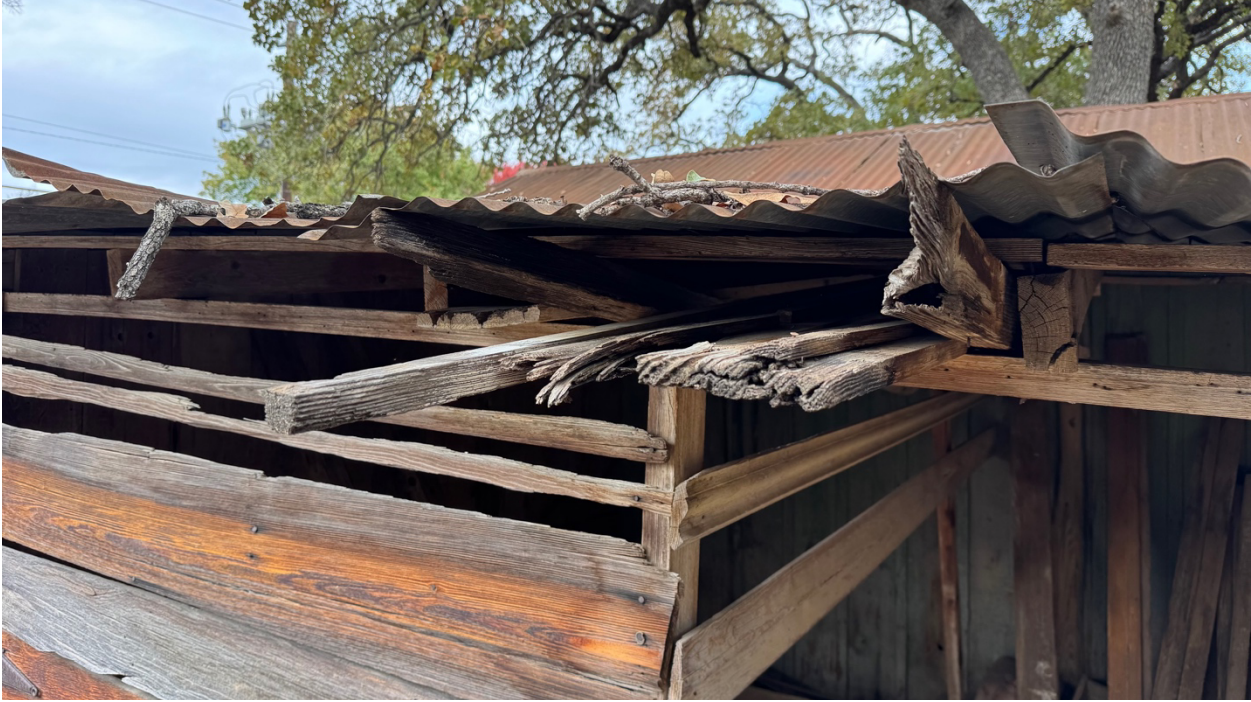
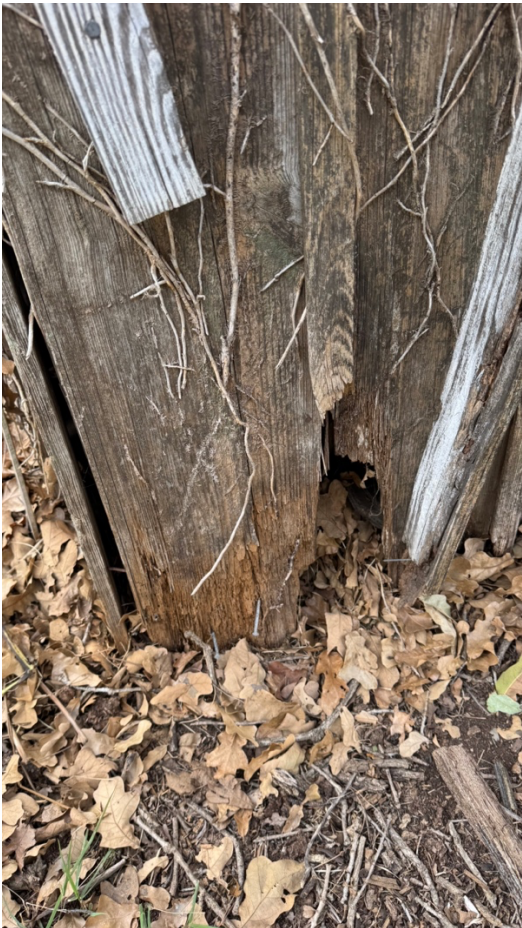
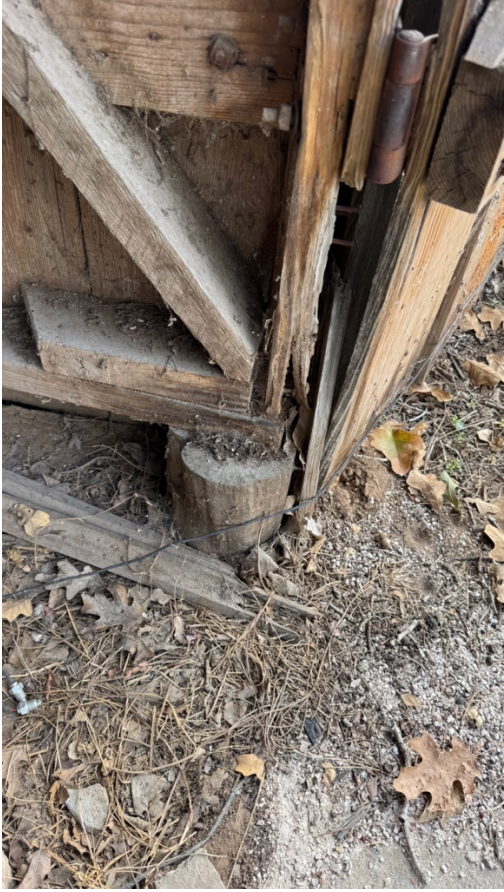
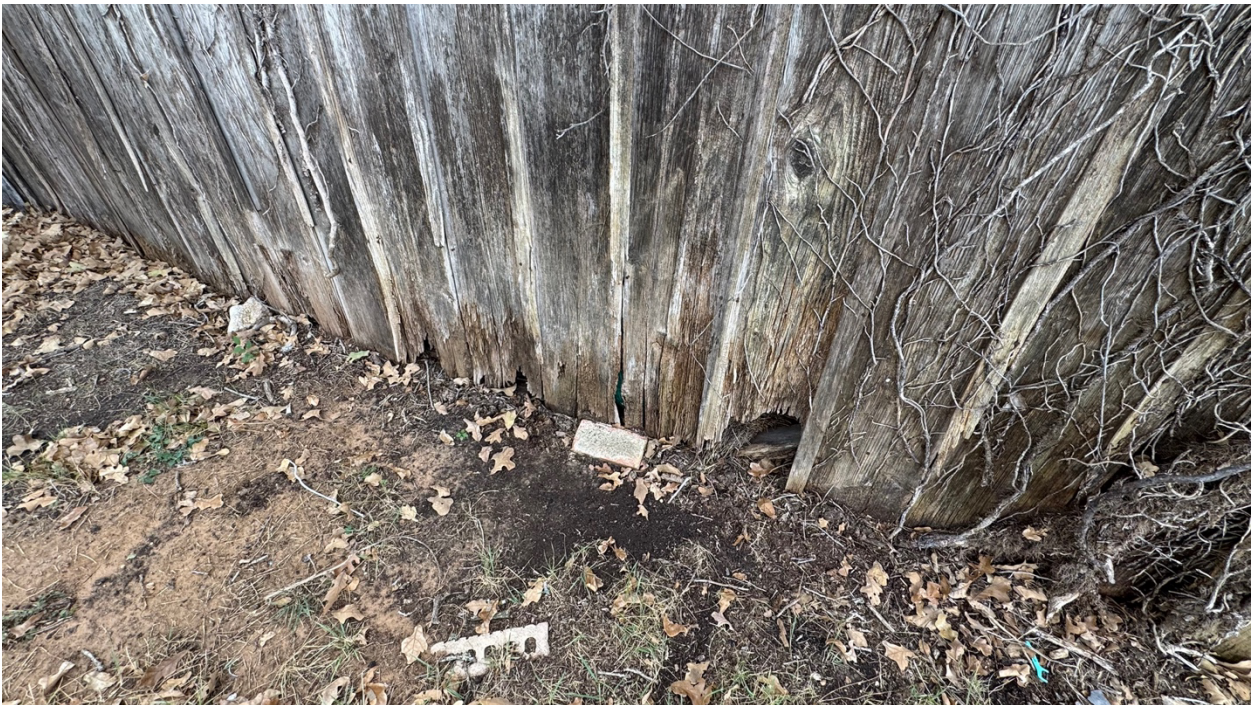
(c). The building is structurally dangerous and hazardous to public safety. Please see attached stamped letter from Civil Engineer Andrew Belton. To summarize his findings, the building is “deteriorating and beyond repair”, the condition

creates an “unsafe situation”, and that, due to its deteriorated condition, the “structure would collapse” if manipulated.

(f) 1. The only reusable building materials in the structure are one interior barnwood wall and a portion of the rear wall facing the backyard. Less than 20% of the existing barnwood cladding is useable as full-length boards. The remaining structural components, roofing, and barnwood cladding are deteriorated beyond use.

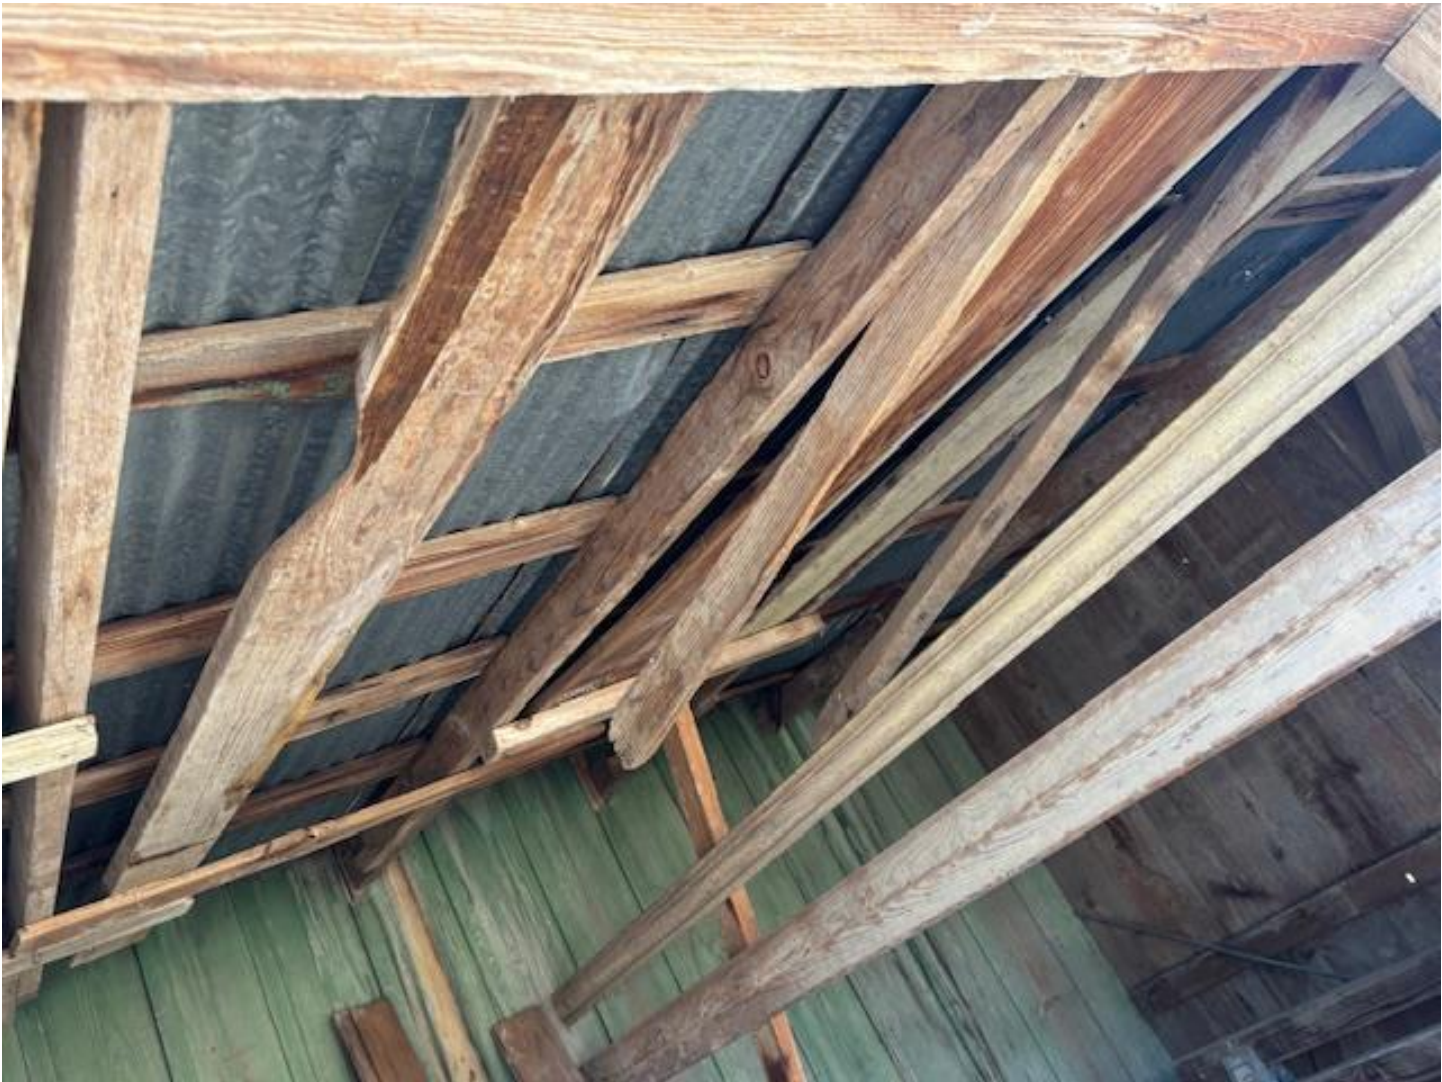
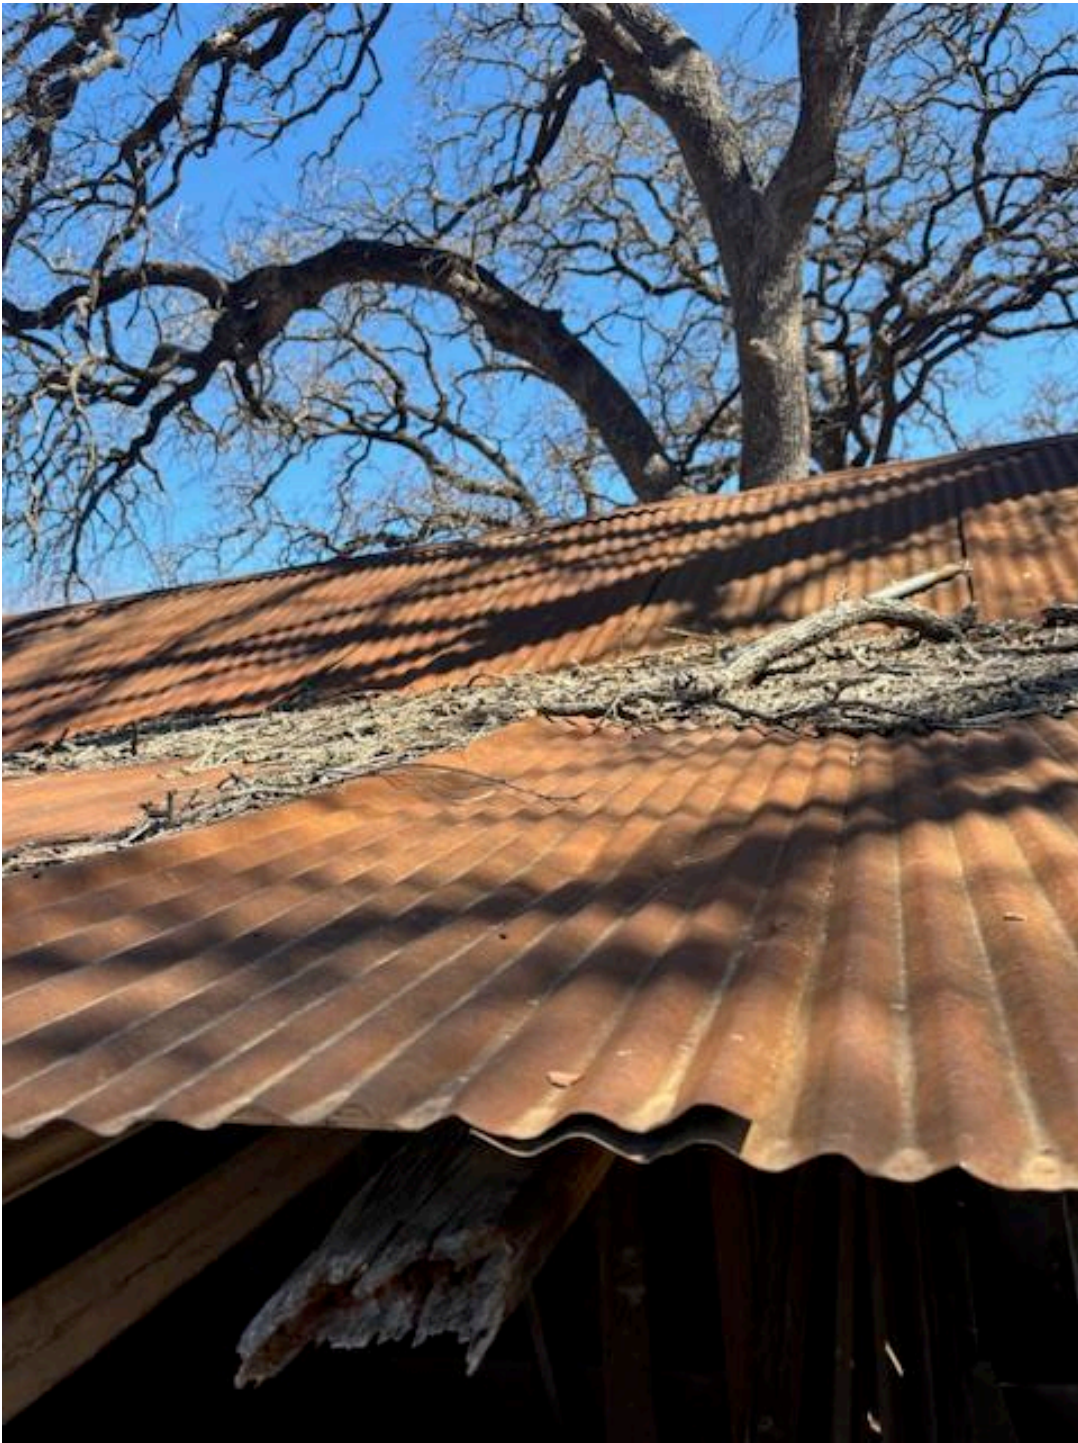
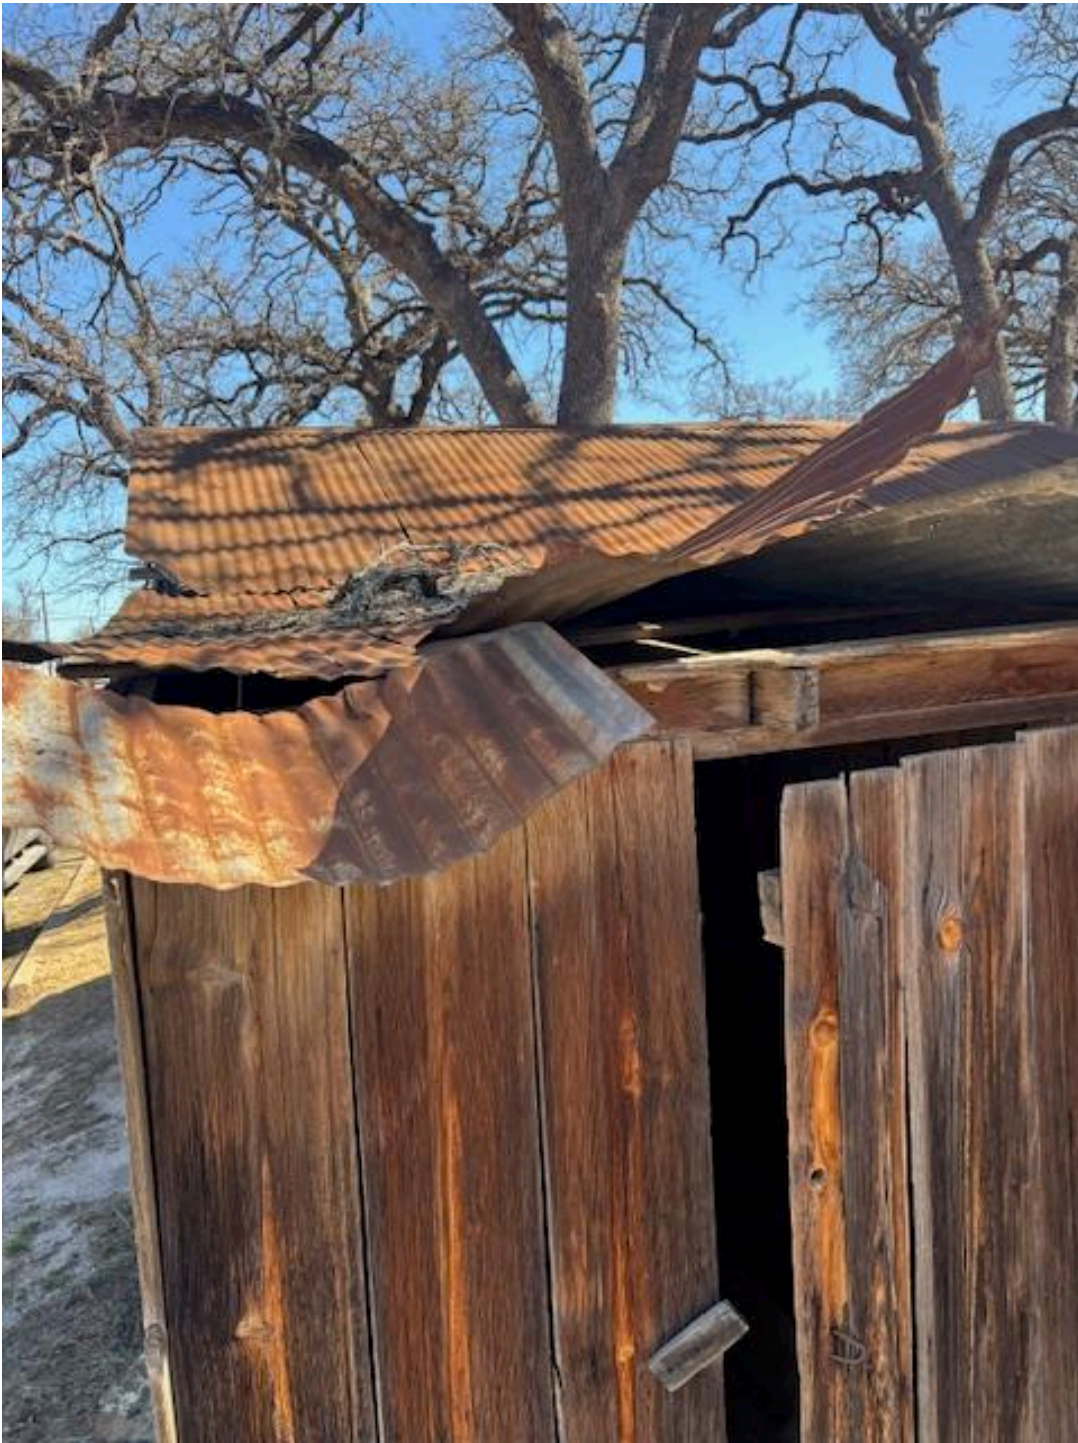
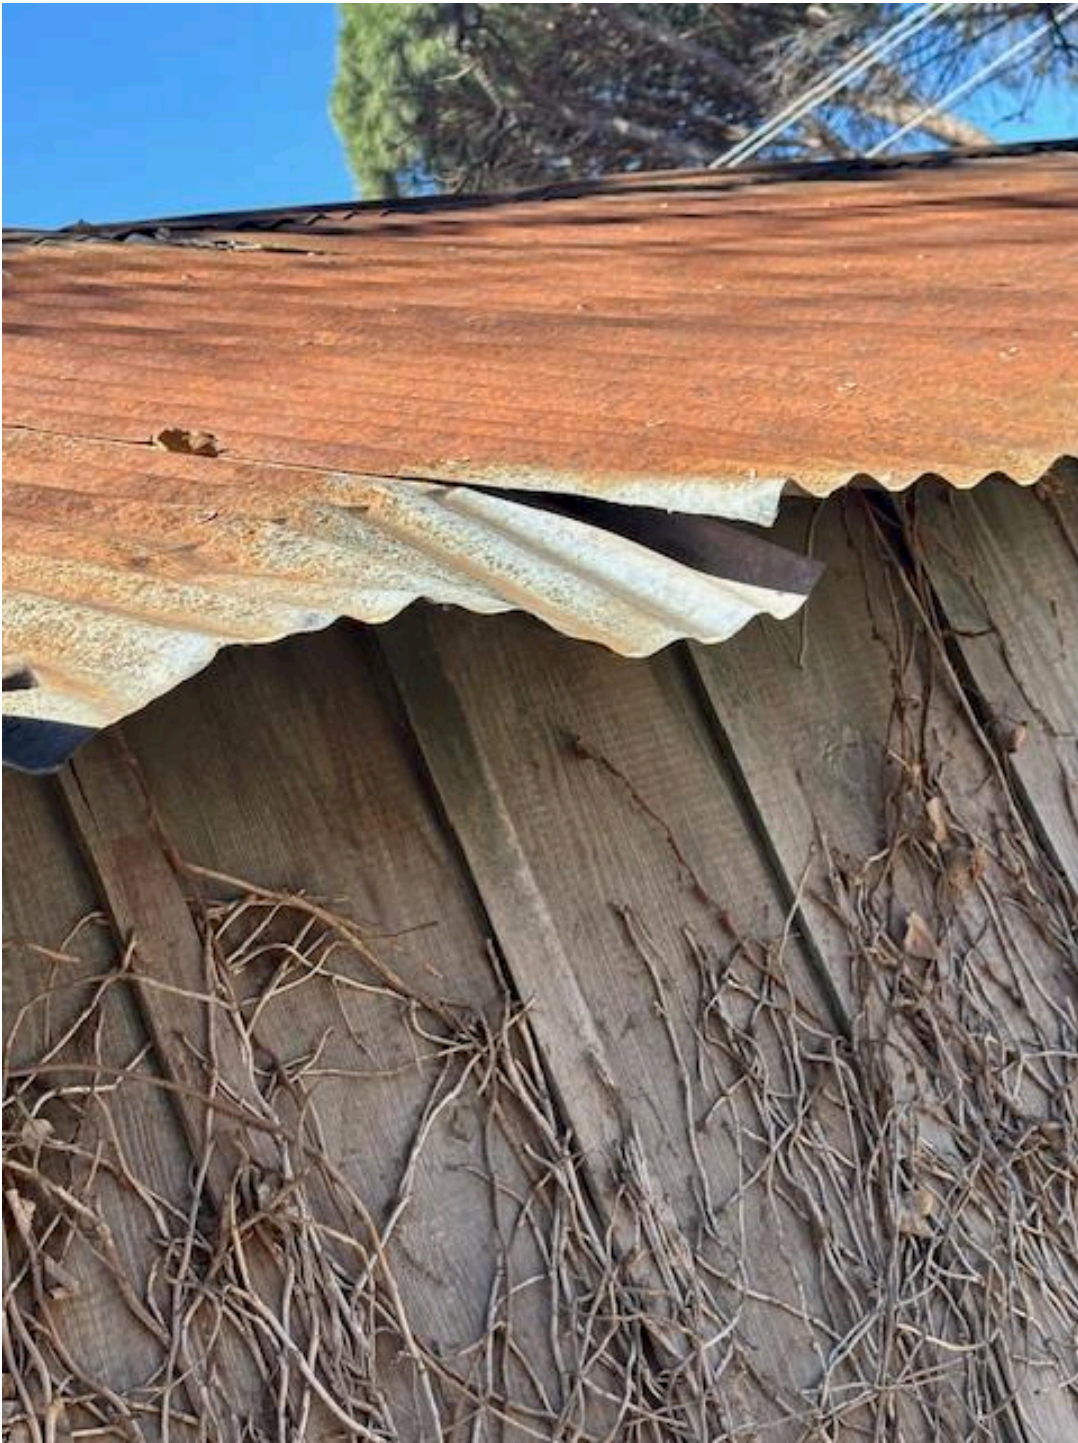
# **HILL COUNTRY ROOFING INC**

- Overall, at time of inspection, the current 29 gauge metal roof and building framing is in very poor condition and unusable
- Age of roof was not able to be determined at time of inspection
- At time of inspection, existing metal roof has wind damage and is creasing and creating holes in the panels
- Current roof panels are installed with ring shank nails and are backing out of the substrate
- Due to age of roof, if nails are to be attempted to be removed, the metal panels will tear and create further leak spots
- Existing framing of the structure is in poor condition and has rotten wood that a new roof cannot be properly attached to.
- It is of the opinion of Hill Country Roofing Inc. that the storage building roof is unrepairable and will need to be replaced. It is unusable for any future roofing.

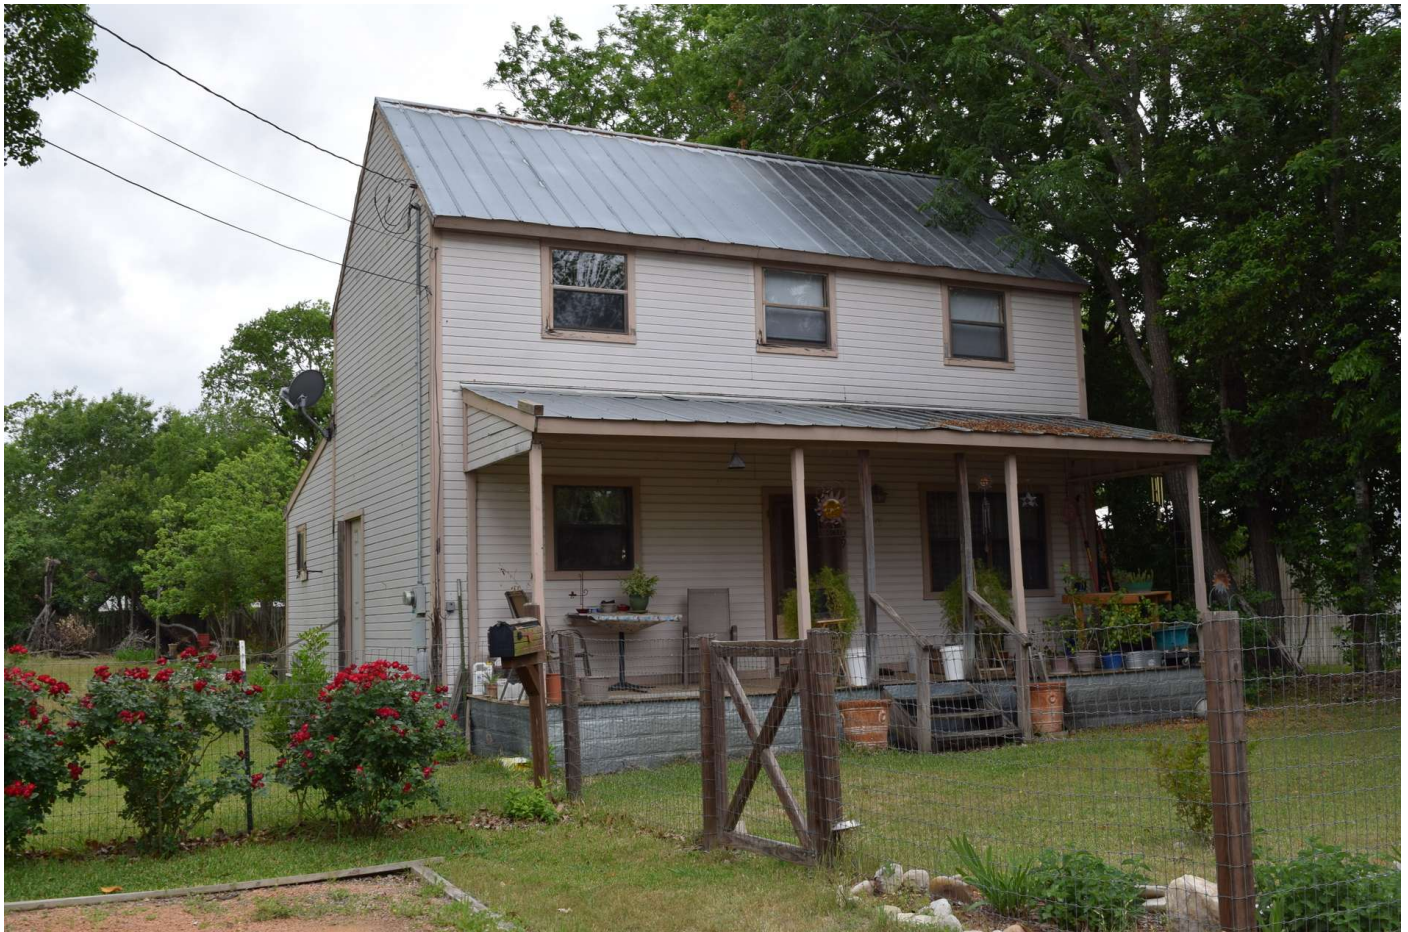
**YR. BUILT** c.1890 **YR. SOURCE** Estimate **FORM** Rectangular  
**TYPE** Building **CURRENT FUNCTION** Domestic: Single dwelling  
**PRIMARY STYLE** Vernacular **HISTORIC FUNCTION** Domestic: Single dwelling  
**SECONDARY STYLE** No secondary style

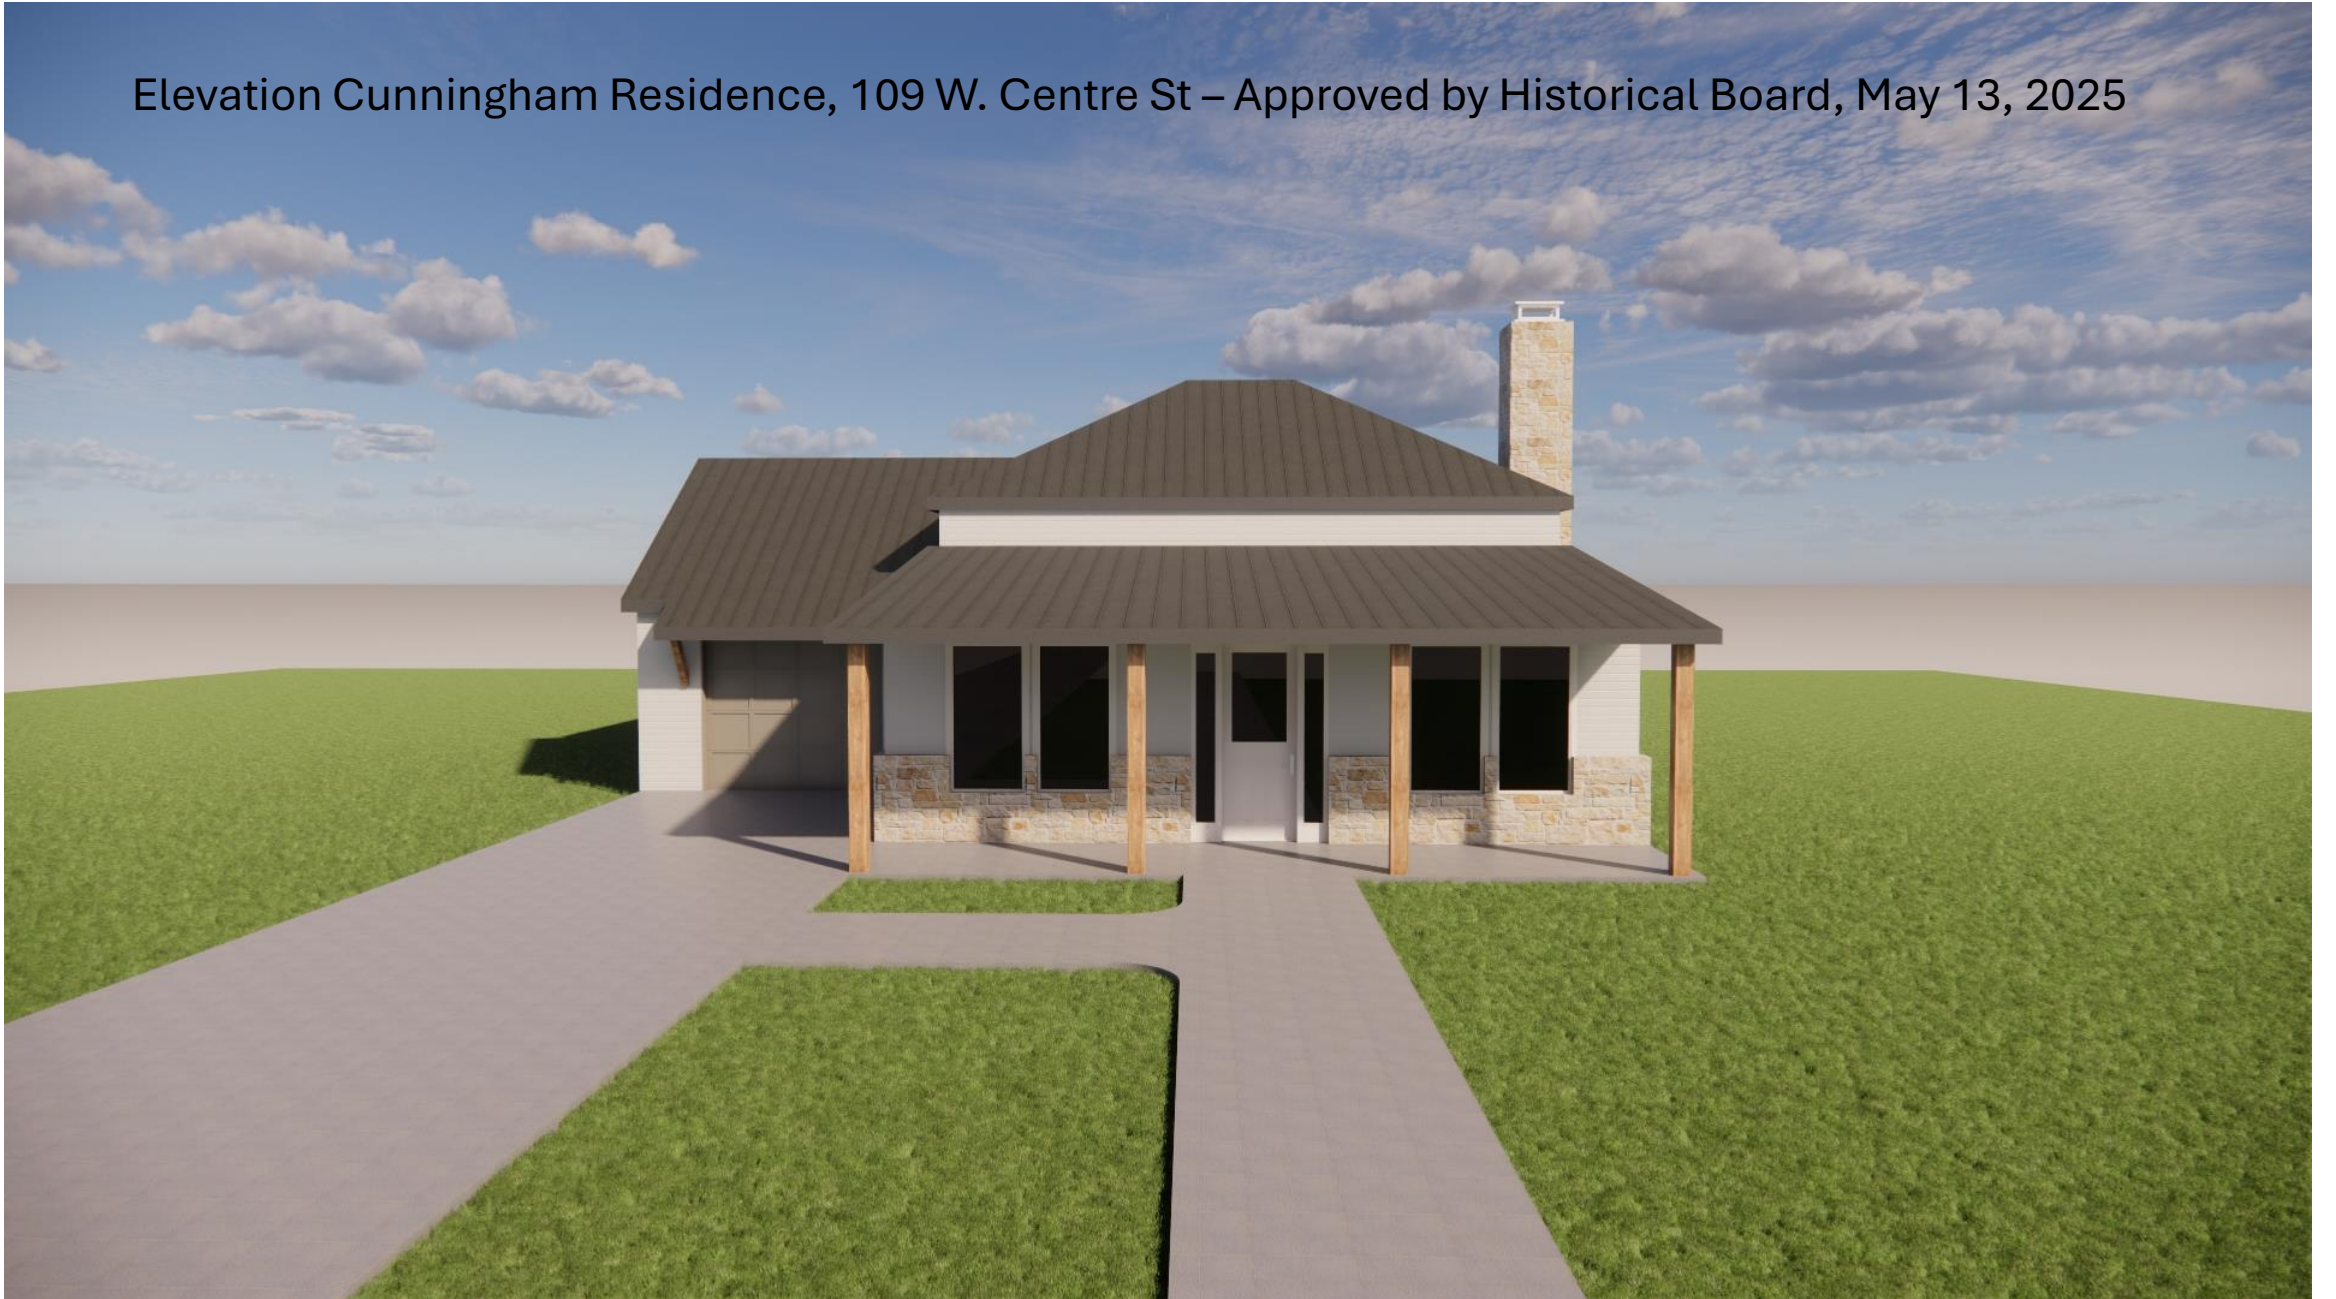
Elevation Cunningham Residence, 109 W. Centre St – Approved by Historical Board, May 13, 2025

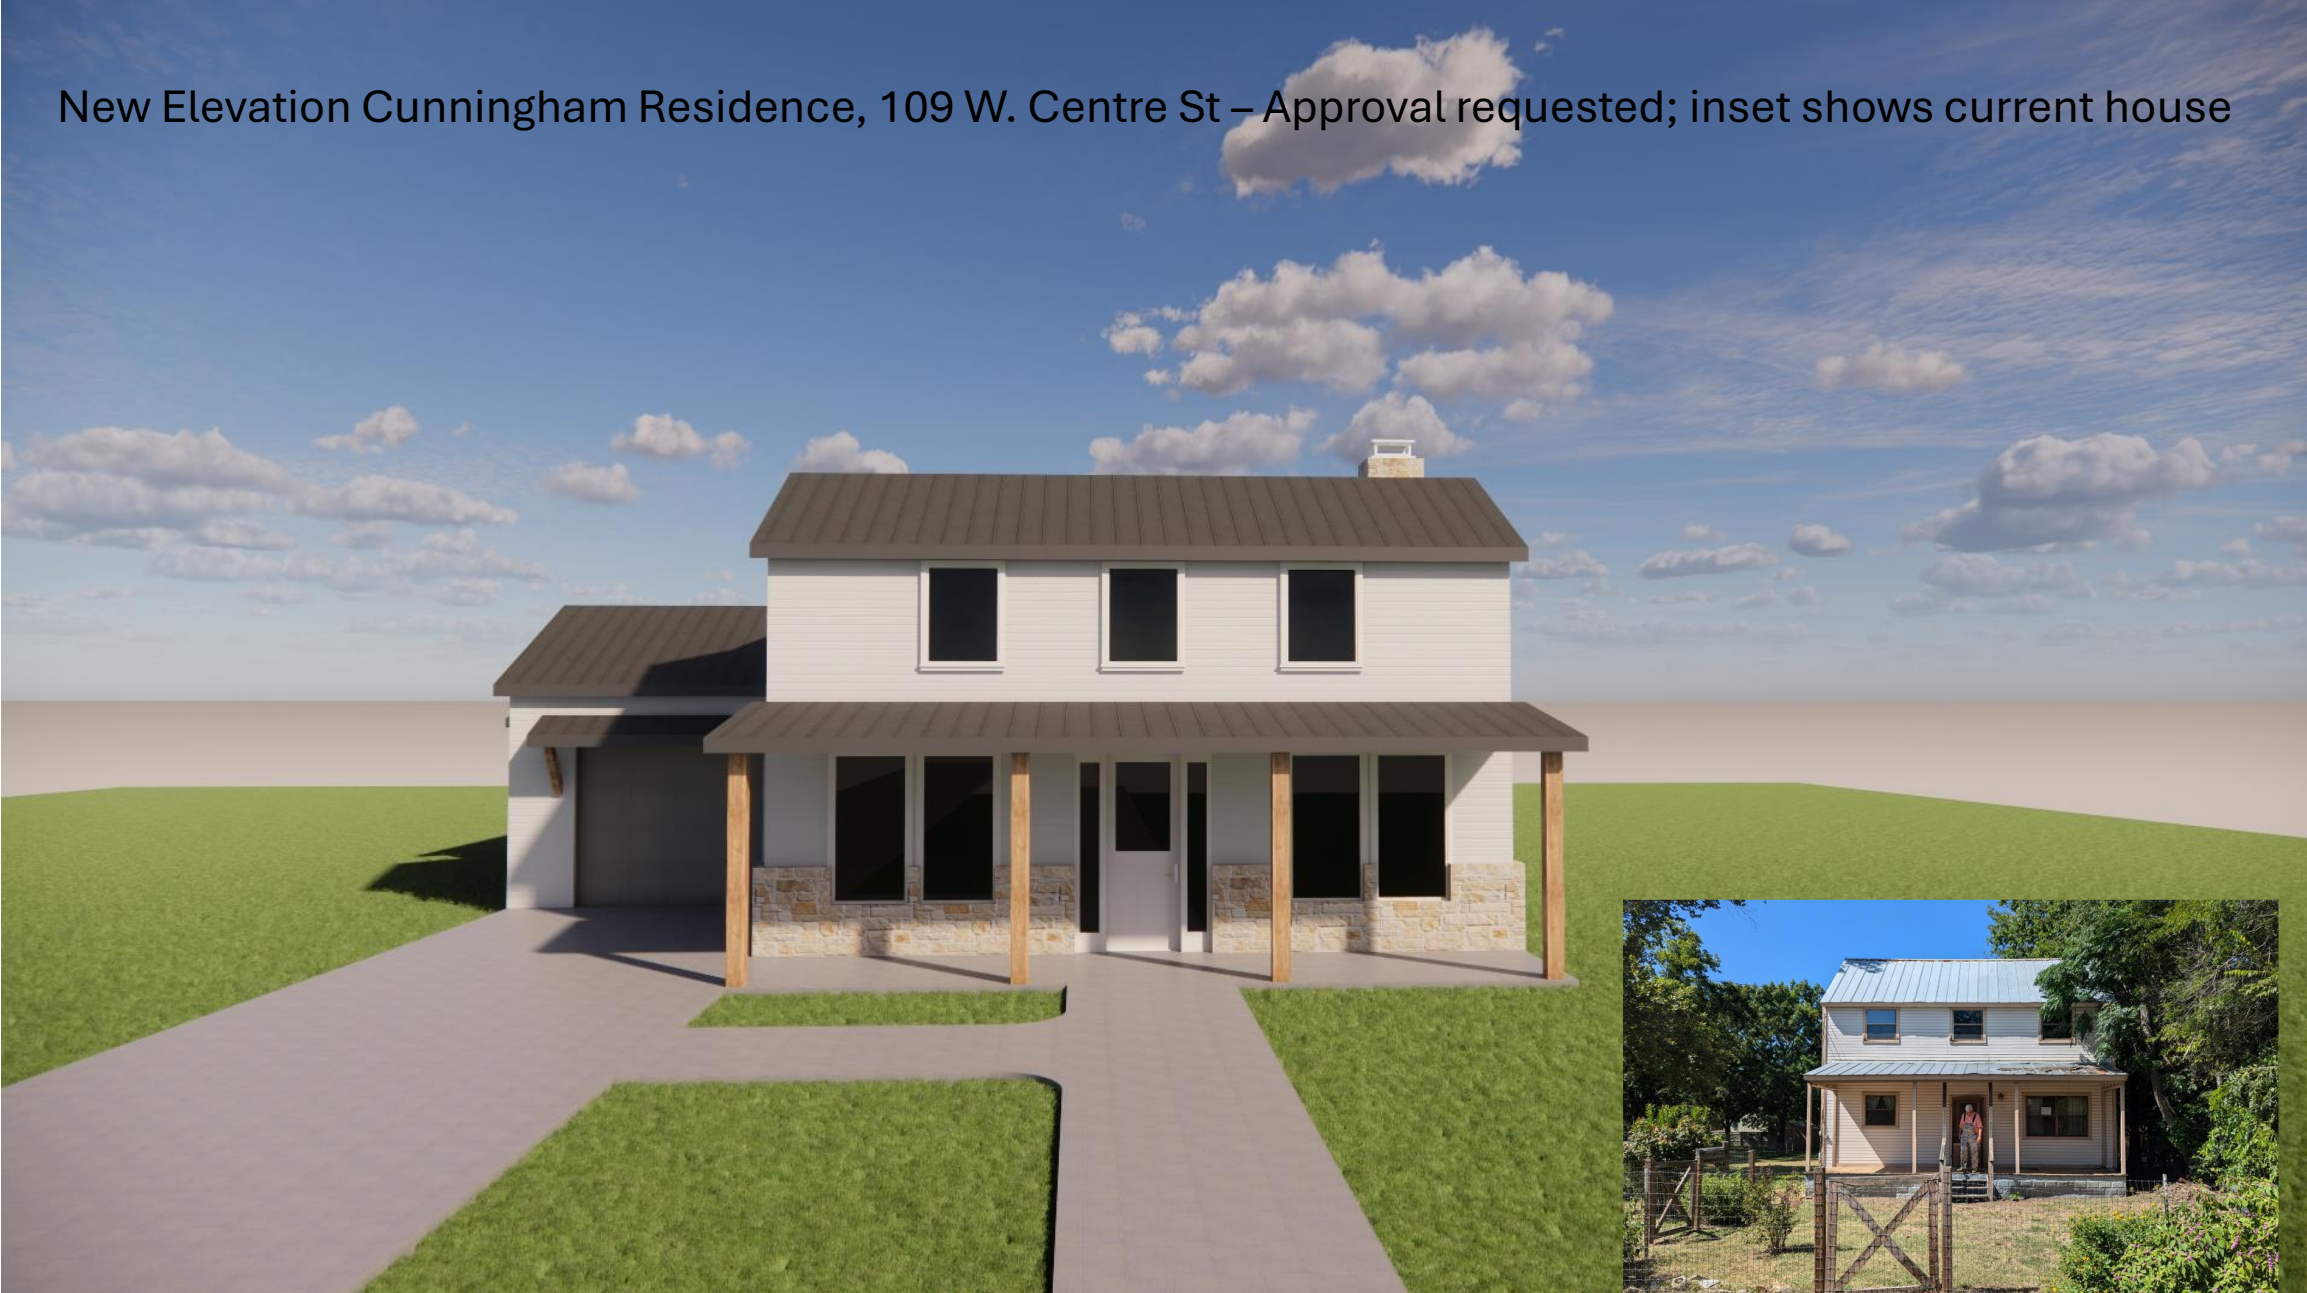
New Elevation Cunningham Residence, 109 W. Centre St – Approval requested; inset shows current house
