City of Fredericksburg

Historic Review Board Meeting Agenda
Tuesday, August 12, 2025 ~ 5:30 PM
New City Hall at East Campus
2818 E. U.S. Hwy. 290
Fredericksburg, Texas 78624

HISTORIC REVIEW BOARD AGENDA MEMO

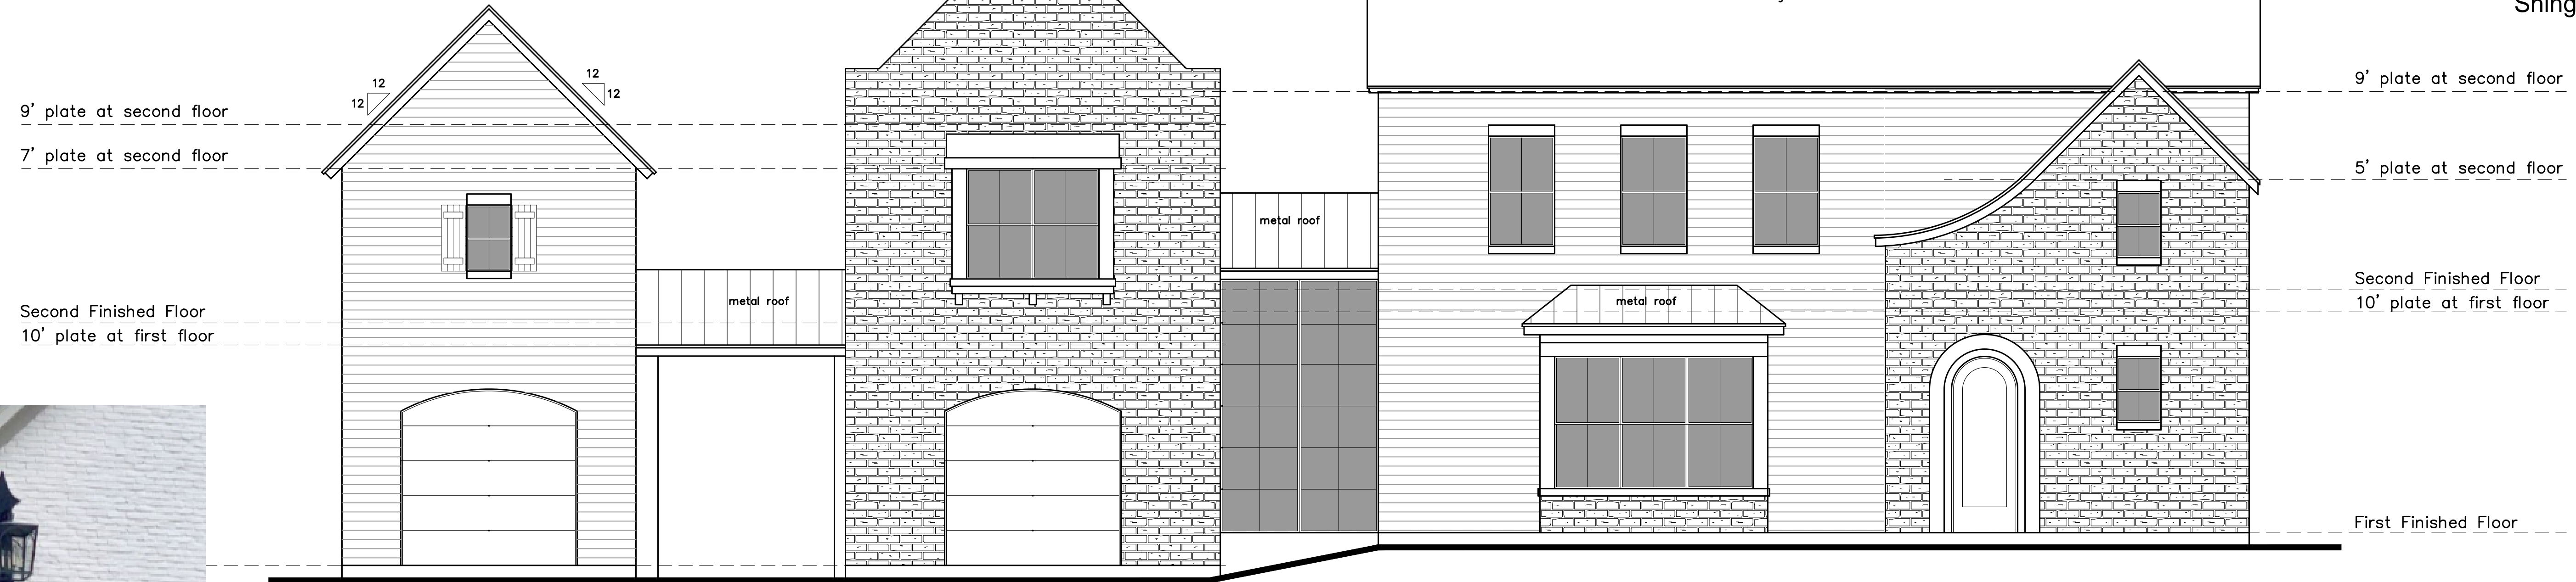
FRONT ELEVATION

Shingle Roof

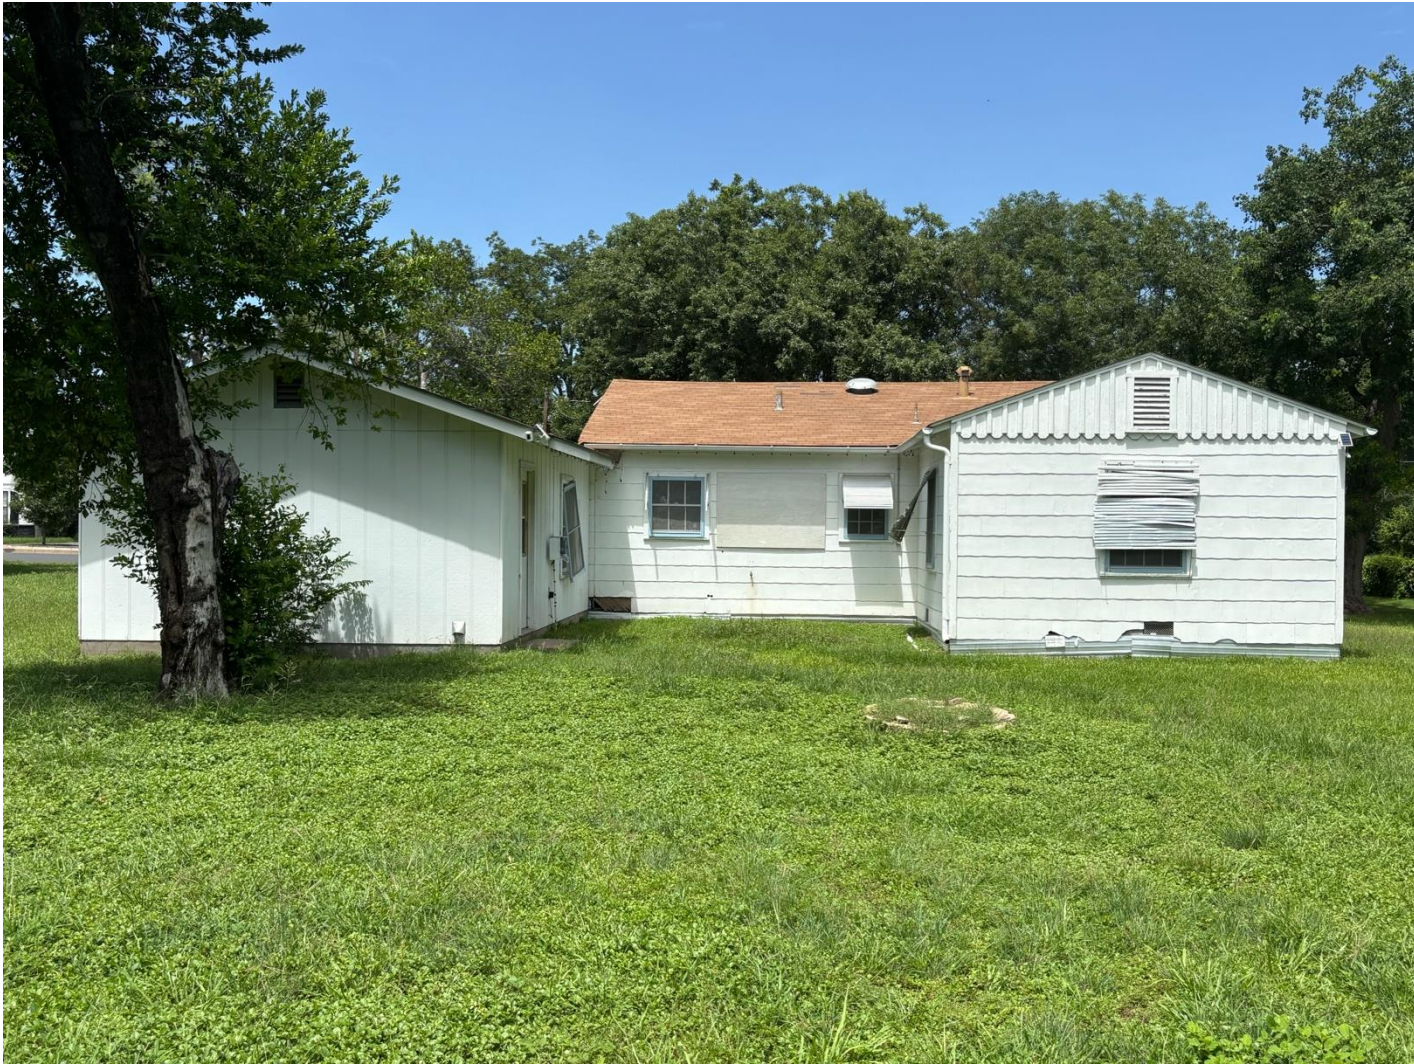
South Side (Back Yard)

There is evidence of deterioration in the roof form and materials as the roof is now sagging towards the center of the resource .
