City of Fredericksburg

Historic Review Board Meeting Agenda
Tuesday, February 10, 2026 ~ 5:30 PM
New City Hall at East Campus
2818 E. U.S. Hwy. 290
Fredericksburg, Texas 78624

HISTORIC REVIEW BOARD AGENDA MEMO

CAPTION: 2026-64 - 309 W. San Antonio St. - Consideration and possible action on a request for a Certificate of Appropriateness (COA) to construct a new addition to the existing structure and add a new gate to the existing fence for the property located at 309 W. San Antonio St., bearing the legal description of ST MARYS ADDN, LOT 1-PT.

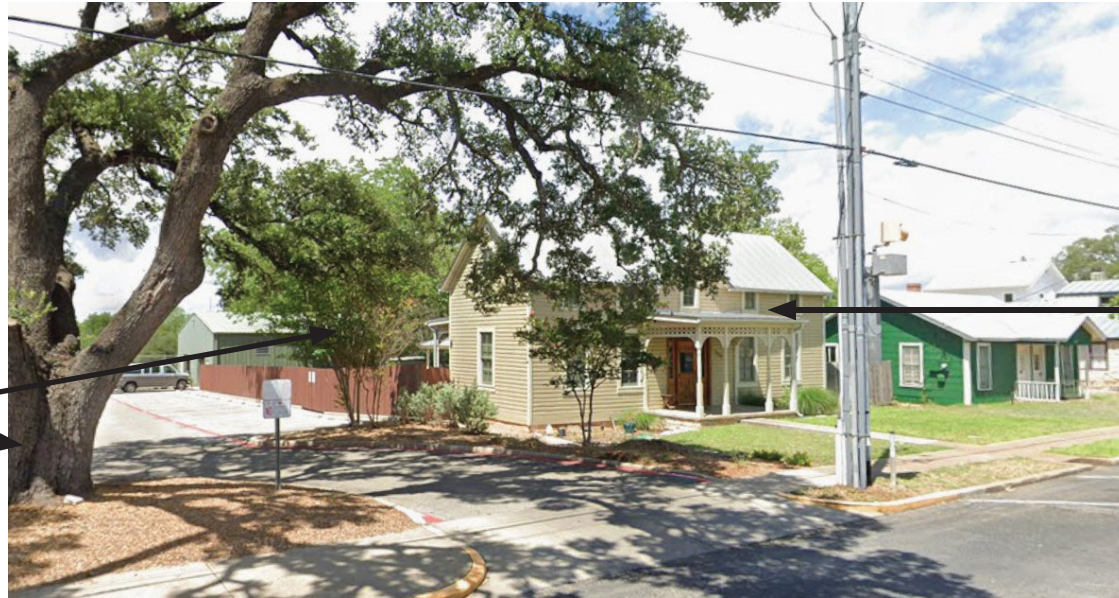
EXISTING TREES AND
LANDSCAPING TO
REMAIN

EXISTING HOUSE AND ALL
ARCHITECTURAL DETAILS
TO REMAIN

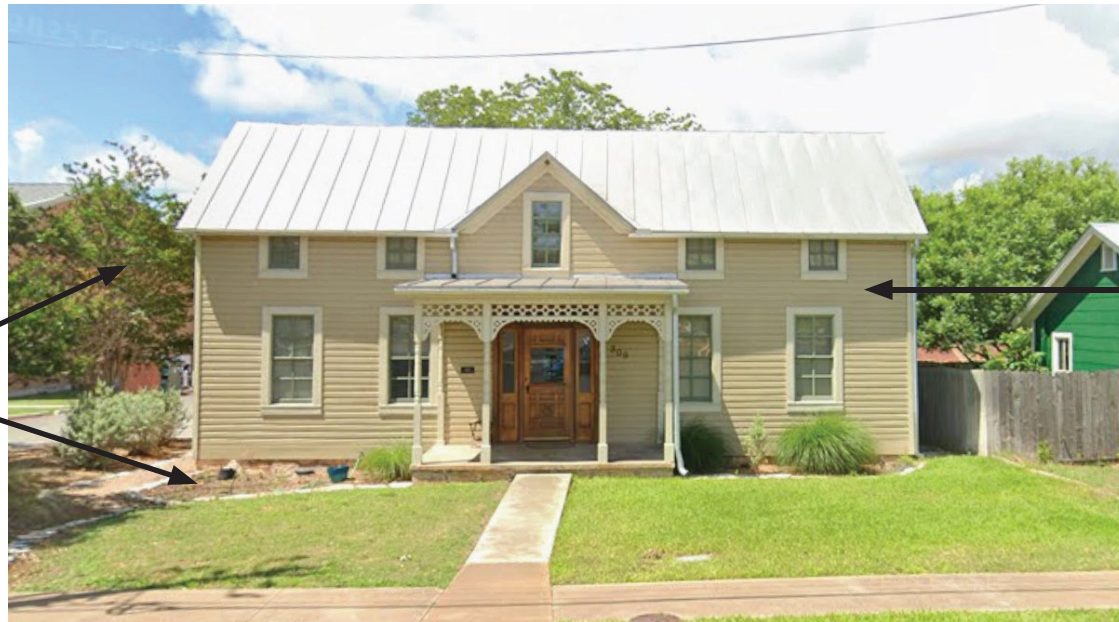
EXISTING TREES AND
LANDSCAPING TO
REMAIN

EXISTING HOUSE AND ALL
ARCHITECTURAL DETAILS
TO REMAIN

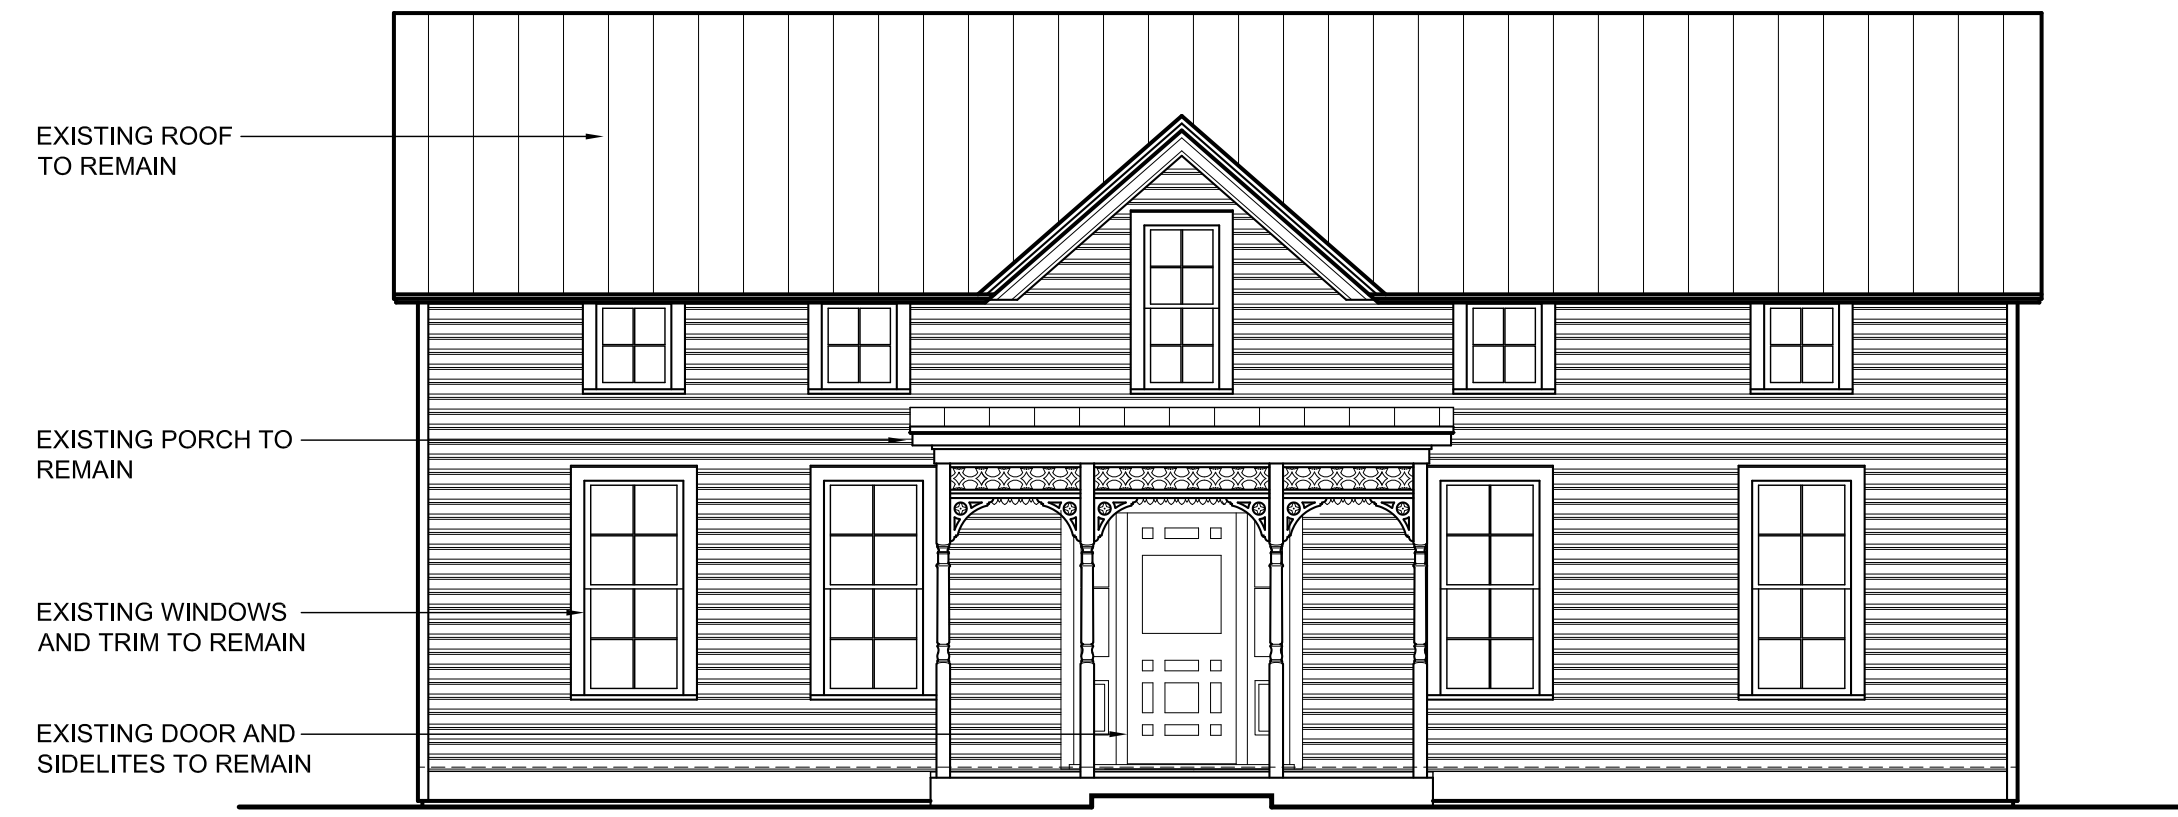
NORTH ELEVATION

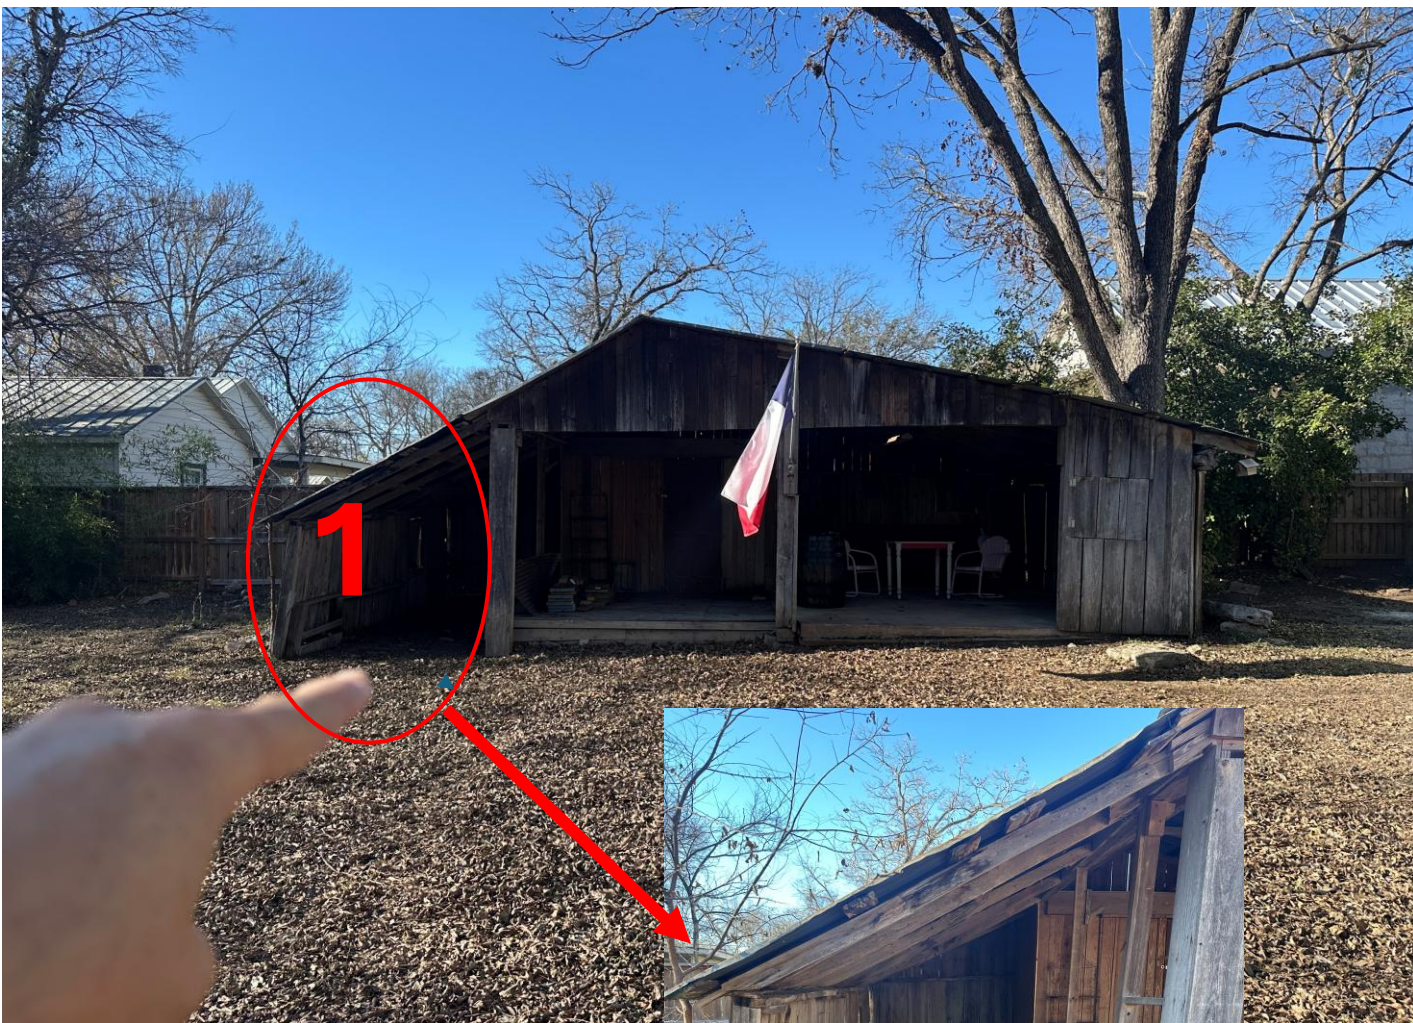
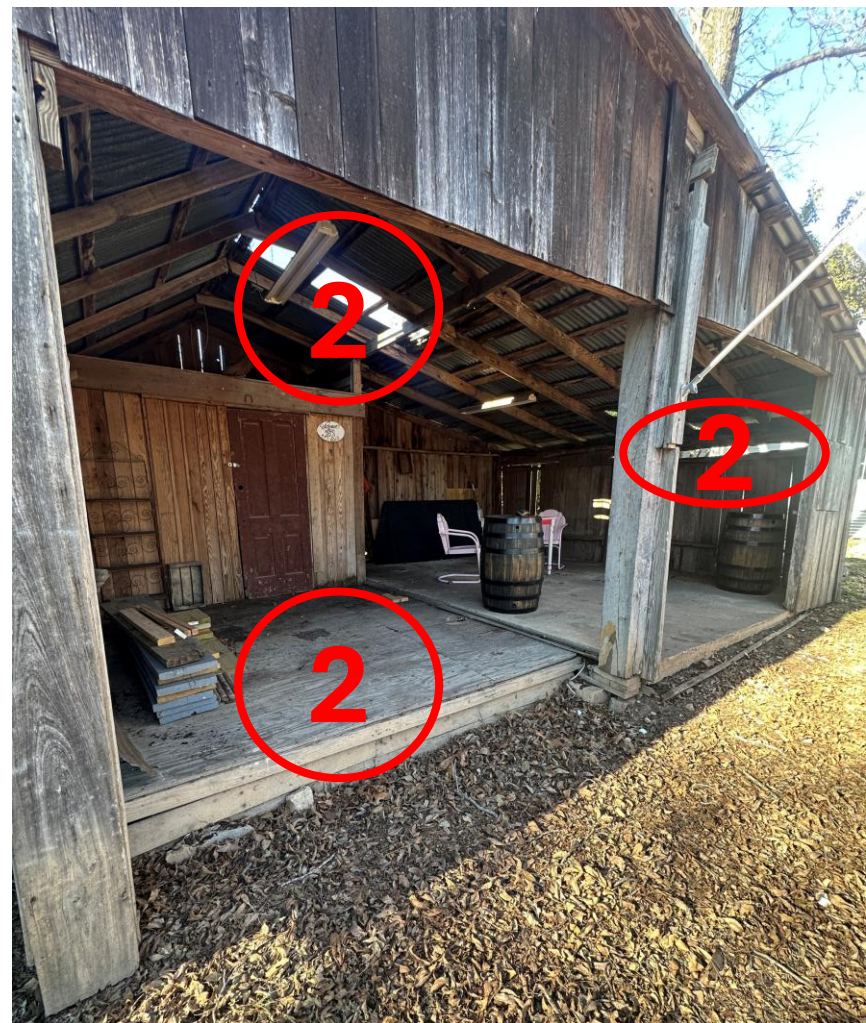
Barn Renovation:

1. Remove this dirt stall, reclaim wood and roof sheet metal
2. Renovate remaining two stalls with reclaimed wood and sheet metal to repair missing roof sheet metal and broken/rotten floor/wall wood planks; retaining old barn look & fell

The applicant is requesting a Certificate of Appropriateness to complete renovations to an existing barn on the property. The proposal is to remove a small dirt stall and reclaim the wood and sheet metal roof to repair two larger stalls. The applicant intends to retain the old barn vintage look and feel.

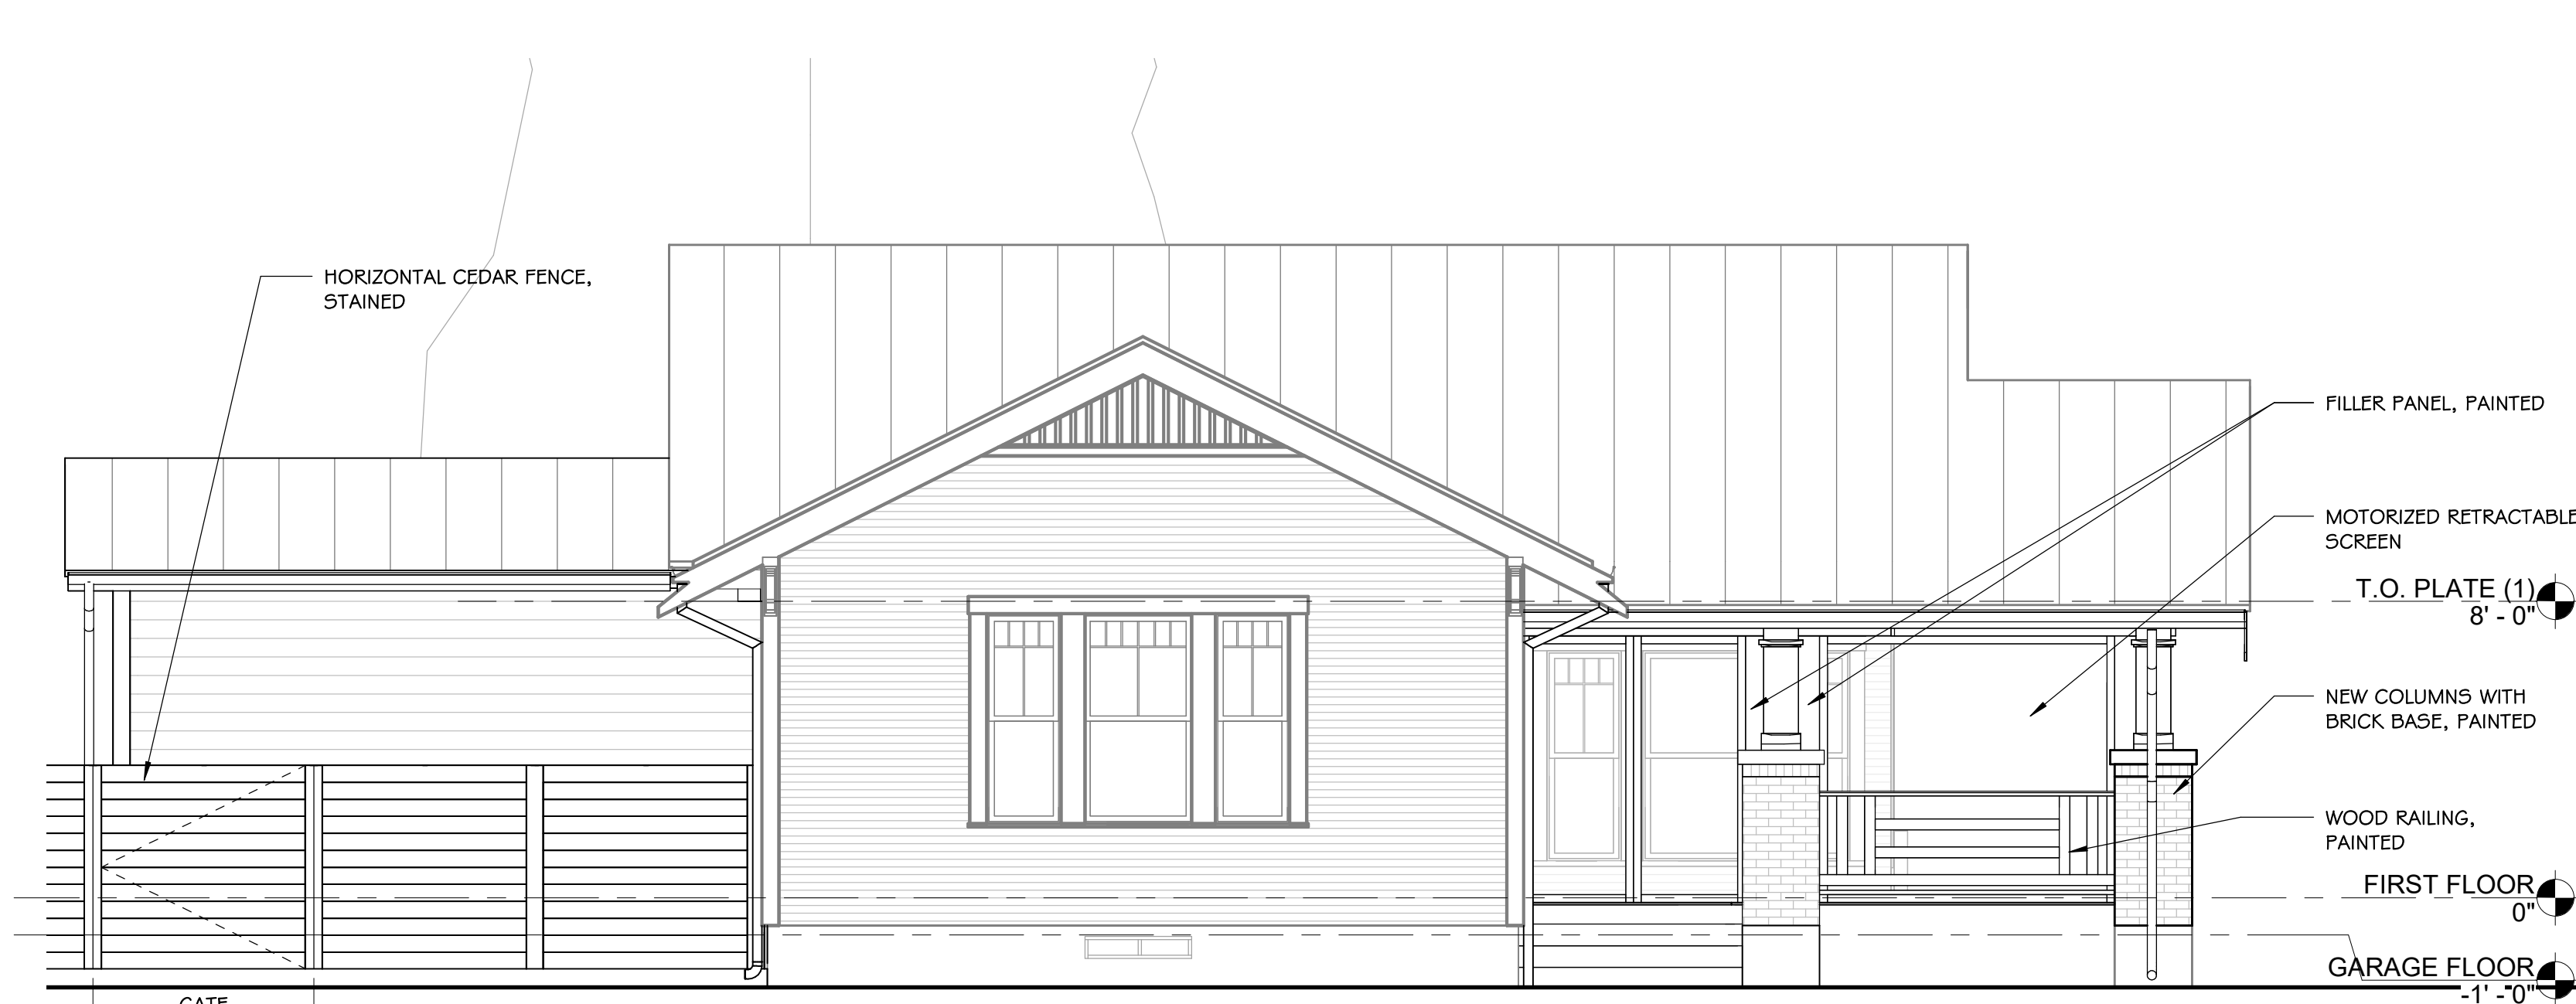
04 EAST ELEVATION
SCALE: 1/4" = 1'-0"

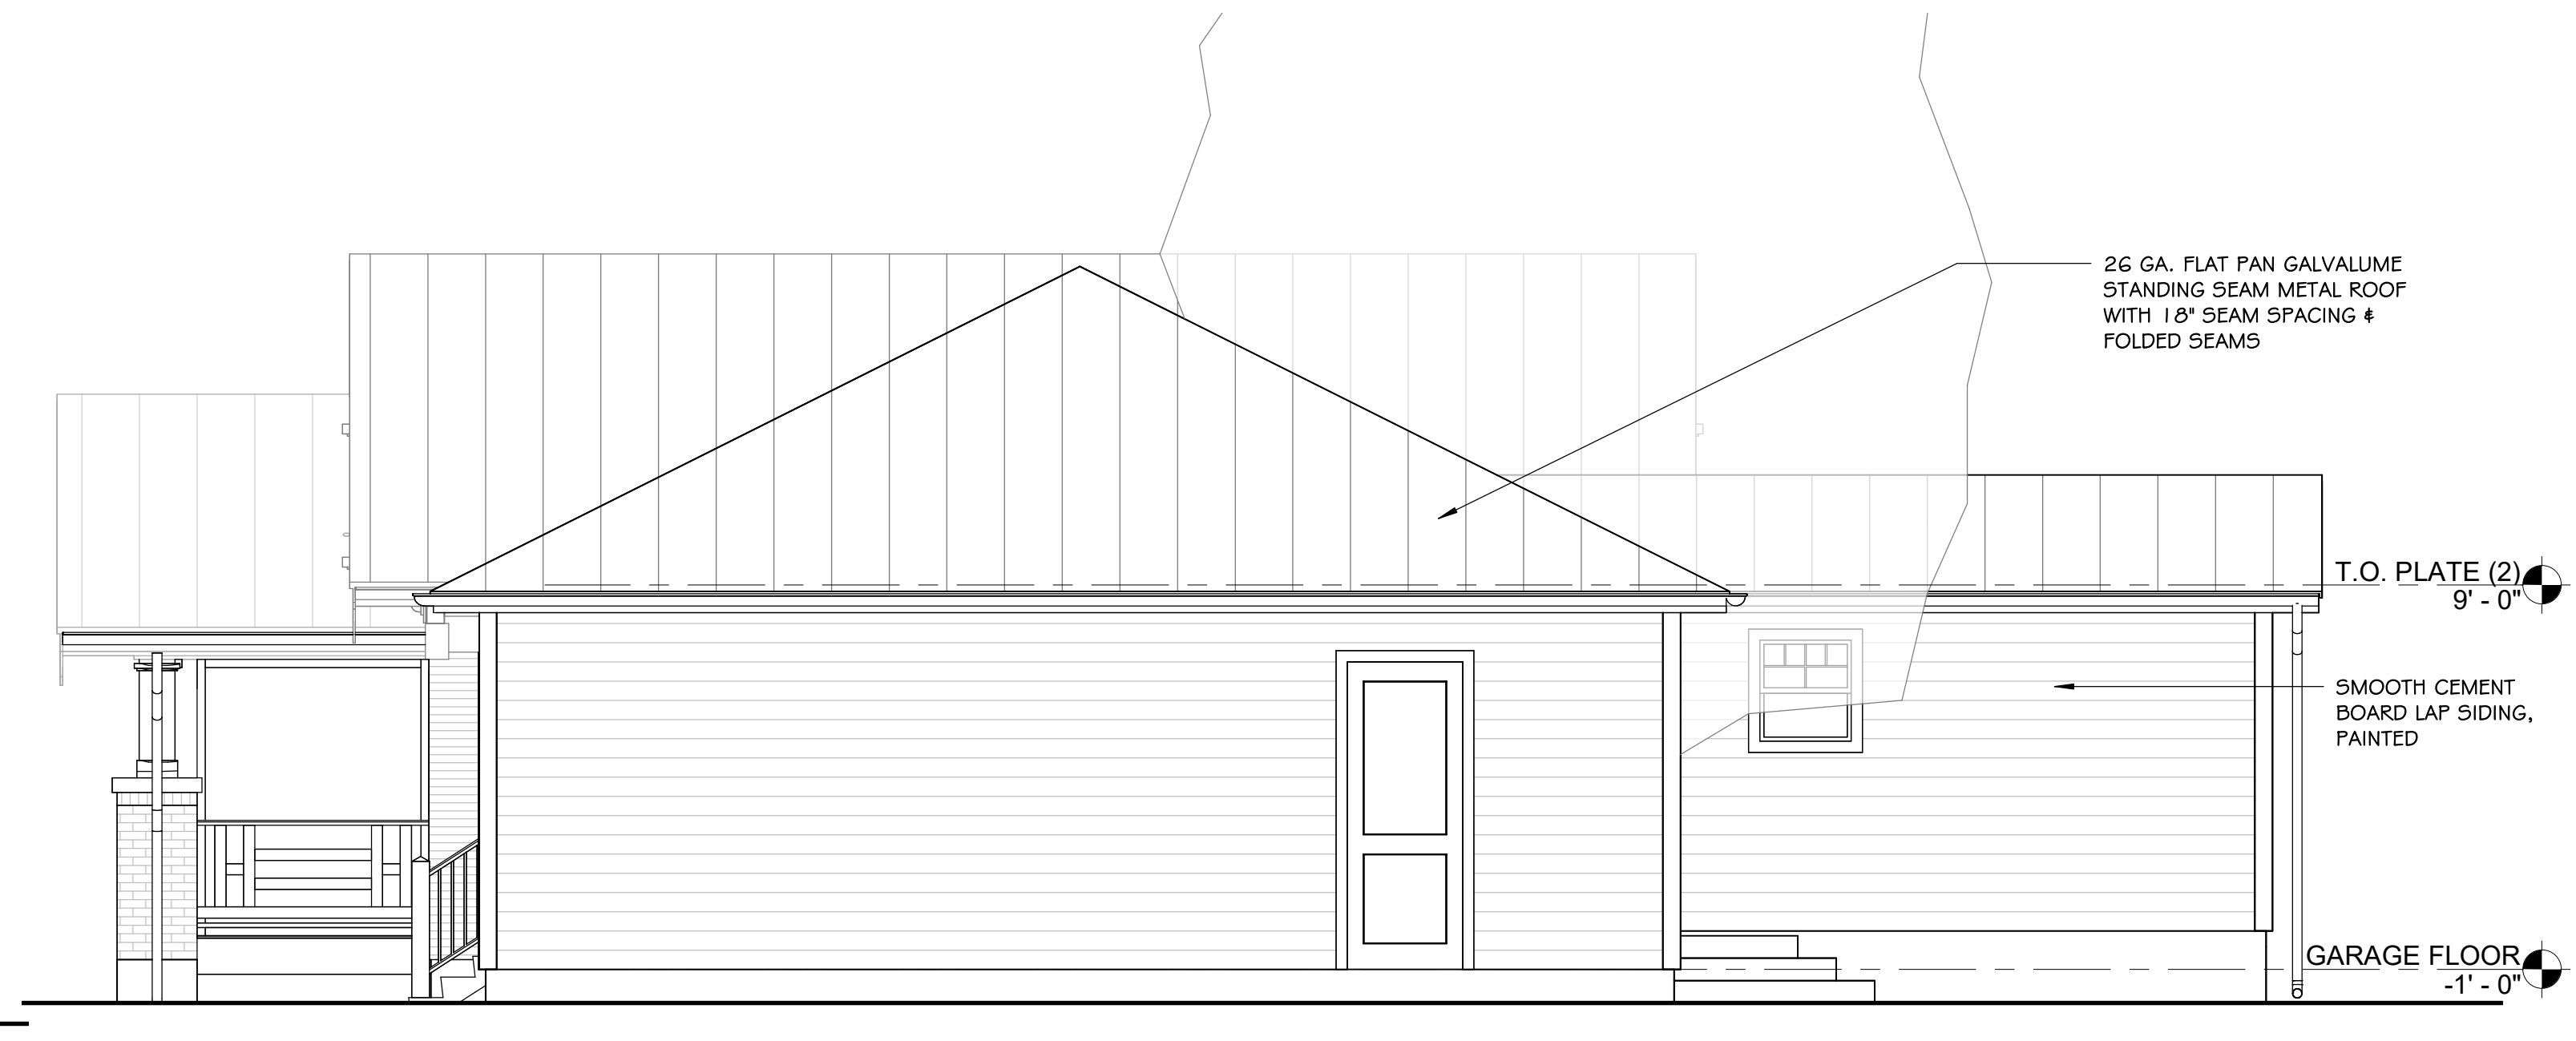
03 WEST ELEVATION
SCALE: 1/4" = 1'-0"

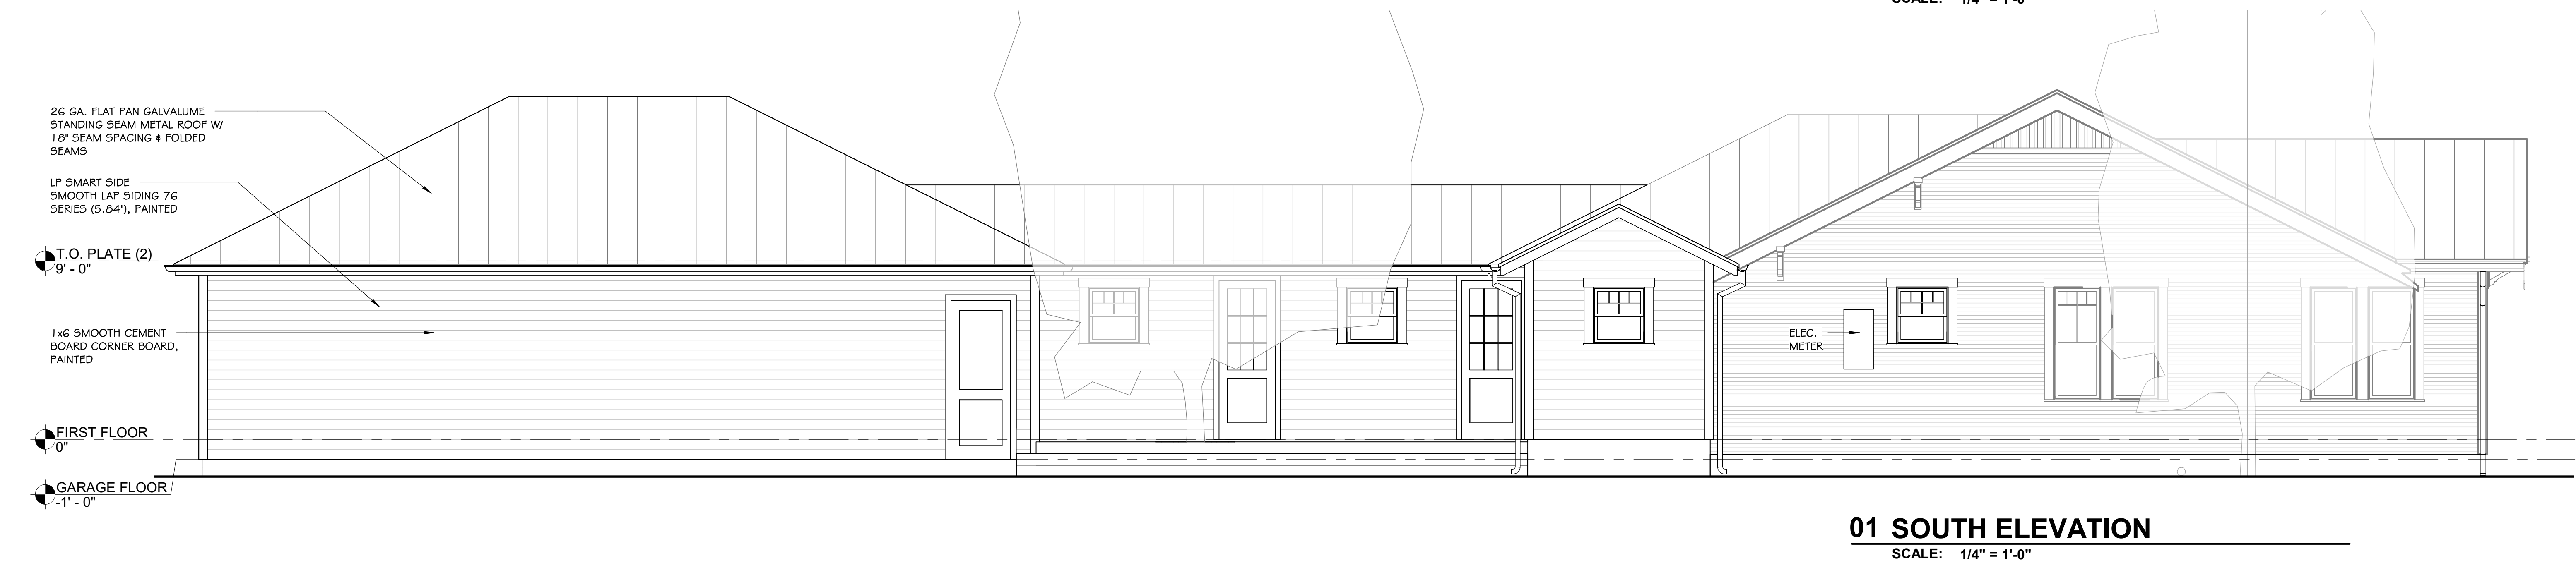
01 SOUTH ELEVATION
SCALE: 1/4" = 1'-0"

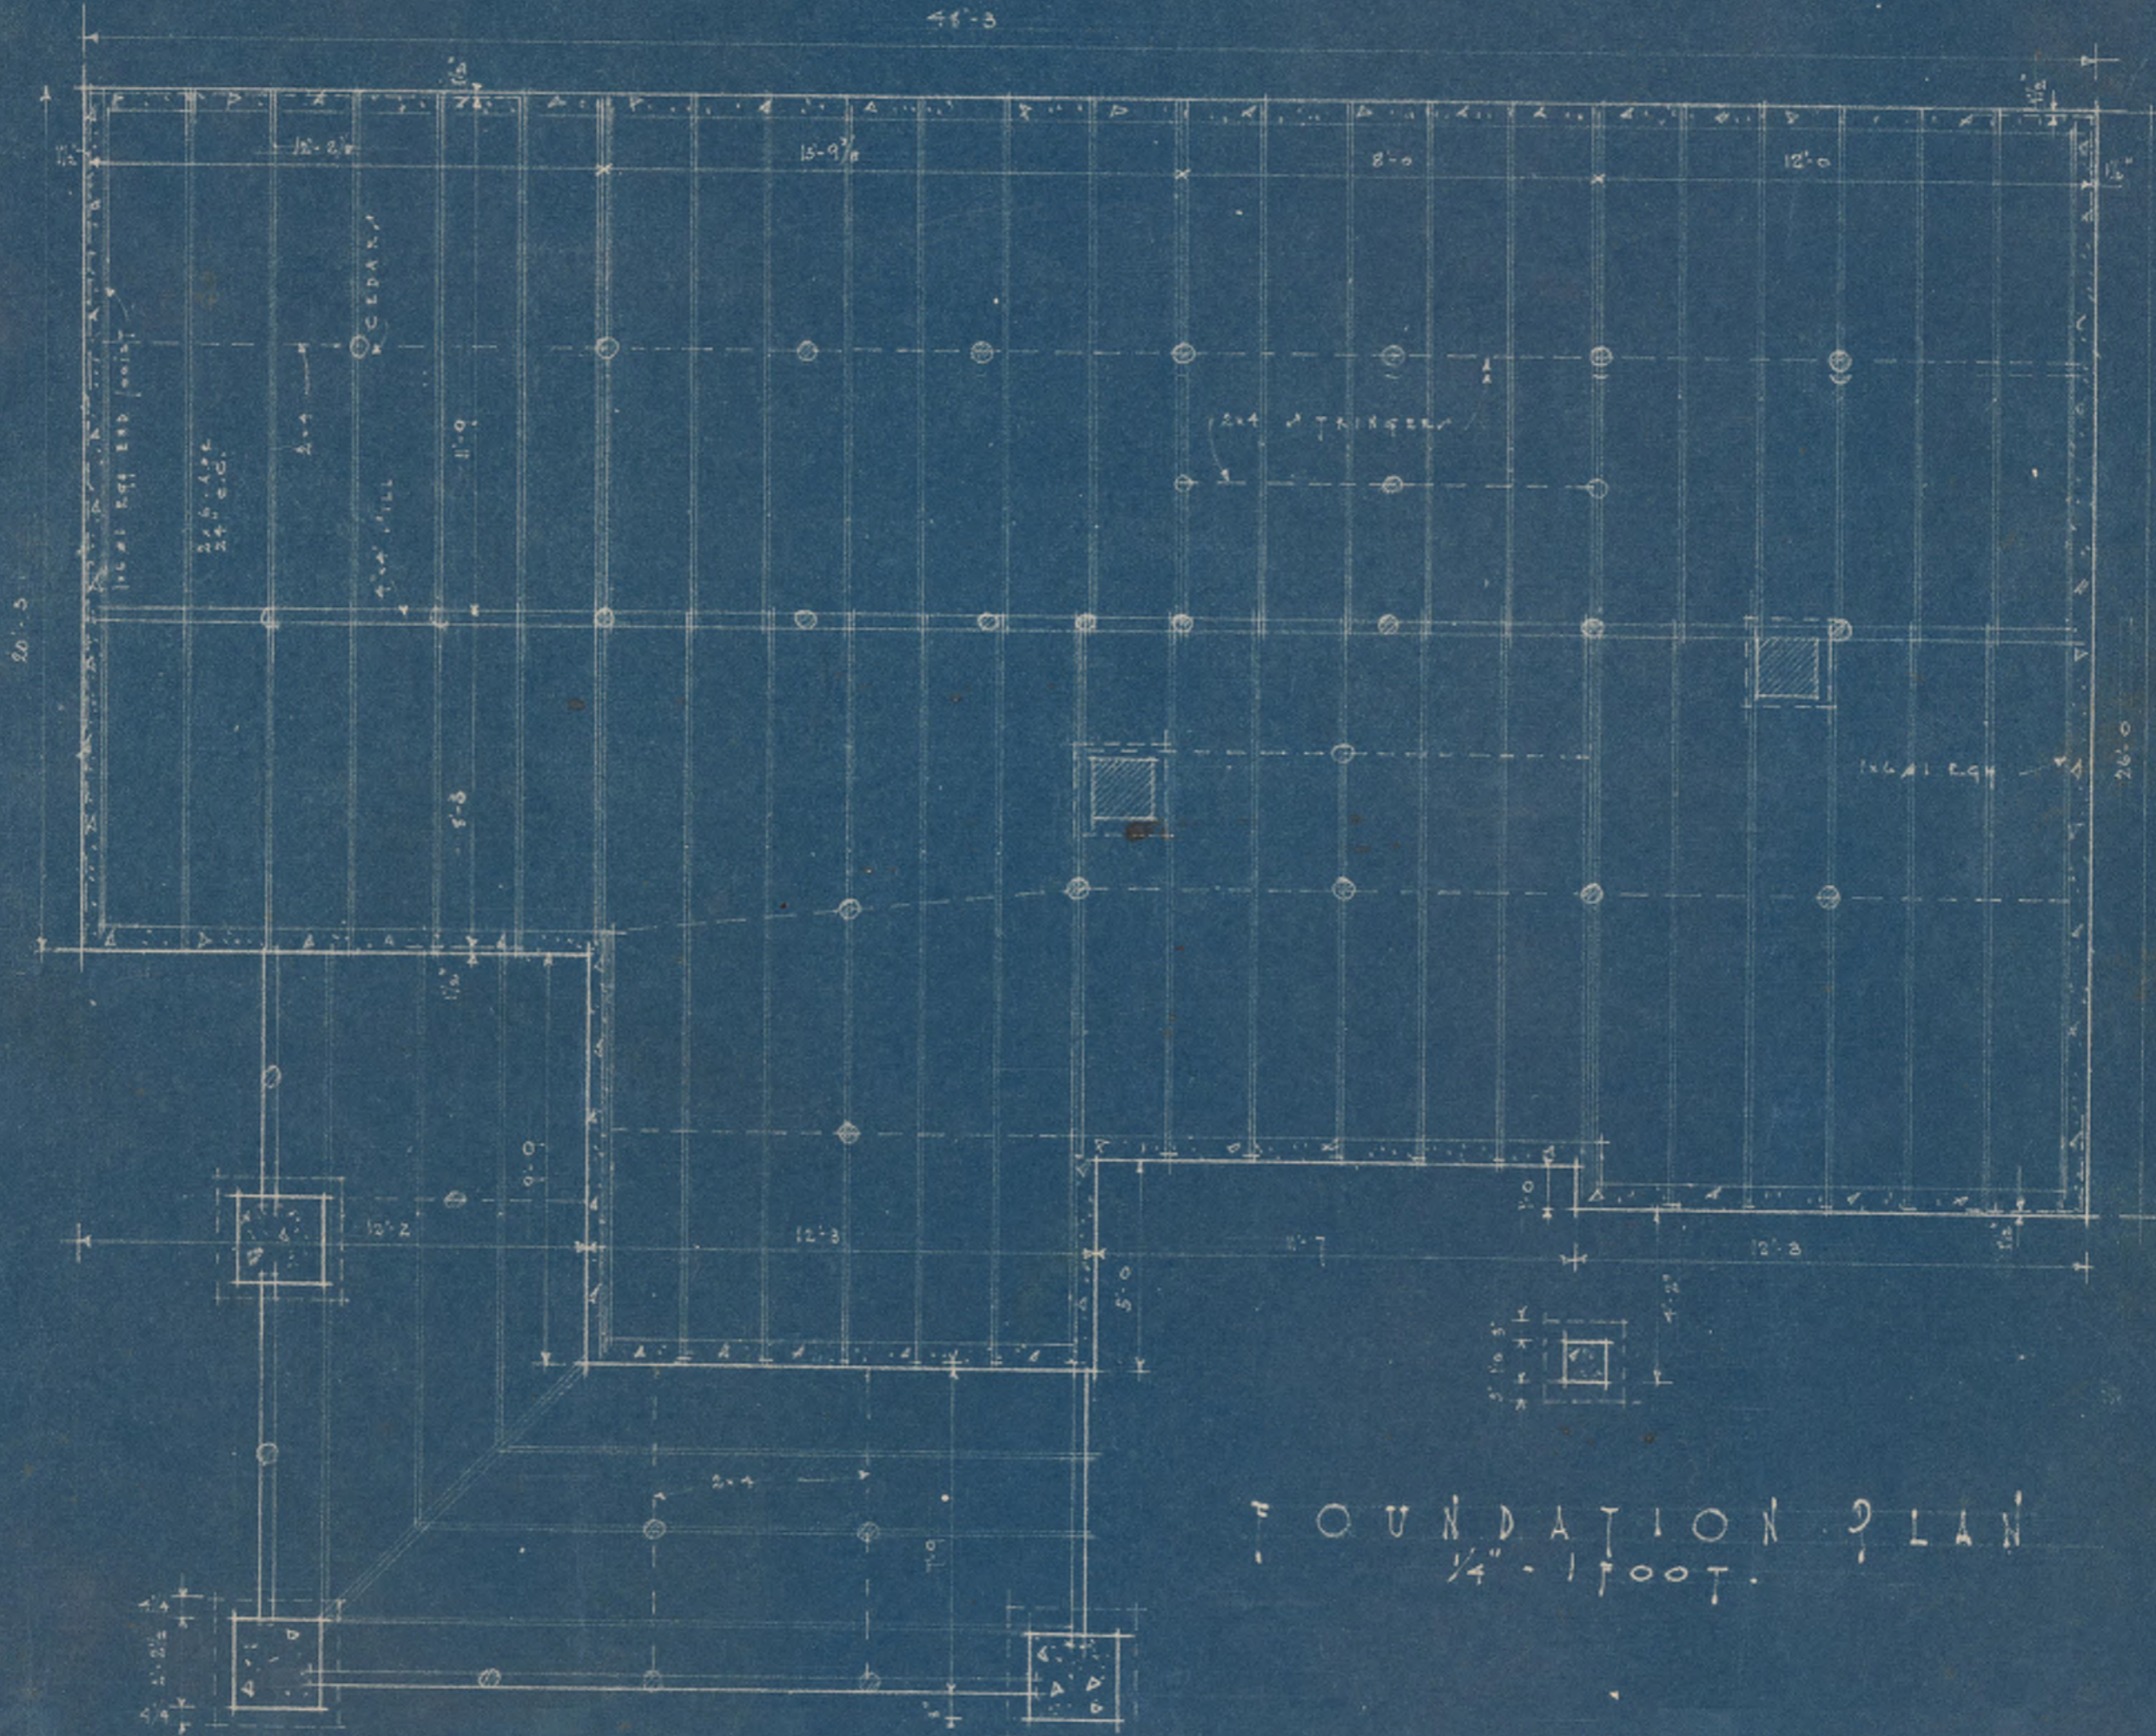
FOUNDATION PLAN
 1/4" = 1 FOOT.

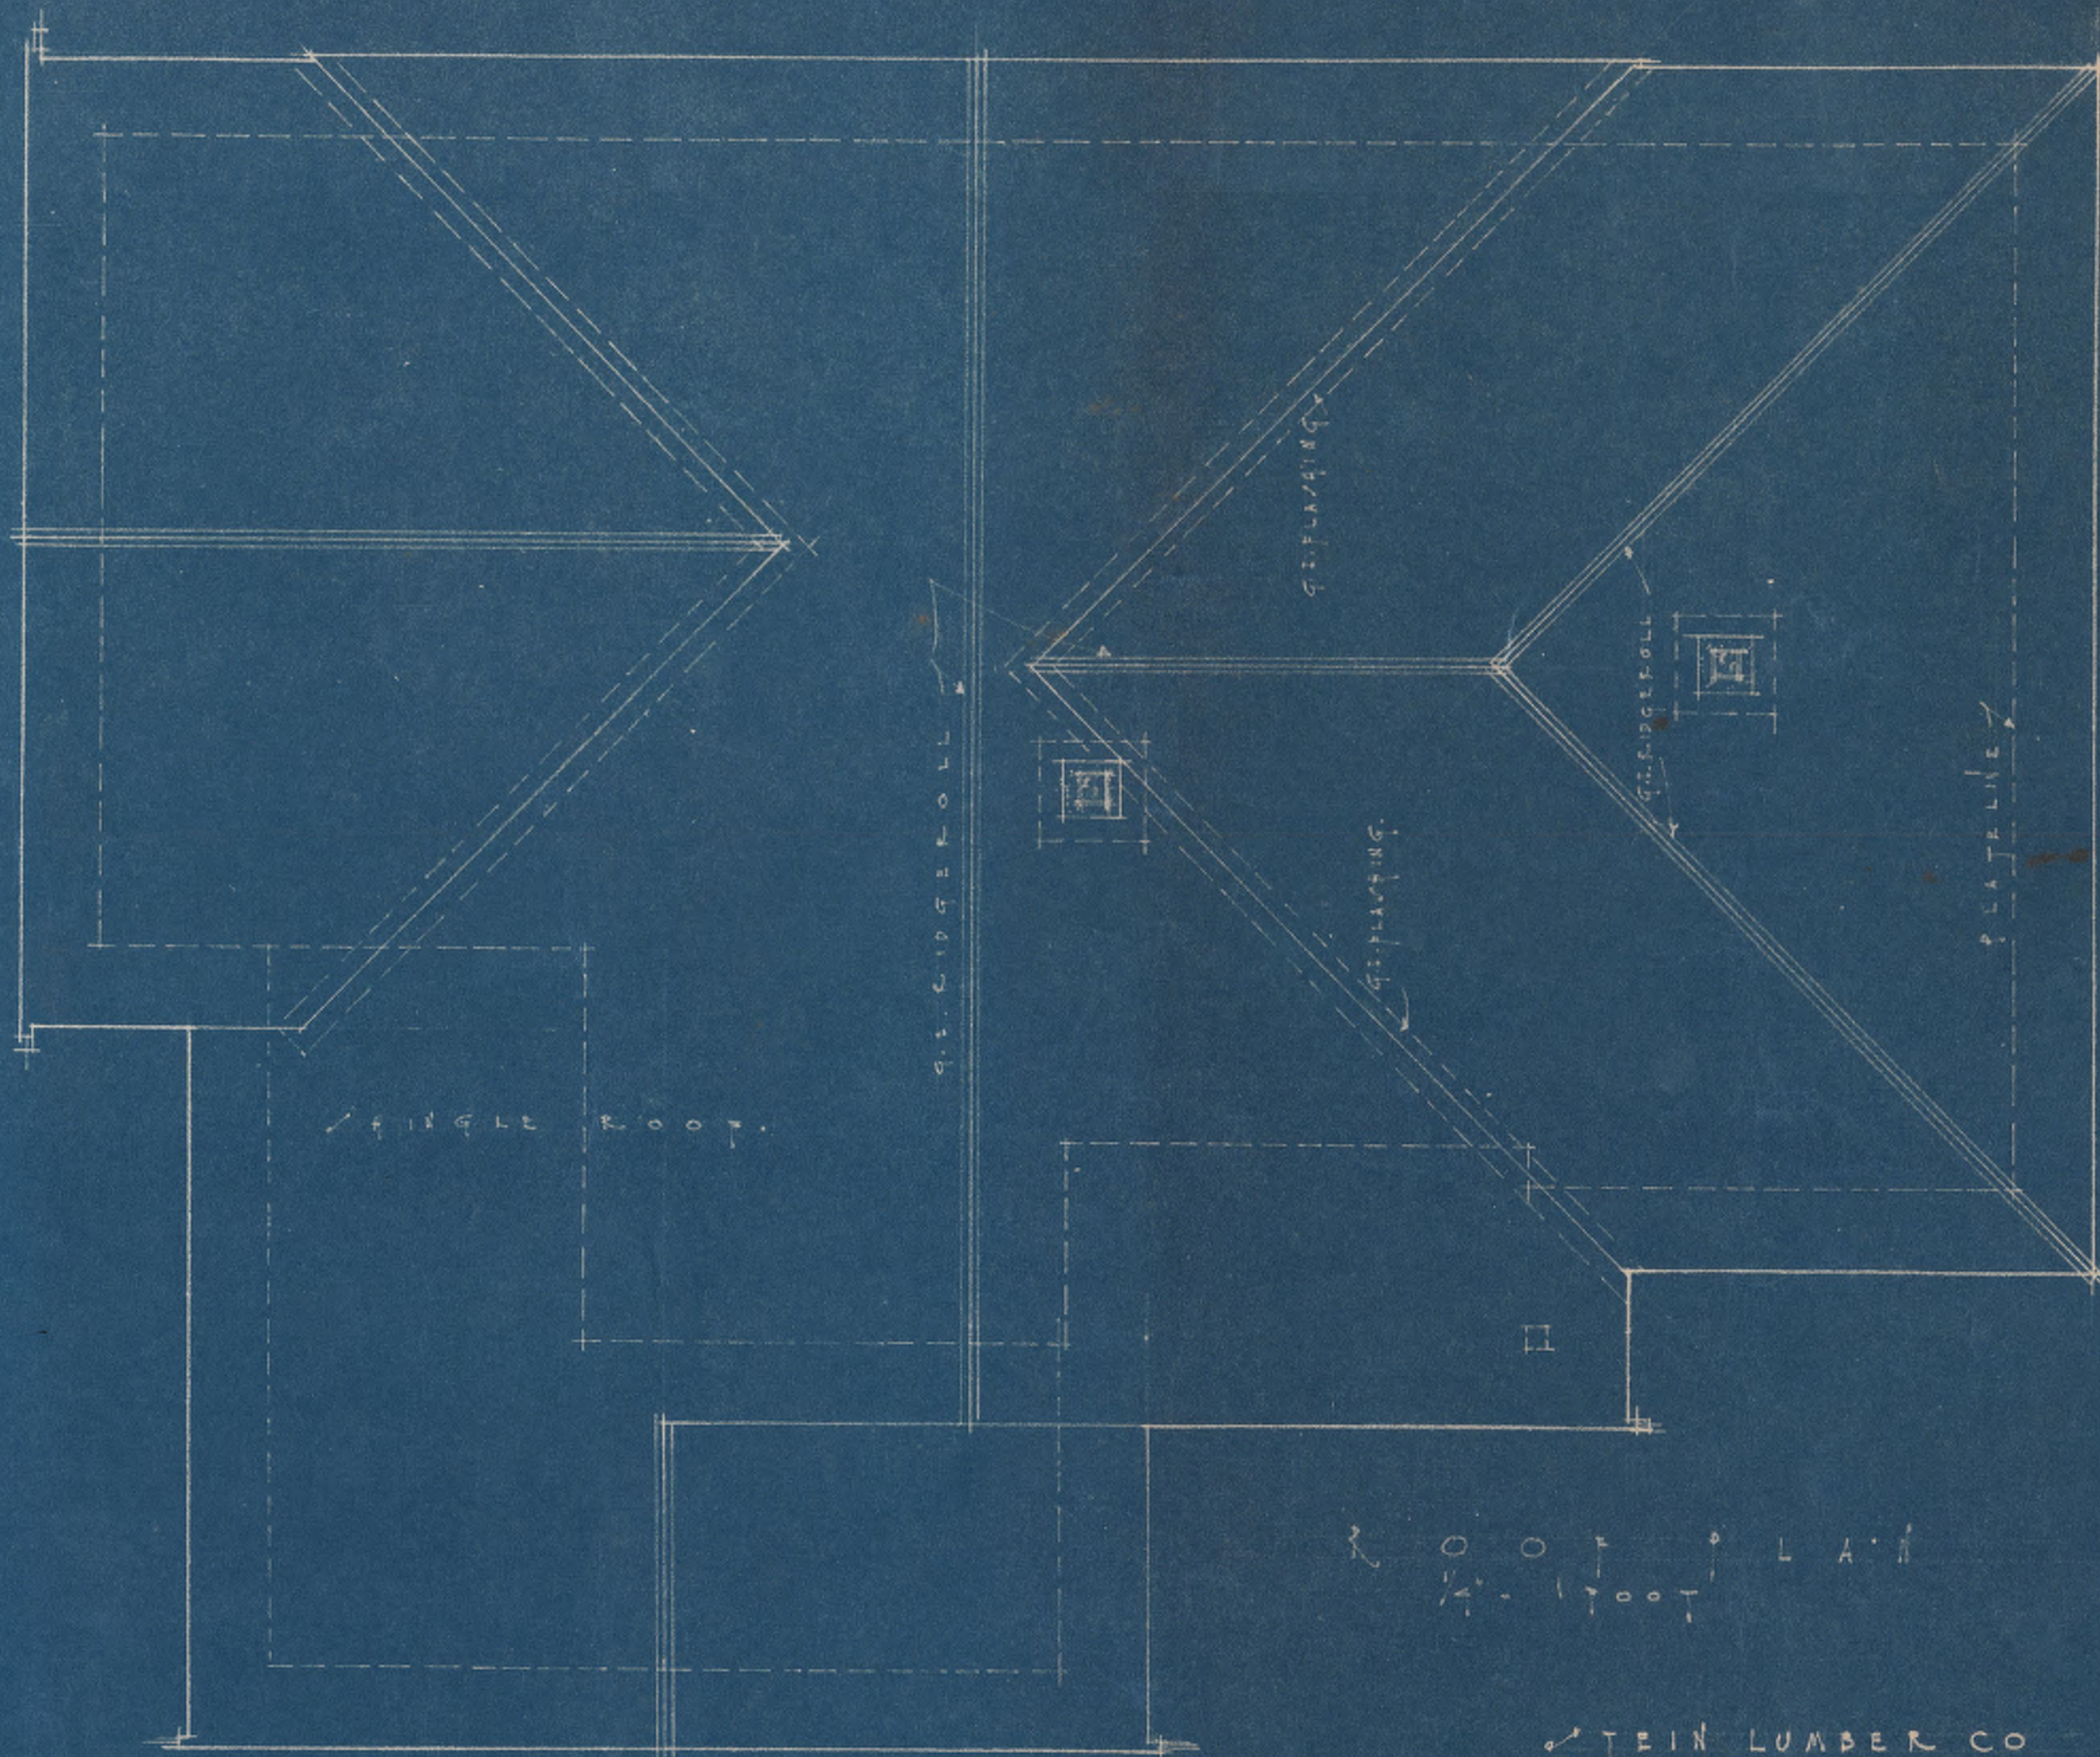
ROOF PLAN
 1/4" = 1' 00"

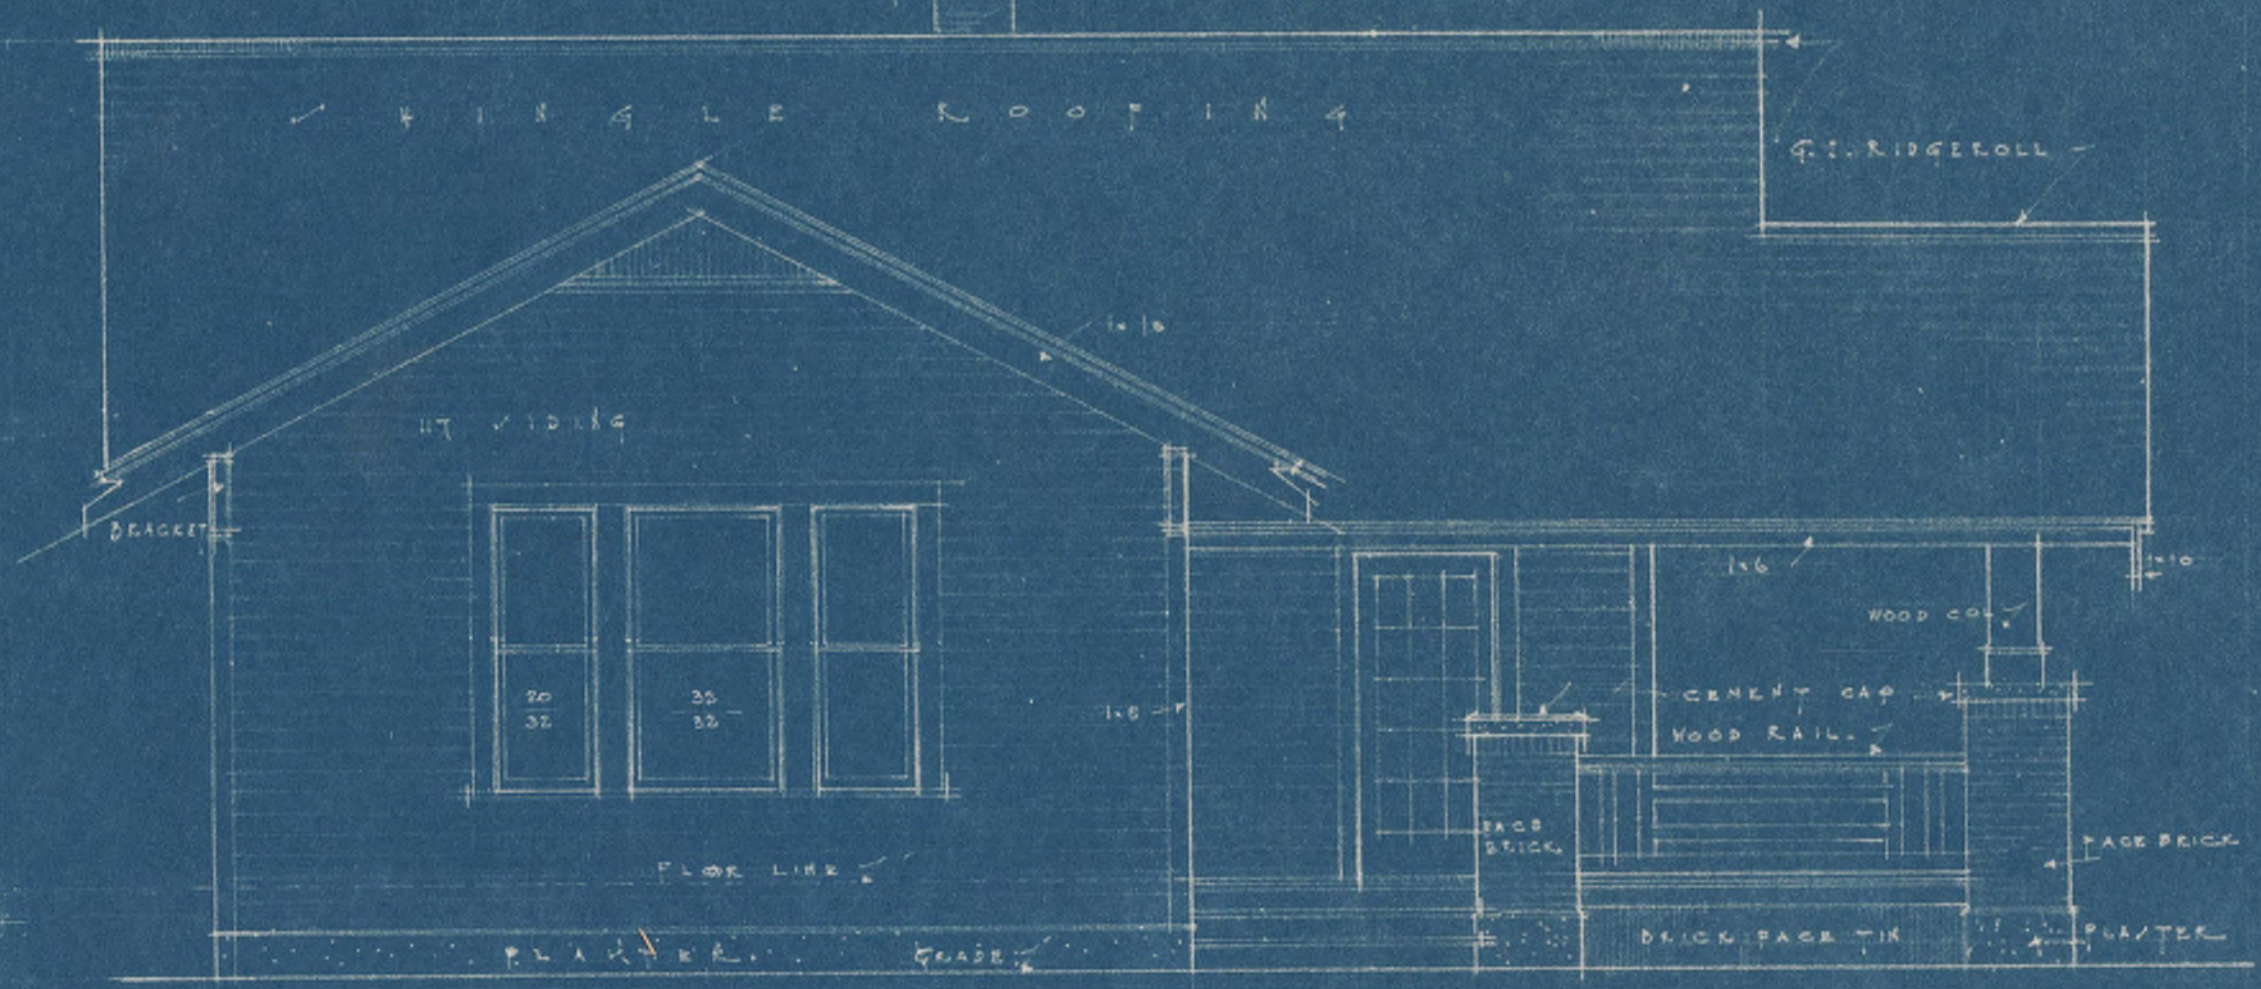
SOUTH EAST ELEVATION
